Technical Report No. 11-10

Haines Highway Mile 25 to the Border: 10-Year Mitigation Monitoring

Alaska Department of Fish and Game

Division of Habitat

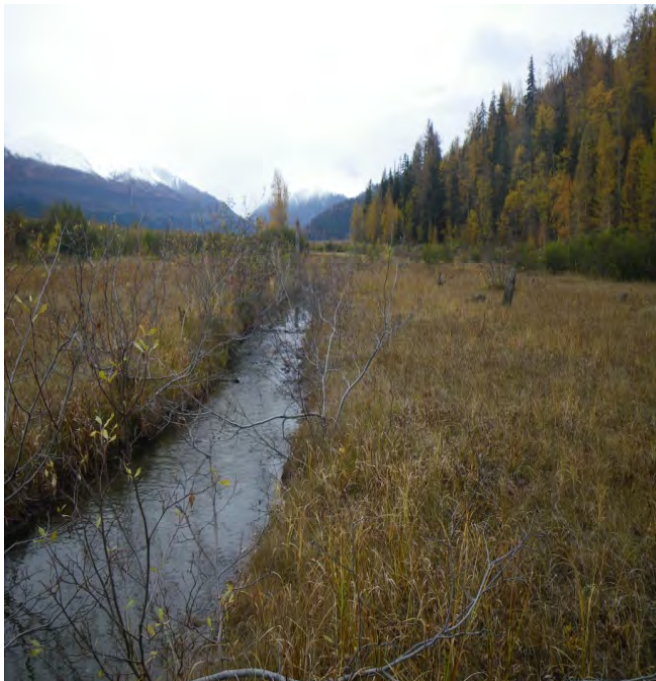
Figure 2.–WT-5 (Section A) looking west.

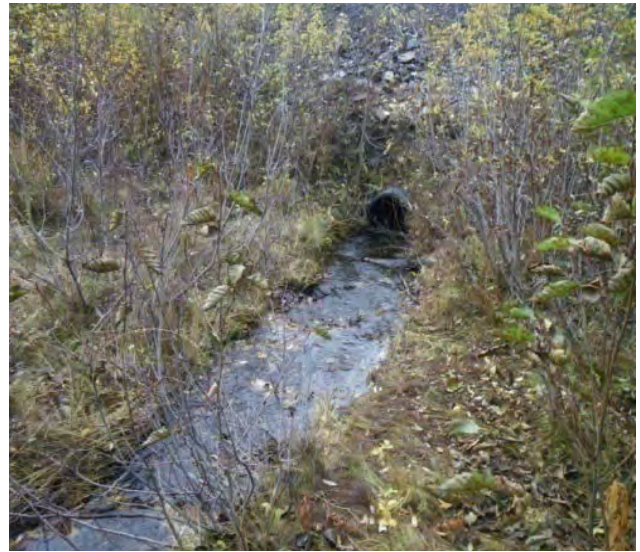
9) and channel that drain the pond in WT-6 are not identified in the original mitigation monitoring plan (Inter-Fluve, 2000) and it is not clear when ADOT&PF installed the culvert designed for water conveyance rather than fish passage.

Figure 9.—Culvert draining WT-6.

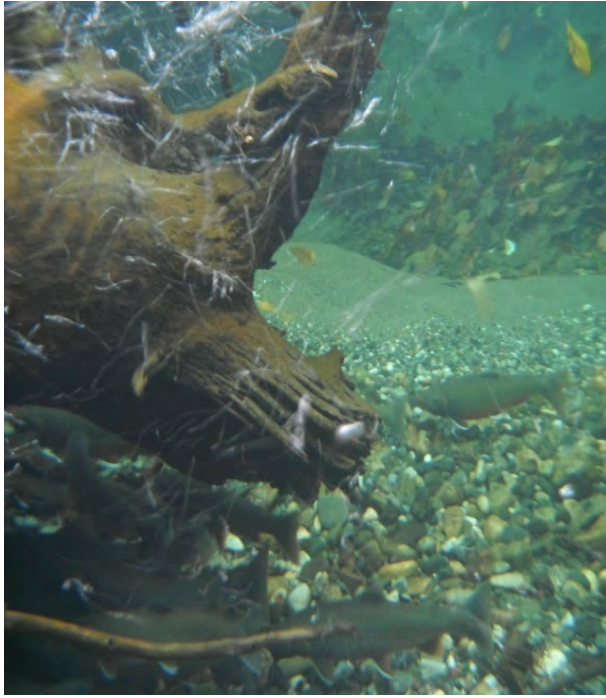
During our survey, we observed adult salmonids throughout CH-13. We saw adult Dolly Varden char and coho salmon holding near almost every river-right rootwad structure (Figure 11). While walking the bank of CH-13, we flushed fish out of holding areas for identification. We observed over 250 adult salmonids while surveying CH-13, the majority of which (80%) were Dolly Varden char. Though our survey was early in the season, we observed a few adult coho salmon carcasses along the banks of CH-13.

Figure 11.—Multiple Dolly Varden char under large woody debris.

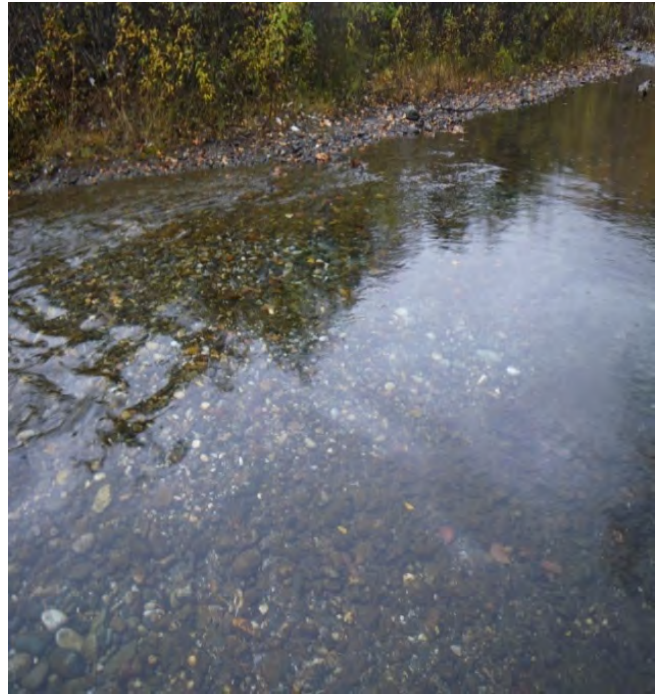
We observed large salmon redds in multiple areas along CH-13, with the majority in the riffle/run area near the inlet of culvert CV-7 (Figure 12). Division of Habitat and Sport Fish staff reported adult Chinook salmon actively spawning in this reach of CH-13. We soaked minnow traps for 24 hours and captured 7 Dolly Varden char (40–95 mm) and 3 coho salmon (60 mm). We observed juvenile salmonids throughout CH-13 during our streambank survey.

Figure 12. Redds upstream of CV-7.

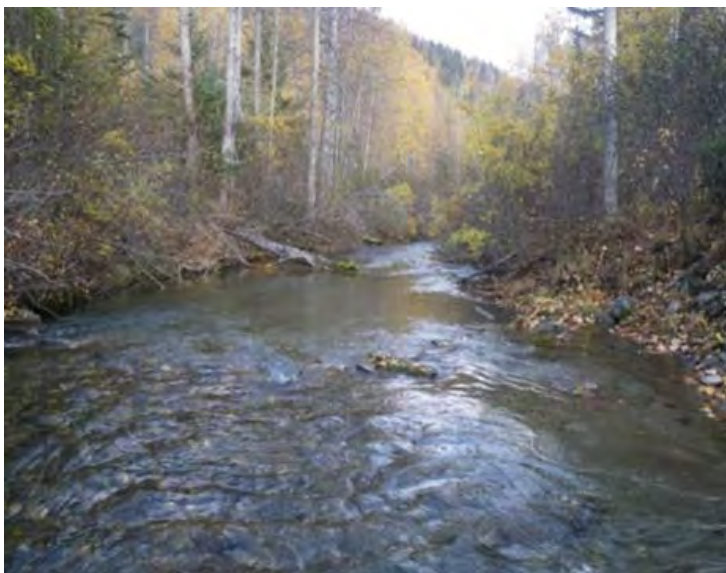
We observed adult Dolly Varden char as we did in stream channel CH-13, holding under the woody debris. Spawning gravels are located in small sections throughout CH-14. The majority of the spawning gravels, however, are located within 100 feet of the outlet of culvert CV-9. We noted that gravel and large woody debris placement in other sections of CH-14 help create habitat diversity, including riffle/run and pool habitat. Juvenile fish trapping, near the outlet of culvert CV-9, produced 7 Dolly Varden char and 3 coho salmon ranging in size from 60 to 170 mm (trap set for 24 hours). We observed juvenile salmonids throughout the survey area.

Figure 13.—Large woody debris and spawning gravels in CH-14.

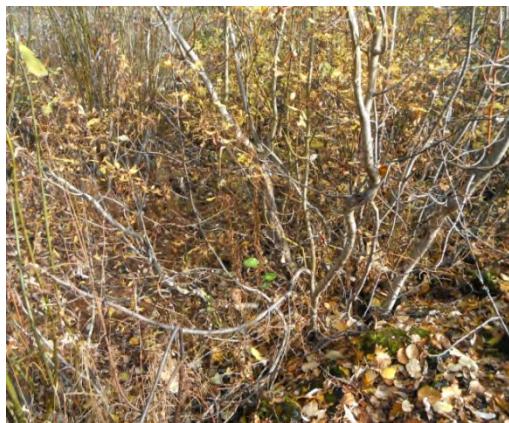
During our survey, both sections of CH-16 were dry. Therefore we did not sample for adult or juvenile salmonids. Vegetation in the channel is established, especially in the lower section of CH-16 (Figure 15), indicating that the channel is dry most of the year. Surface water was only present in the upper pond (Figure 16), where we observed an adult Dolly Varden char.

Figure 15.—Lower section of stream channel CH-16.

By removing the culvert and establishing channel CH-16, the mitigation objective has been achieved. However it is not clear if the design features of the channel contribute to the seasonal flows of Spring Pond Creek. Therefore, we recommend that habitat biologists return to survey the site during a period of high water so we can determine if a modification is required.

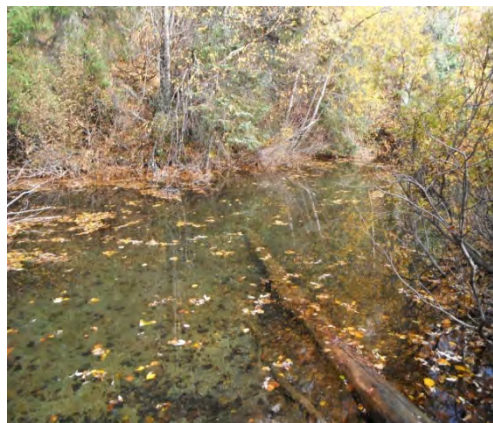
Figure 16—Upper pond of CH-16.

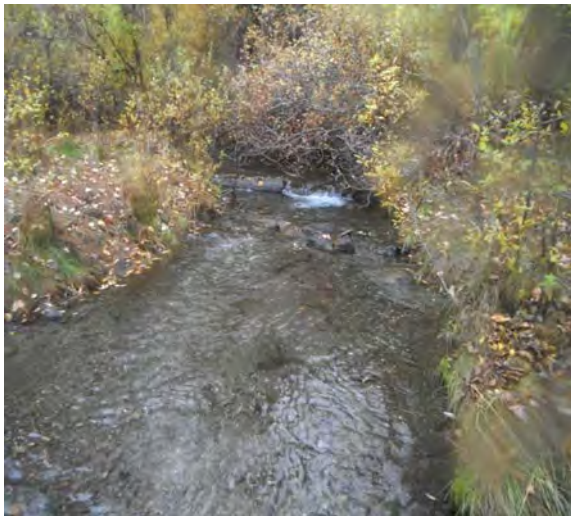
Stream channel CH-17 flows into 37 Mile Creek near stream channel CH-14. The slow to moderate velocity flow in the channel suggests that fish are able to pass through this area. A pool/riffle feature in the upper section of CH-17 is stable and functioning (Figure 17). Streambed material in the channel is made up of sand, organics and some areas of small gravel. The streambanks along CH-17 are gradually sloping, except for a few areas where undercut banks are starting to develop. Riparian vegetation is established, and the channel appears to provide rearing habitat. Though we did not set minnow traps in the channel, we observed juvenile salmonids. We did not observe adult salmonids during our survey. Anecdotally, area residents report that adult coho salmon pass through CH-17 to access upstream spawning habitat.

Figure 17.–Pool/riffle habitat in CH-17.

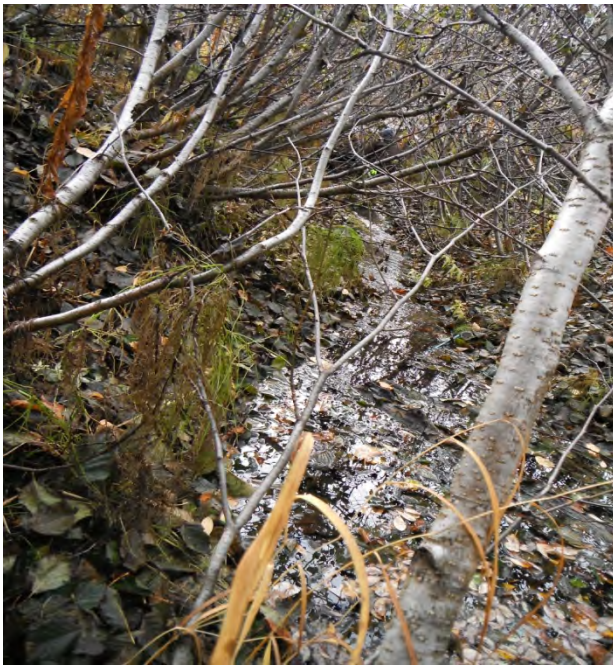
Figure 18.—Low water in stream channel CH-18.

The mitigation objective for stream channel CH-18 is too vague. Stream channel CH-18 does convey water flow to culvert CV-10, but we were unable to document fish passage through the channel. The 37½ Mile Creek is cataloged for coho salmon and Dolly Varden char. When replacing a section of a cataloged stream, fish passage needs to be maintained. We recommend that habitat biologists return to survey the channel when water levels are higher.

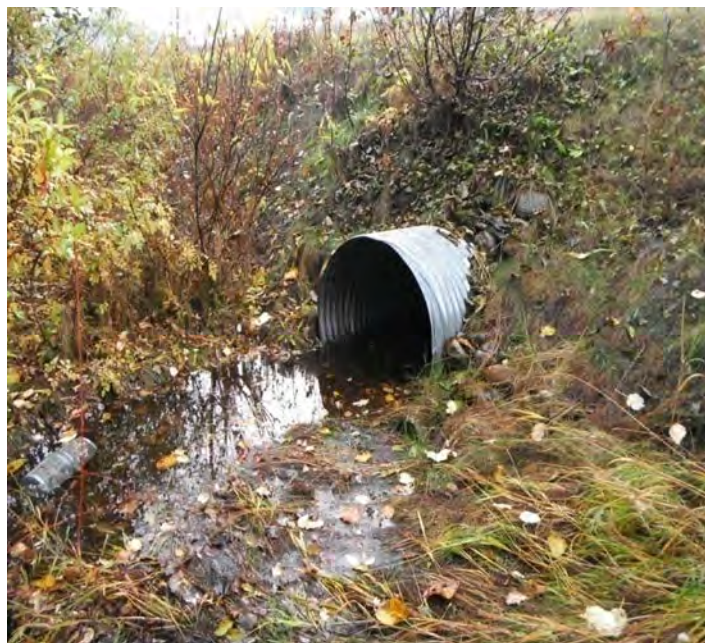
The culvert is well bedded at the inlet (Figure 20), where multiple juvenile salmonids were observed. The streambed within the culvert is comprised of sand, gravel and organic material that is stable. The size of the culvert is appropriate for the size of the stream, and there is no visual change in water velocity as the stream enters the culvert. We set a baited minnow trap near the inlet of CV-6 and soaked it for 24 hours.

Figure 20.—Inlet to culvert CV-6.

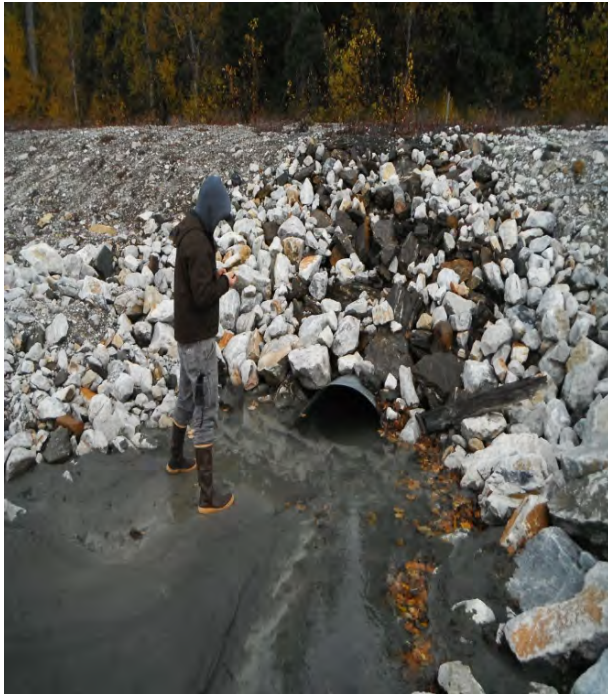
The outlet of culvert CV-6 may have been set to design specifications, but it is slowly filling up with sediment (Figure 21). The boulders placed near the outlet of the culvert may compound sediment accumulation (Figure 22). We observed juvenile salmonids near the outlet of CV-6, and set a baited minnow trap near the outlet, soaking it for 24 hours. We captured 15 Dolly Varden char (60–100 mm) and 7 coho salmon (60–80 mm) near the inlet of culvert CV-6. The trap set near the outlet of CV-6 produced 7 Dolly Varden char (60–100 mm) and 26 coho salmon (50–75 mm).

Figure 21—Outlet of culvert CV-16.

Culvert CV-6 has met the mitigation objective by providing fish passage; however the accumulation of sediment near the culvert outlet will need to be addressed. The accumulation may restrict adult fish passage through CV-6, and it may become a problem for juvenile fish passage in the future. We recommend that ADOT&PF work with Habitat Division to address this issue as soon as possible.

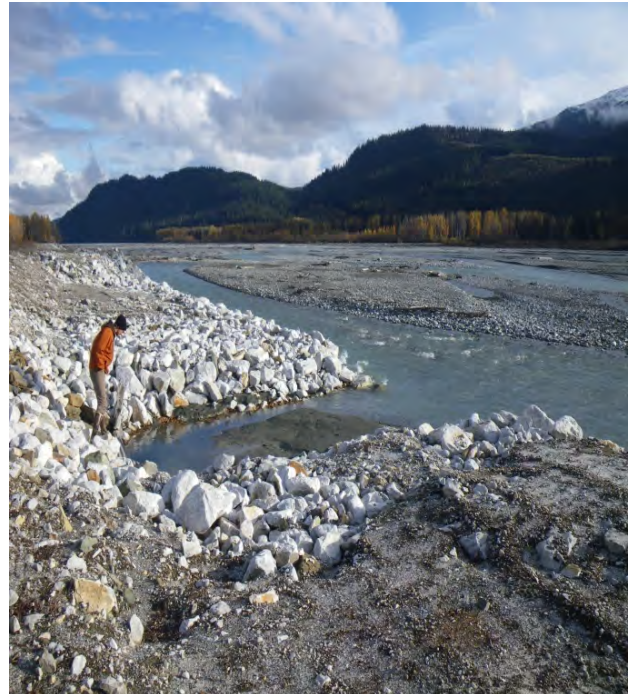
Culvert CV-6 is located in a section of the Haines Highway that is directly adjacent to the Klehini River (Stream No. 115-32-10250-2077). Fill material has been placed along this section of the highway (1–2 miles) to help stabilize the highway embankment and protect against erosion. This project is not identified in the original mitigation plan. It is not clear when the

Figure 22.—Fill material placed near CV-6.

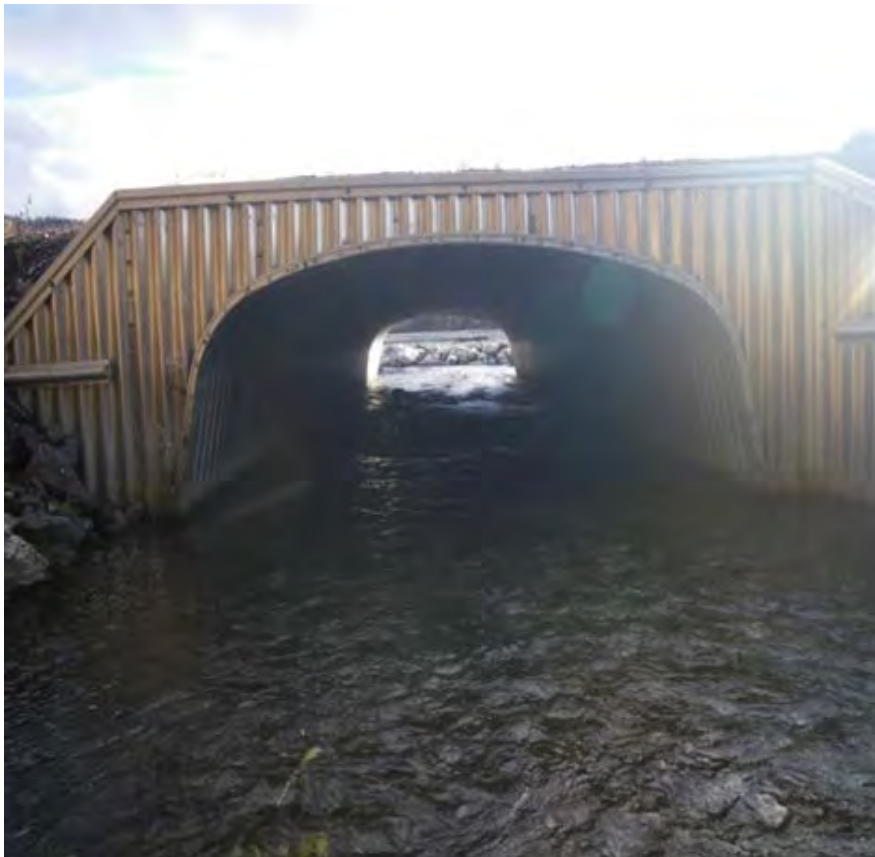
Streambed material within culvert CV-7 is stable (spawning sized gravel; Kondolf and Wolman, 1993), and the culvert is the appropriate size for the stream (Figure 23). Water velocity through the culvert does not appear to change or represent a fish passage barrier. We set two baited minnow traps near the culvert inlet allowed them to soak for 24 hours, capturing 7 Dolly Varden char (40–95 mm) and 1 coho salmon (60 mm). We observed multiple redds approximately 20 feet upstream of the culvert inlet, and Divisions of Habitat Sport Fish staff observed adult Chinook salmon actively spawning within the culvert earlier in the season.

Figure 23.—Inlet to culvert CV-7.

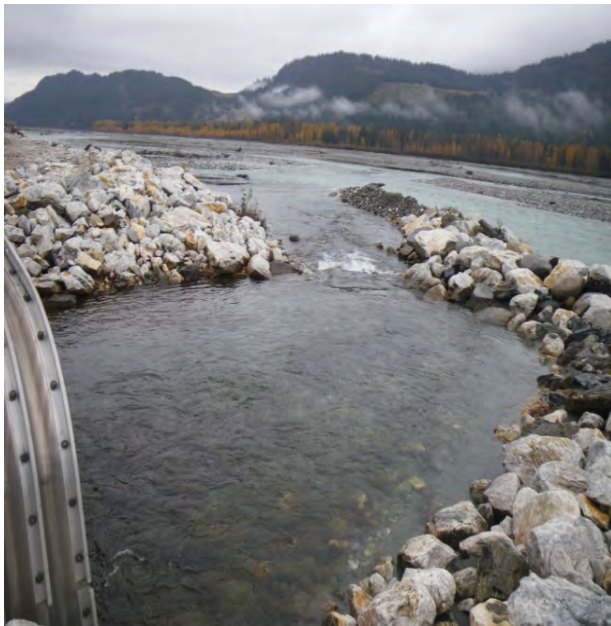
Approximately 50 adult salmonids (coho salmon and Dolly Varden char) were holding in the constructed pool just downstream of the culvert (Figure 24). Fill material has also been placed along the highway near the outlet of culvert CV-7 and is placed in a way that prevents sediment accumulation from the Klehini River. We observed adult coho salmon holding under rootwad structures associated with the fill project along the highway (Figure 25).

Figure 24.—Outlet pool and fill material near CV-7.

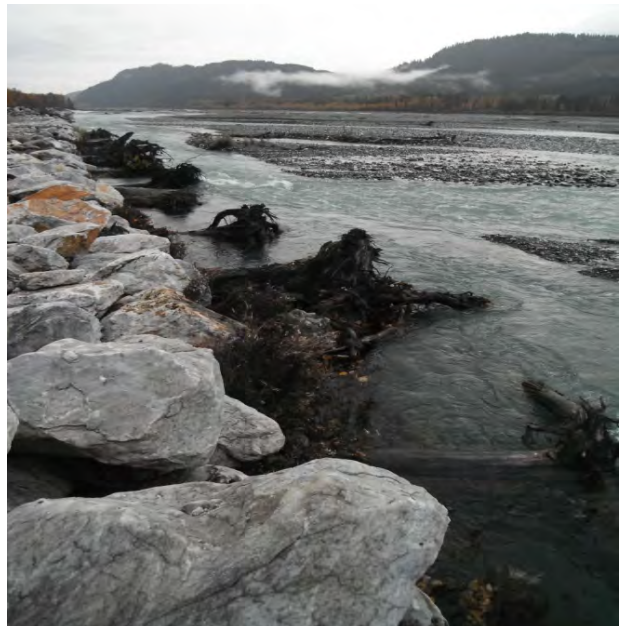
Figure 25.—Rootwad structures near CV-7.

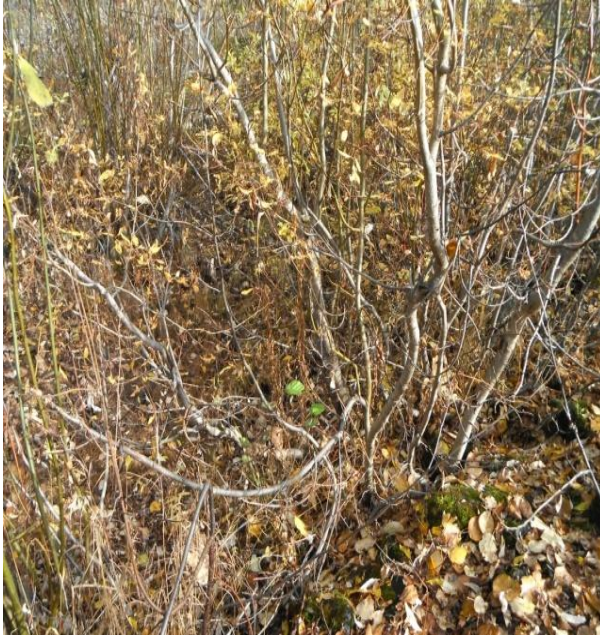
During the 2011 survey, both sections of CH-16 were dry (Figure 2). There was no sampling effort for adult or juvenile salmonids within the stream channel. Surface water was only present in the upper pond, where an adult Dolly Varden char was observed. During the 2011 survey, it was not clear if design features of the channel contributed to the seasonal flows of Spring Pond Creek. Therefore, it was recommended that ADF&G biologists return to survey the site during a period of high water so it can be determined if a modification is required (Hitselberger and Kern, 2011).

Figure 2.–Lower section of CH-16 10/10/2011.

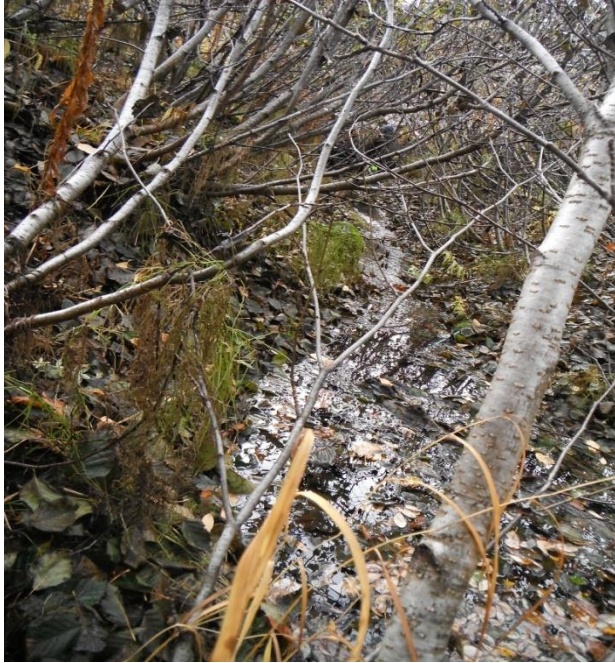
During the 2011 survey the water level in CH-18 was very low (Figure 4), and salmonids were not observed or captured in the stream channel. It was recommended that habitat biologists return to survey the channel when water levels are expected to be higher and a more thorough fish survey can be done (Hitselberger and Kern 2011).

Figure 4.—Stream Channel CH-18 10/10/11.

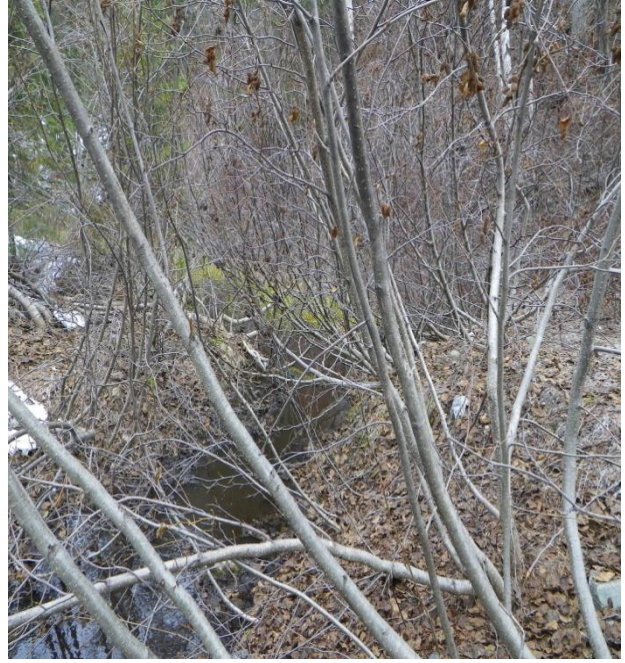
The water level in stream channel CH-18 was higher during our 5/10/12 survey (Figure 5). We electrofished the stream channel and 37½ Mile Pond, however no fish were observed or captured while electrofishing. Baited minnow traps were placed in the upper section of stream channel CH-18 on 6/13/12, and were set for 24 hours. Four juvenile coho salmon (40–60 mm) were captured when the traps were retrieved on 6/14/12.

Figure 5.—Stream Channel CH-18 5/10/12.

Stream channel CH-18 does provide anadromous fish habitat and passage from culvert CV-10 to 37 ½ Mile Pond. Based on our observations, the mitigation objective for stream channel CH-18 has been achieved. Without knowing what type of habitat was covered by fill during the reconstruction project, there are no modifications recommended for stream channel CH-18.

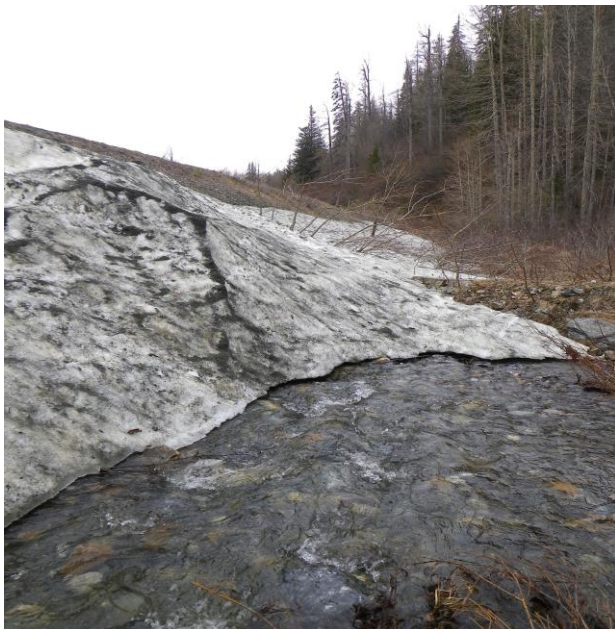
The culvert appears to be installed to the design specifications; however ice and snow limited our 5/10/12 survey (Figure 9). No fish were observed or captured while electrofishing above the culvert. Baited minnow traps were placed up and downstream of the culvert on 6/13/12. They were retrieved on 6/14/12 with no fish were captured. On 8/5/12, six baited minnow traps were placed downstream of culvert CV-11 in a large pond (Figure 10). This pond is also directly downstream of culvert CV-12. Minnow traps were retrieved on 8/6/12 with no fish captured in the pond. However, multiple Dolly Varden char (350–400 mm) were documented during a rod and reel survey of the pond that same day.

Figure 9.—CV-9 inlet 5/10/12.

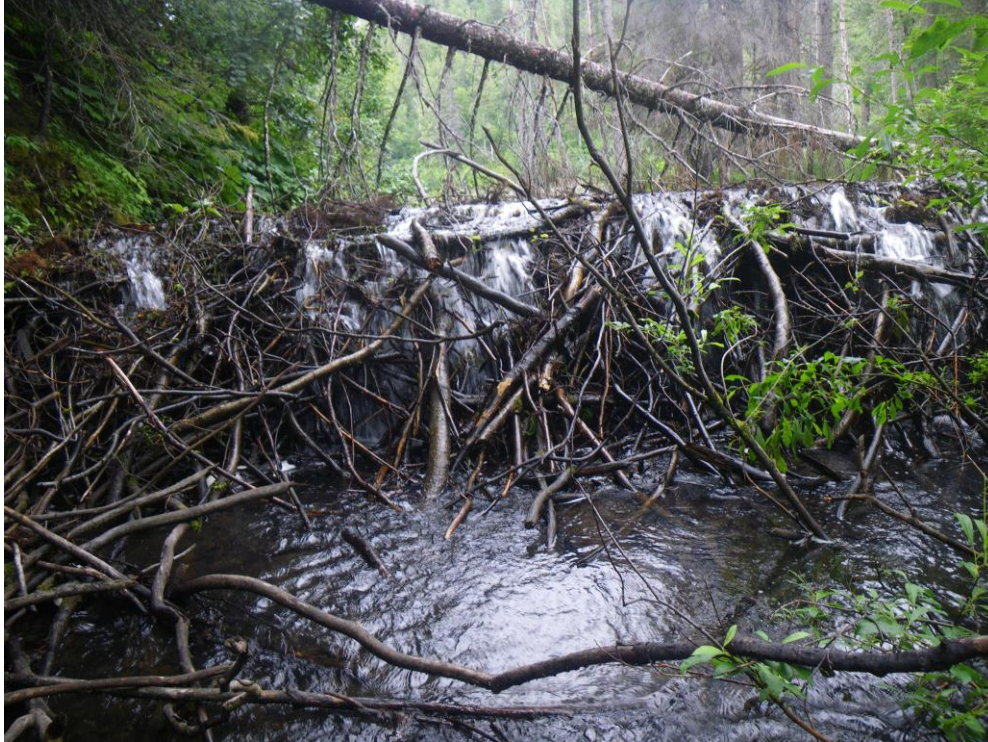
Due to the lack of anadromous fish in this portion of 37 Mile Creek, we conducted a survey downstream of the pond on 8/9/12. A large beaver dam complex was located just downstream of the pond (Figure 11). The first beaver dam measured approximately 4.5 ft above the water line. The pool below the dam was clogged with woody debris, and we were unable to record the maximum depth of the pool. The Alaska Forest Resources & Practices Regulations (Alaska FRPA, 2007) identify an anadromous fish barrier when the unobstructed pool depth is less than 1.25 times the jump height (Table 1). This beaver dam is an anadromous fish barrier because of the obstructed pool directly below the beaver dam.

Figure 11.—Beaver dam downstream of culvert CV-11 and CV-12.

The major indicator of project success is salmonid use of the mitigation sites. Anadromous fish have not been documented above culvert CV-11 during this survey because of a natural anadromous fish passage barrier downstream. There is no evidence that suggests design and installation features of culvert CV-11 restrict up and downstream fish passage. This culvert has been designed and installed to specifications that are intended to achieve the mitigation objective.

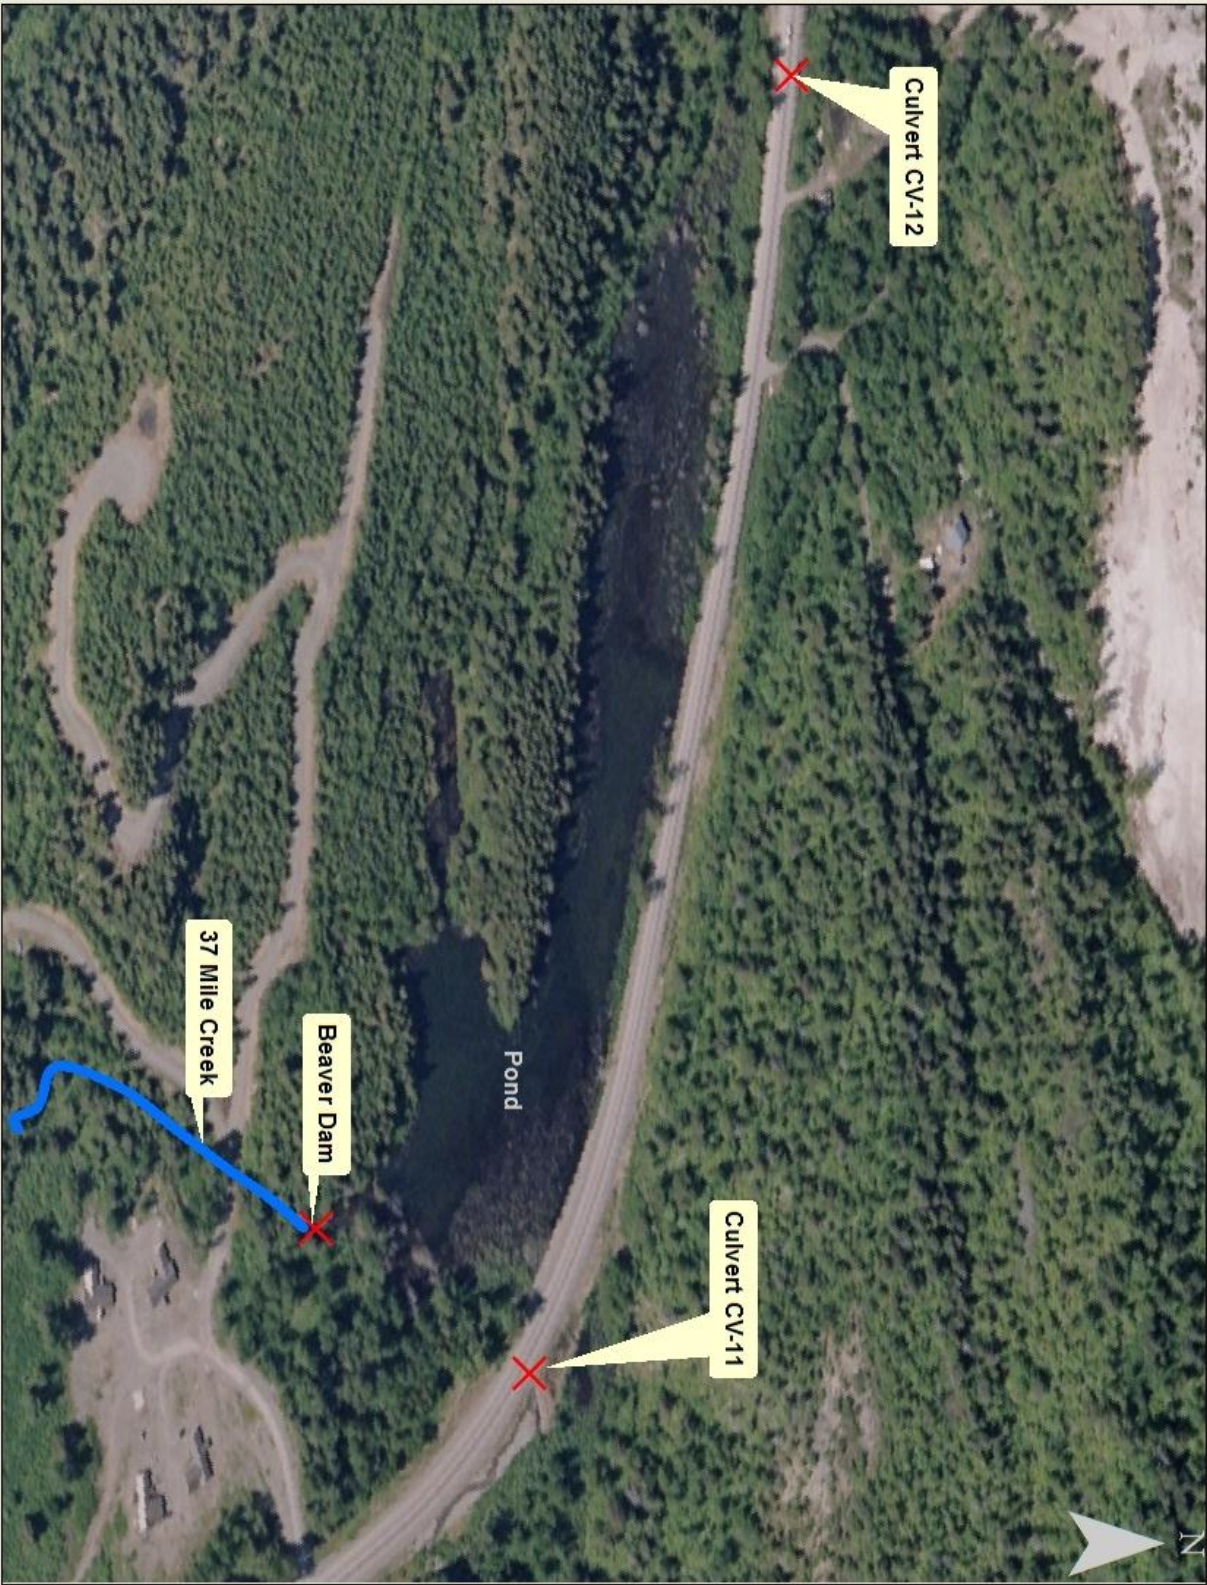
Figure 14.—Location of beaver dam, and Culvert CV-11 and CV-12.

During this survey, anadromous fish were not documented above culvert CV-12 because of a downstream anadromous fish barrier (Figure 14). The culvert is designed and installed to specifications and there are no modifications needed to provide adequate passage for fish upstream and downstream.

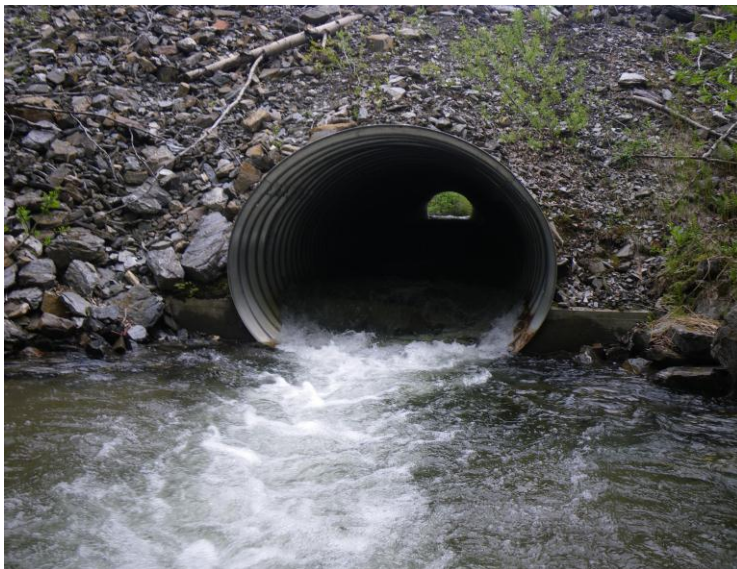
Figure 15.–Culvert CV-13 outlet with baffles.

The mitigation objective for culvert CV-13 has been achieved, no further monitoring is recommended.
