**GEOLOGIC HAZARD SUMMARY**  
**ARRANGED BY 2012 SEIS STATIONING**  
 LYNN CANAL HIGHWAY PHASE 2  
 2012 SEIS ALIGNMENT HAZARD REVISIONS

HDR / 2012 SEIS JUNEAU ACCESS / AK

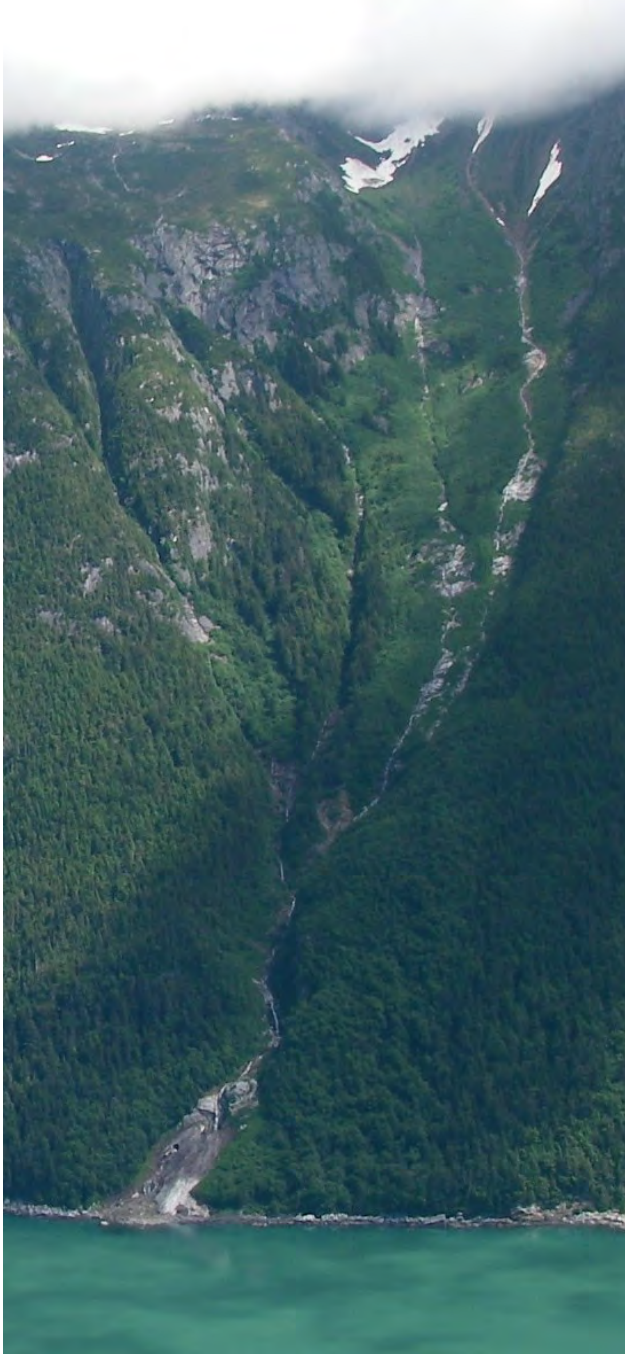
DF29. View east/upslope at debris flow channel and avalanche path.

Hazard ID #:	DF29
Hazard Type:	debris_flow
HIN:	153
Rating:	A
2012 SEIS Alignment Location:	2115
Frequency (yrs):	1-5
Predictability:	moderate
Material Volume (CY):	10-100
Clast Size (ft):	1-2
Source Elev. (ft):	3000+
Centerline Slope:	fan
Alignment Location:	deposition_zone
Impact Alignment:	yes
Alignment Exposure (ft):	200-500
Vegetation:	denuded
Deciduous Trees:	yes
2012 SEIS Alignment South Margin:	2114+10
2012 SEIS Alignment North Margin:	2116+60
Photo #:	5125, 5926, 6248

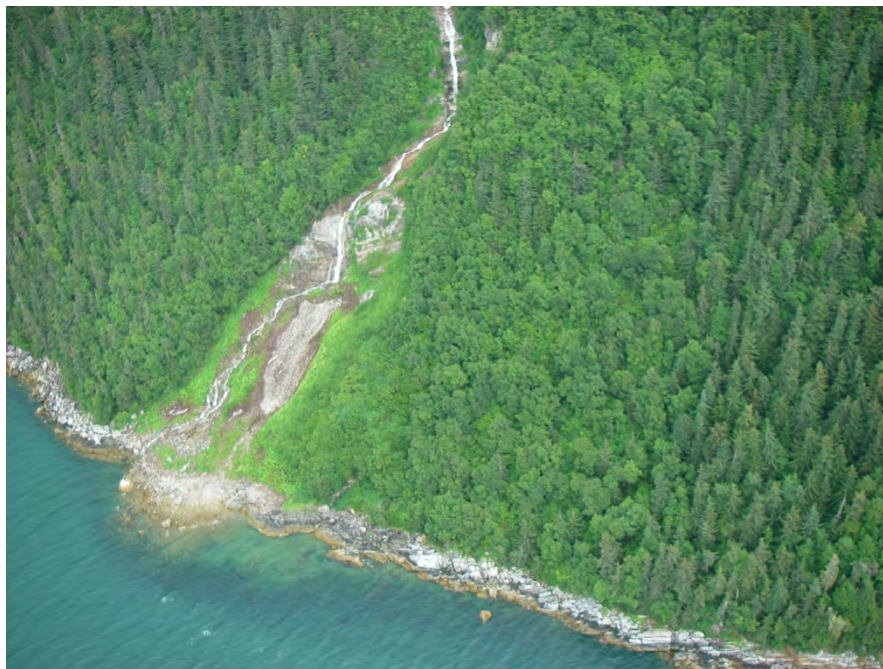
DF29. View northeast (up alignment and upslope) at debris flow deposition zone and avalanche path.

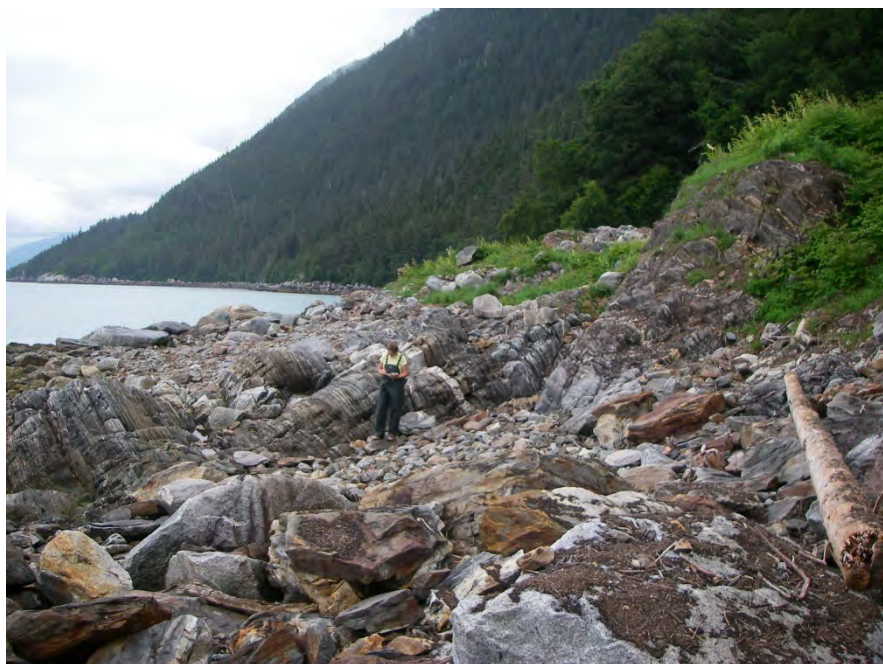
DF29. View north/up alignment across debris flow fan at base of avalanche path.

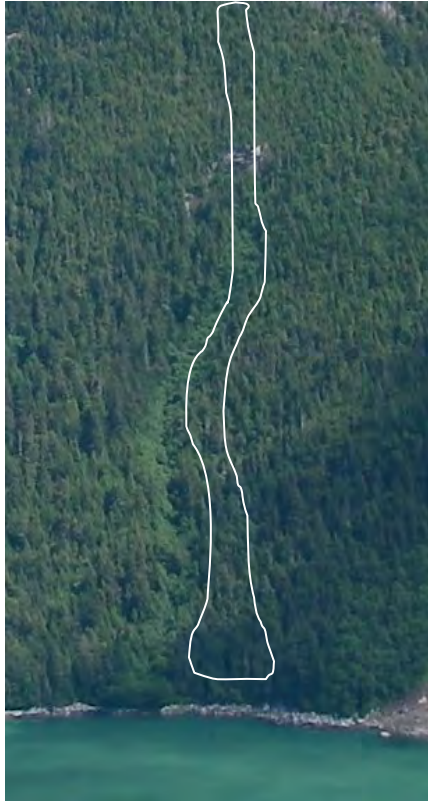
DF30. View east/upslope at debris flow path.

Hazard ID #:	DF30
Hazard Type:	debris_flow
HIN:	135
Rating:	B
2012 SEIS Alignment Location:	2122
Frequency (yrs):	5-25
Predictability:	low
Material Volume (CY):	10-100
Clast Size (ft):	0-1
Source Elev. (ft):	1000-2000
Centerline Slope:	single_channel
Alignment Location:	deposition_zone
Impact Alignment:	yes
Alignment Exposure (ft):	50-200
Vegetation:	disturbed
Deciduous Trees:	yes
2012 SEIS Alignment South Margin:	2122+00
2012 SEIS Alignment North Margin:	2123+00
Photo #:	5168, 5927, 6250

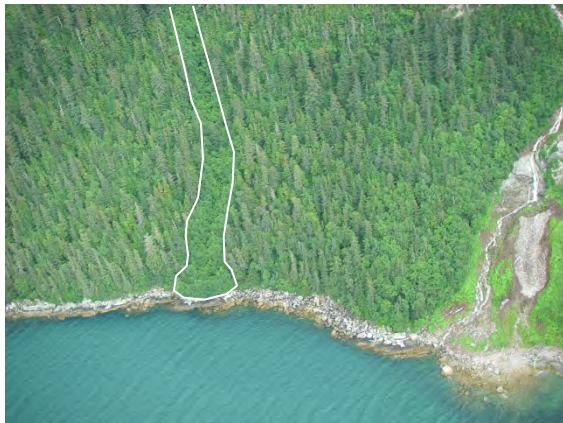
DF30. Disturbed vegetation marks path of debris flow.

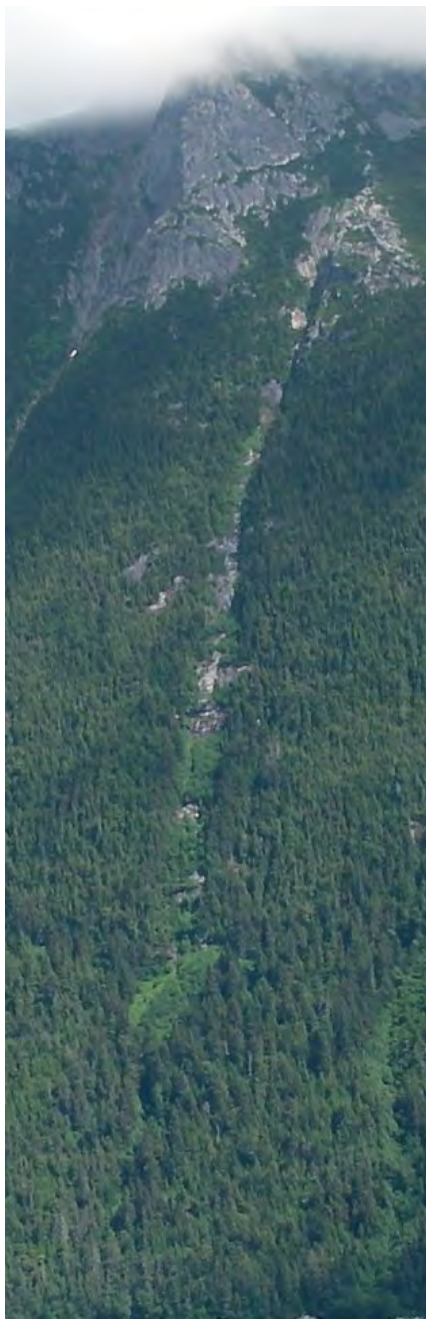
RF17. View east/upslope at rockfall hazard area.

Hazard ID #:	RF17
Hazard Type:	rockfall
HIN:	201
Rating:	A
2012 SEIS Alignment Location:	2128
Frequency (yrs):	1-5
Predictability:	unpredictable
Material Volume (CY):	<10
Clast Size (ft):	3-4
Source Elev. (ft):	1000-2000
Centerline Slope:	open_soil_slope
Alignment Location:	path
Impact Alignment:	yes
Alignment Exposure (ft):	50-200
Vegetation:	disturbed
Deciduous Trees:	yes
2012 SEIS Alignment South Margin:	2128+00
2012 SEIS Alignment North Margin:	2128+60
Photo #:	5928, 6251

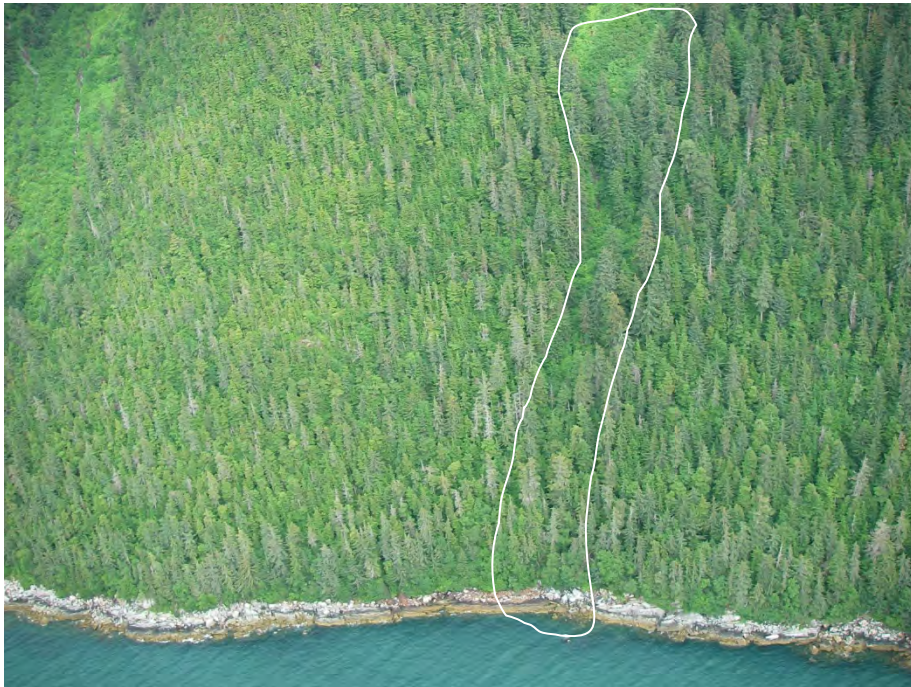
RF17. View east/upslope at rockfall path.

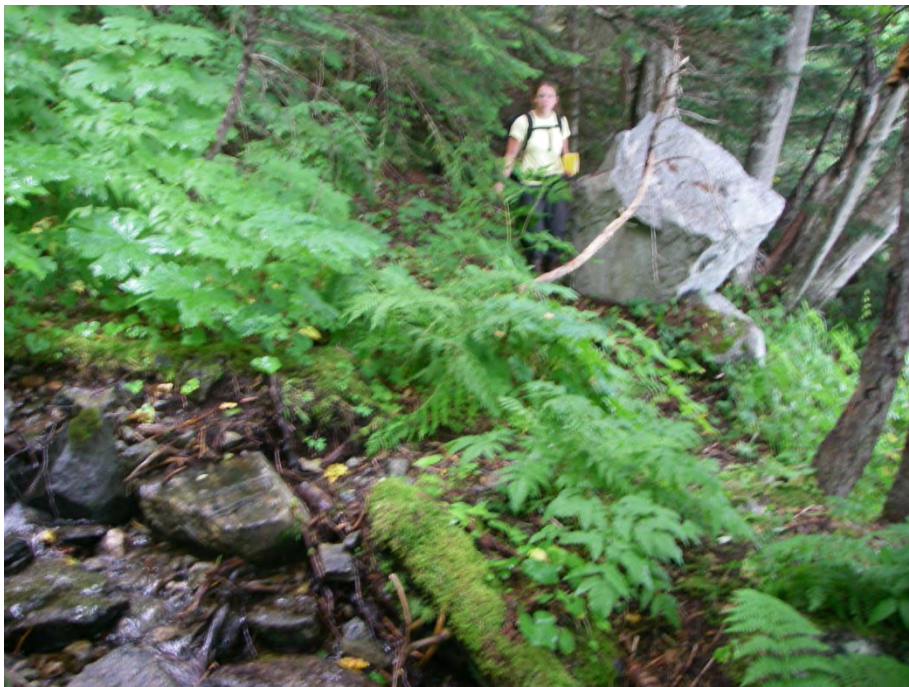
RF17. View south/down alignment across rockfall with 3-5 ft diameter boulders.

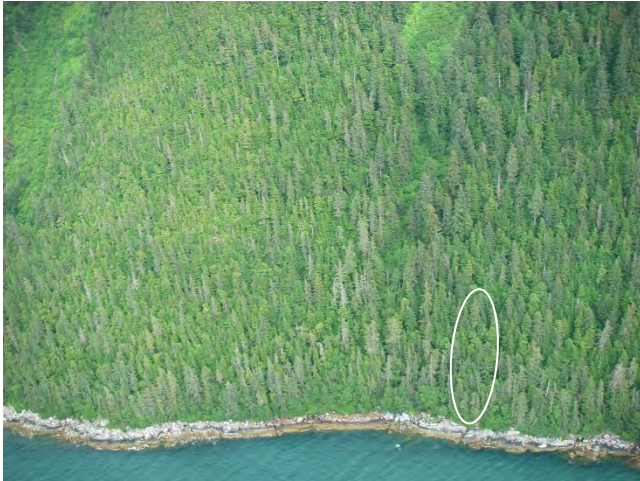
SR02. View east/upslope at soil raveling area.

Hazard ID #:	SR02
Hazard Type:	soil_raveling
HIN:	171
Rating:	B
2012 SEIS Alignment Location:	2128
Frequency (yrs):	0-1
Predictability:	unpredictable
Material Volume (CY):	<10
Clast Size (ft):	0-1
Source Elev. (ft):	<100
Centerline Slope:	single_channel
Alignment Location:	deposition_zone
Impact Alignment:	yes
Alignment Exposure (ft):	<50
Vegetation:	disturbed
Deciduous Trees:	yes
2012 SEIS Alignment South Margin:	2128+30
2012 SEIS Alignment North Margin:	2128+70
Photo #:	3889, 5168

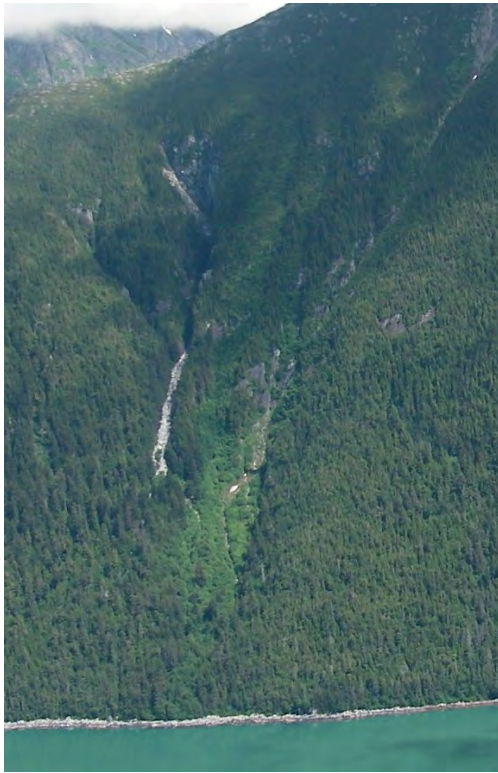
RF19. View east/upslope at large rockfall area.

Hazard ID #:	RF19
Hazard Type:	rockfall
HIN:	273
Rating:	A
2012 SEIS Alignment Location:	2144
Frequency (yrs):	1-5
Predictability:	unpredictable
Material Volume (CY):	<10
Clast Size (ft):	4+
Source Elev. (ft):	3000+
Centerline Slope:	fan
Alignment Location:	deposition_zone
Impact Alignment:	yes
Alignment Exposure (ft):	500+
Vegetation:	disturbed
Deciduous Trees:	yes
2012 SEIS Alignment South Margin:	2141+80
2012 SEIS Alignment North Margin:	2149+60
Photo #:	1357, 3491, 3493, 3495, 3498, 5130, 5168

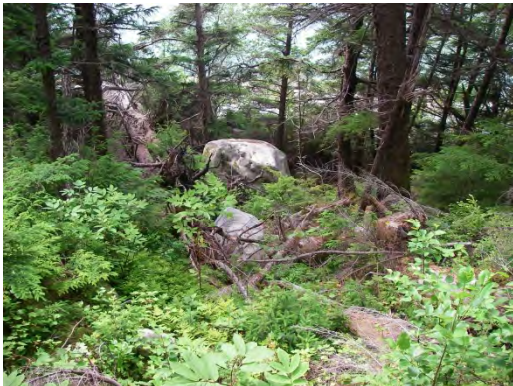
RF19. Fresh 6 ft diameter mega-boulder and related deforestation.

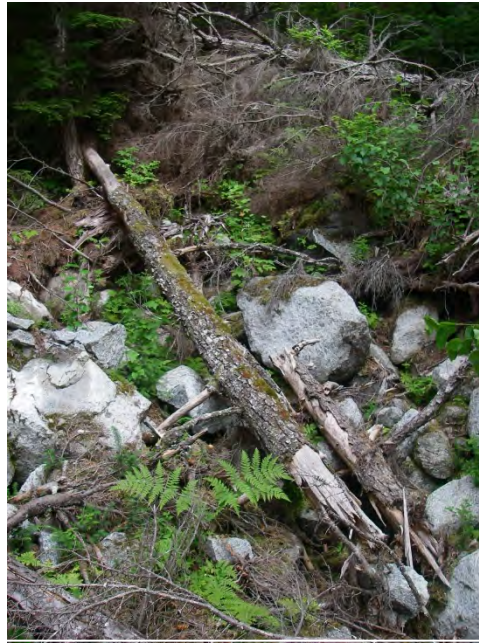
RF19. View west/downslope at rockfall debris deposits.

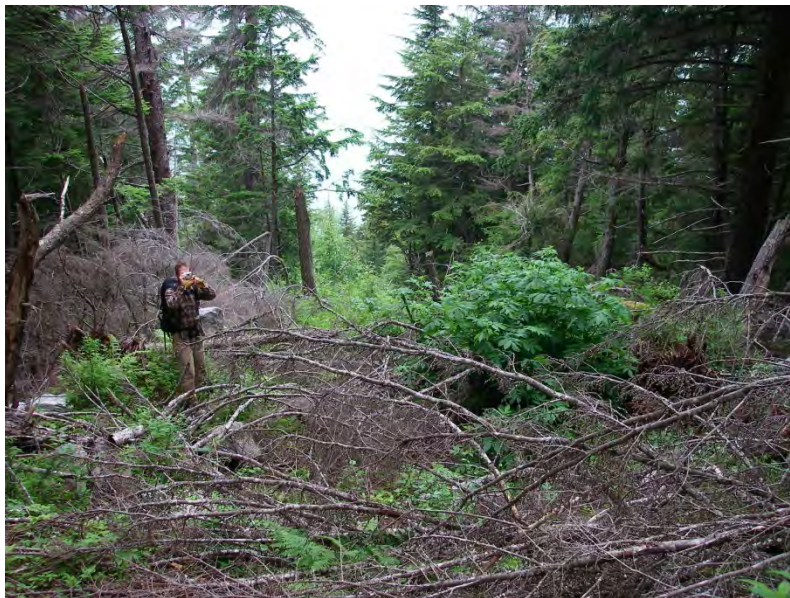
RF19. View west/downslope at rockfall path.

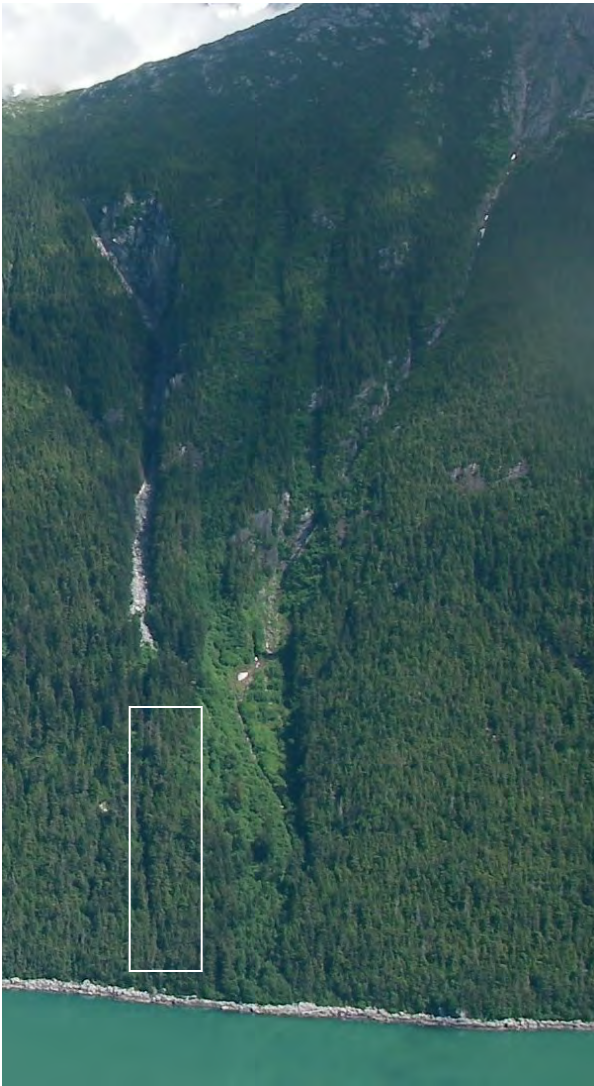
RF20. View east/upslope at rockfall area and avalanche path.

Hazard ID #:	RF20
Hazard Type:	rockfall
HIN:	165
Rating:	A
2012 SEIS Alignment Location:	2145
Frequency (yrs):	1-5
Predictability:	unpredictable
Material Volume (CY):	<10
Clast Size (ft):	4+
Source Elev. (ft):	500-1000
Centerline Slope:	fan
Alignment Location:	deposition_zone
Impact Alignment:	yes
Alignment Exposure (ft):	200-500
Vegetation:	disturbed
Deciduous Trees:	yes
2012 SEIS Alignment South Margin:	2143+60
2012 SEIS Alignment North Margin:	2145+90
Photo #:	1357, 3491, 3493, 3495, 3498, 5130, 5131, 5168

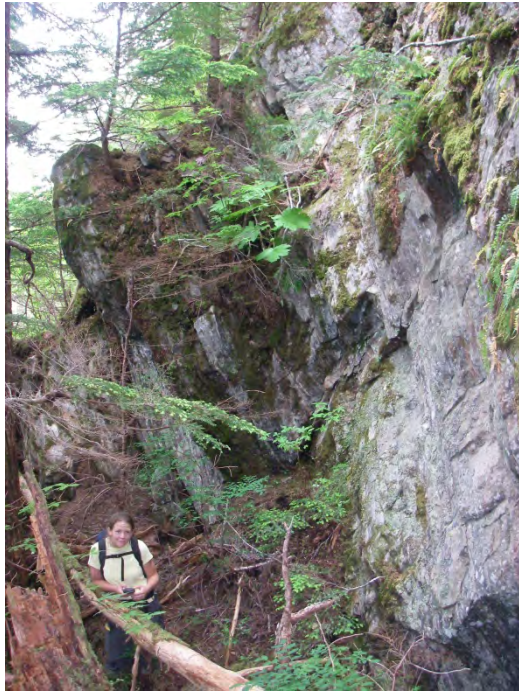
RF21. View north/up alignment at rockfall hazard.

Hazard ID #:	RF21
Hazard Type:	rockfall
HIN:	147
Rating:	C
2012 SEIS Alignment Location:	2154
Frequency (yrs):	1-5
Predictability:	unpredictable
Material Volume (CY):	<10
Clast Size (ft):	2-3
Source Elev. (ft):	500-1000
Centerline Slope:	-
Alignment Location:	below_deposition _zone
Impact Alignment:	no
Alignment Exposure (ft):	50-200
Vegetation:	disturbed
Deciduous Trees:	yes
2012 SEIS Alignment South Margin:	2153+20
2012 SEIS Alignment North Margin:	2154+30
Photo #:	6014

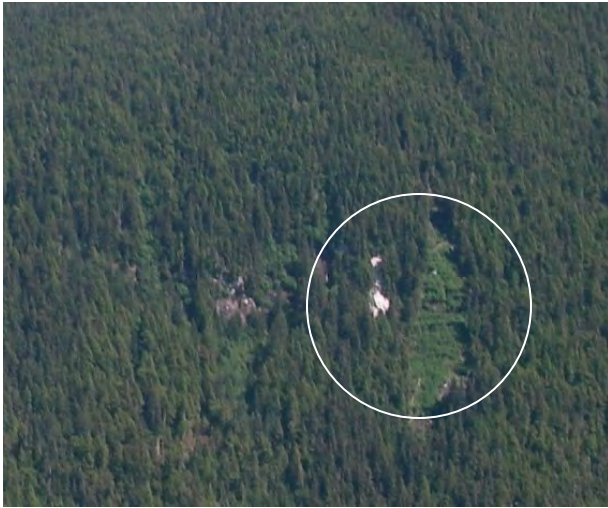
LS01. View east/upslope at landslide area.

Hazard ID #:	LS01
Hazard Type:	landslide
HIN:	255
Rating:	C
2012 SEIS Alignment Location:	2205
Frequency (yrs):	unknown (>25?)
Predictability:	unpredictable
Material Volume (CY):	10-100
Clast Size (ft):	-
Source Elev. (ft):	1000-2000
Centerline Slope:	-
Alignment Location:	below_deposition _zone
Impact Alignment:	no
Alignment Exposure (ft):	>500
Vegetation:	disturbed
Deciduous Trees:	no
2012 SEIS Alignment South Margin:	2202+00
2012 SEIS Alignment North Margin:	2208+00
Photo #:	5171

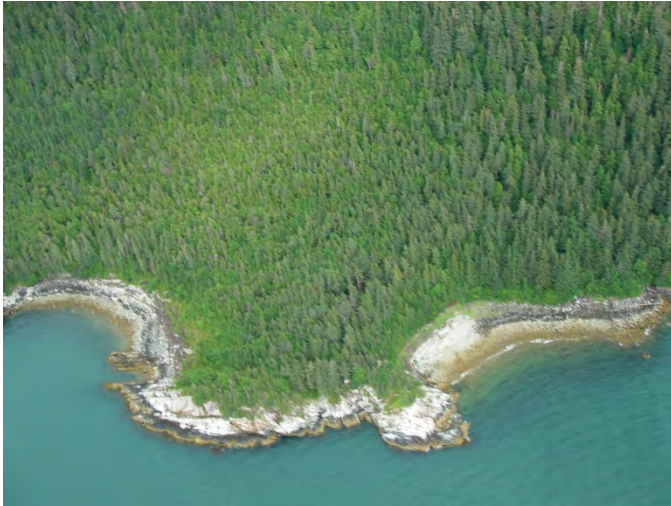
DF32. View east/upslope at outlet of debris flow.

Hazard ID #:	DF32
Hazard Type:	debris_flow
HIN:	51
Rating:	B
2012 SEIS Alignment Location:	2206
Frequency (yrs):	5-25
Predictability:	high
Material Volume (CY):	<10
Clast Size (ft):	0-1
Source Elev. (ft):	500-1000
Centerline Slope:	single_channel
Alignment Location:	path
Impact Alignment:	yes
Alignment Exposure (ft):	50-200
Vegetation:	disturbed
Deciduous Trees:	yes
2012 SEIS Alignment South Margin:	2205+40
2012 SEIS Alignment North Margin:	2206+30
Photo #:	6018

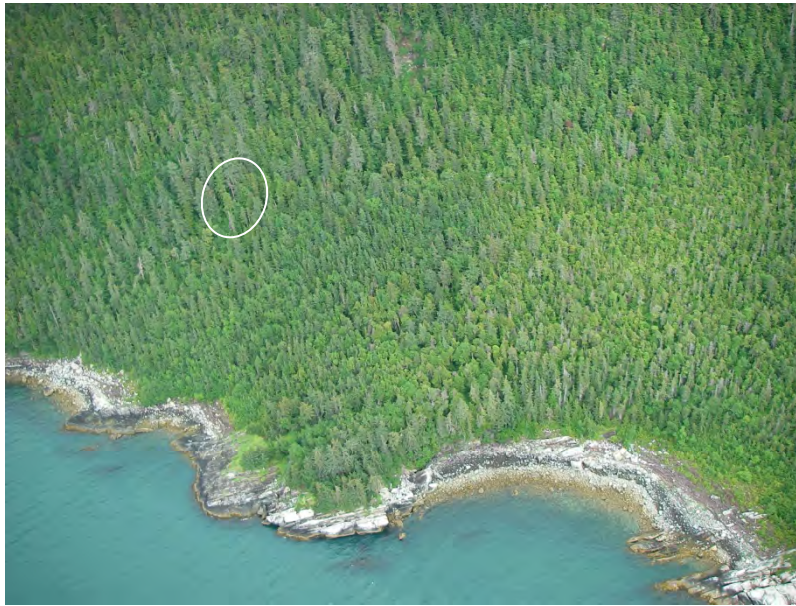
Hazard ID #:	LS02
Hazard Type:	translational_slide
HIN:	135
Rating:	C
2012 SEIS Alignment Location:	2219
Frequency (yrs):	1-5
Predictability:	unpredictable
Material Volume (CY):	10-100
Clast Size (ft):	0-1
Source Elev. (ft):	100-500
Centerline Slope:	-
Alignment Location:	below_deposition_zone
Impact Alignment:	no
Alignment Exposure (ft):	50-200
Vegetation:	denuded
Deciduous Trees:	yes
2012 SEIS Alignment South Margin:	2218+10
2012 SEIS Alignment North Margin:	2219+20
Photo #:	5000, 5937

LS02. View east/upslope at landslide area.

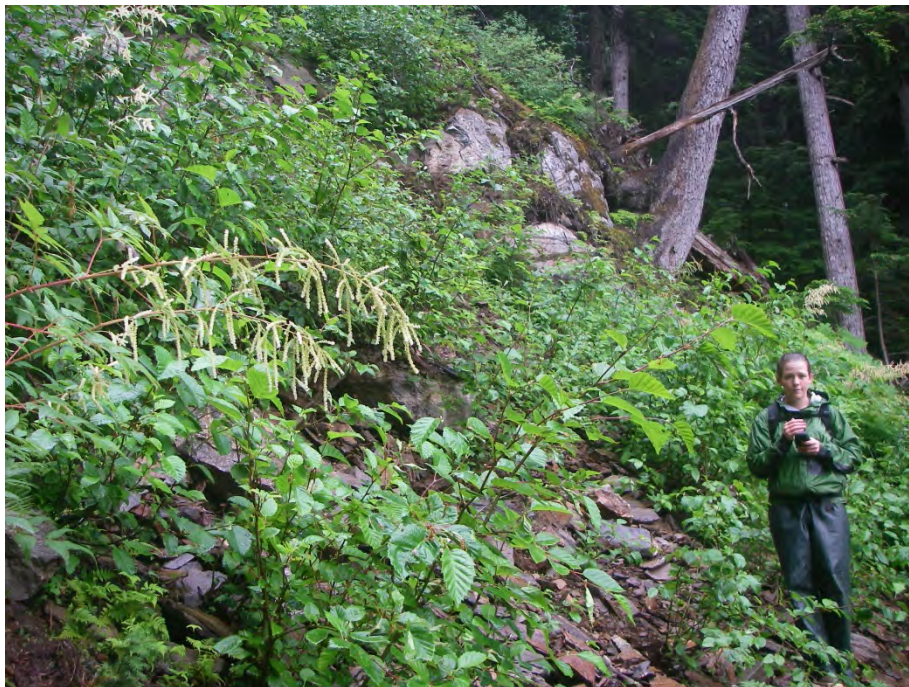
LS02. View south/down alignment at landslide and exposed bedrock.

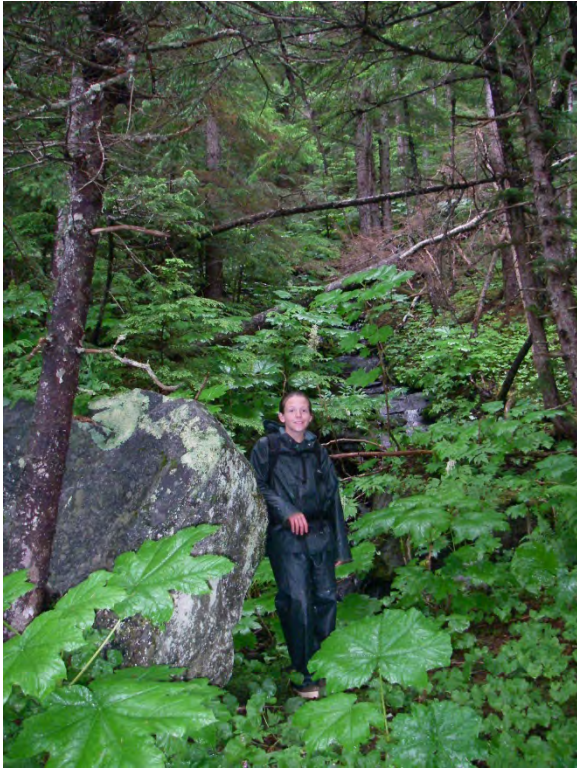
RF22. View east/upslope at fresh rockfall.

Hazard ID #:	RF22
Hazard Type:	rockfall
HIN:	147
Rating:	B
2012 SEIS Alignment Location:	2252
Frequency (yrs):	1-5
Predictability:	unpredictable
Material Volume (CY):	<10
Clast Size (ft):	1-2
Source Elev. (ft):	500-1000
Centerline Slope:	single_channel
Alignment Location:	path
Impact Alignment:	yes
Alignment Exposure (ft):	50-200
Vegetation:	disturbed
Deciduous Trees:	no
2012 SEIS Alignment South Margin:	2252+10
2012 SEIS Alignment North Margin:	2252+70
Photo #:	5941, 6024

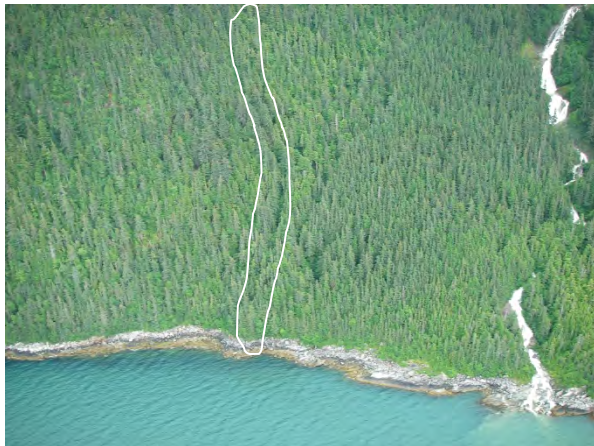
RF22. View east/upslope at rockfall path.

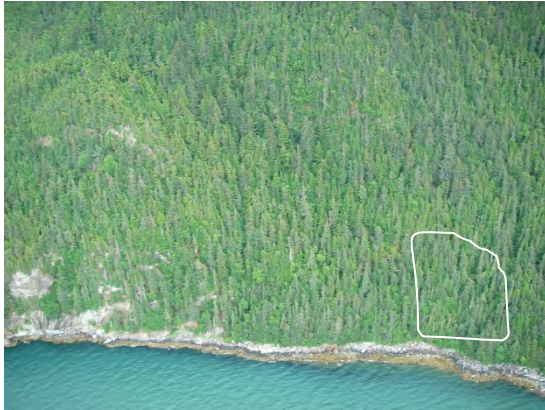
RF24. View east/upslope at rockfall hazard.

Hazard ID #:	RF24
Hazard Type:	rockfall
HIN:	141
Rating:	B
2012 SEIS Alignment Location:	2260
Frequency (yrs):	unknown (1-5?)
Predictability:	unpredictable
Material Volume (CY):	<10
Clast Size (ft):	4+
Source Elev. (ft):	<100
Centerline Slope:	-
Alignment Location:	deposition_zone
Impact Alignment:	yes
Alignment Exposure (ft):	200-500
Vegetation:	disturbed
Deciduous Trees:	yes
2012 SEIS Alignment South Margin:	2258+50
2012 SEIS Alignment North Margin:	2260+75
Photo #:	3507

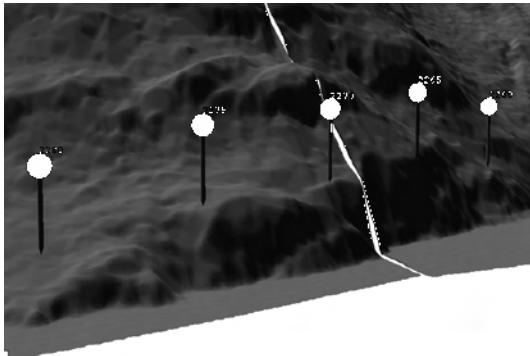
RF24. Bare earth LIDAR image of rockfall hazard. Station labels represent previous IRP 2006 alignment.

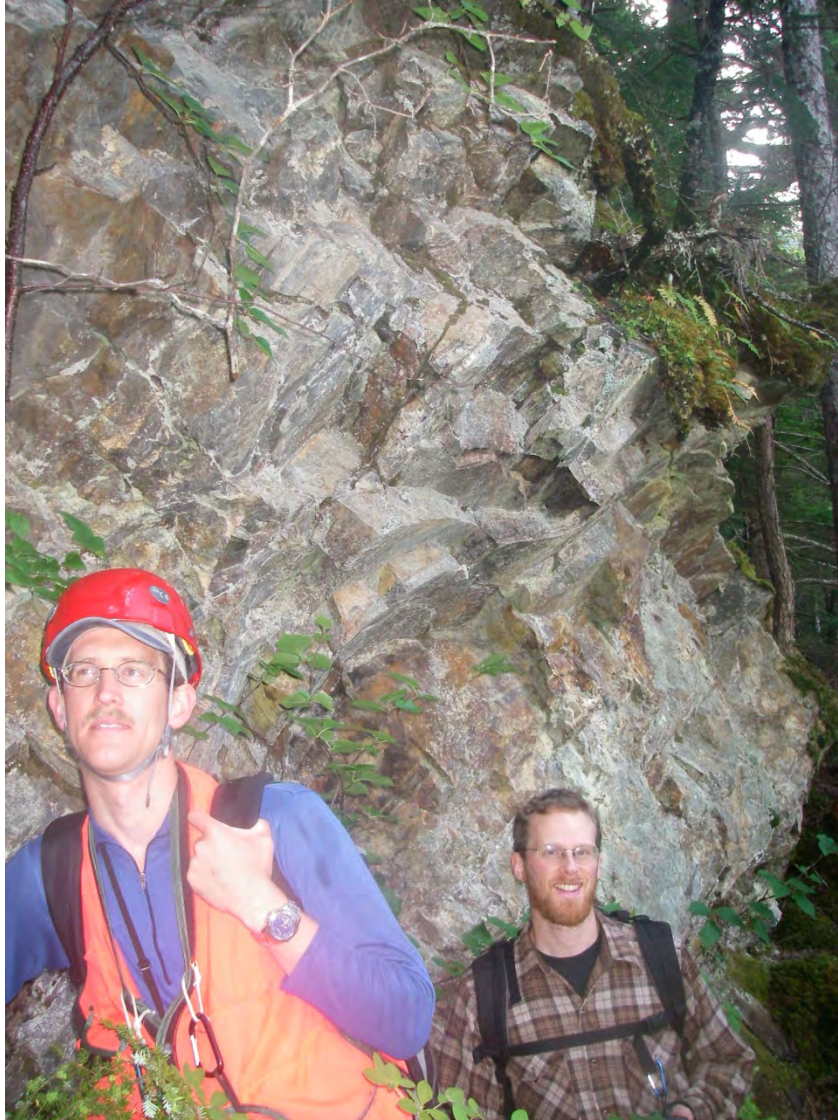
RF24. View east of rockfall hazard with fresh scarring.

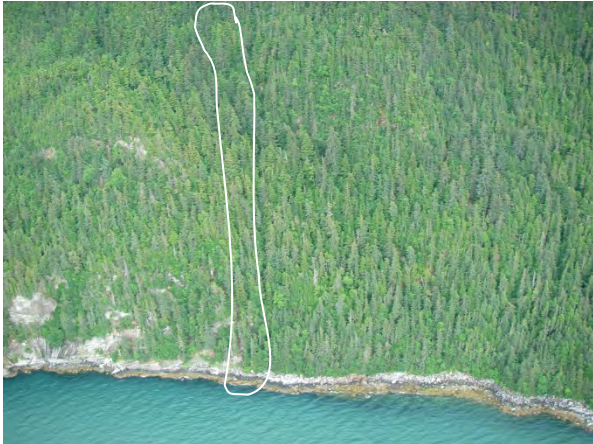
RS02. View east/upslope at rockfall hazard and rockslide.

Hazard ID #:	RS02
Hazard Type:	rock_slide
HIN:	63
Rating:	A
2012 SEIS Alignment Location:	2261
Frequency (yrs):	1-5
Predictability:	moderate
Material Volume (CY):	10-100
Clast Size (ft):	1-2
Source Elev. (ft):	100-500
Centerline Slope:	single_channel
Alignment Location:	path
Impact Alignment:	yes
Alignment Exposure (ft):	50-200
Vegetation:	disturbed
Deciduous Trees:	no
2012 SEIS Alignment South Margin:	2260+75
2012 SEIS Alignment North Margin:	2261+35
Photo #:	3508, 3510, 3511

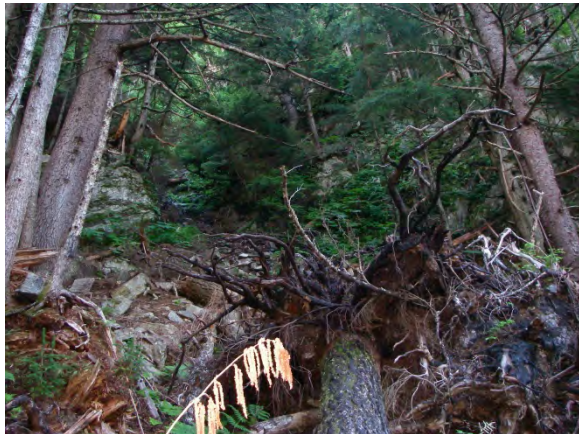
RS02. View east/upslope at rockslide path.

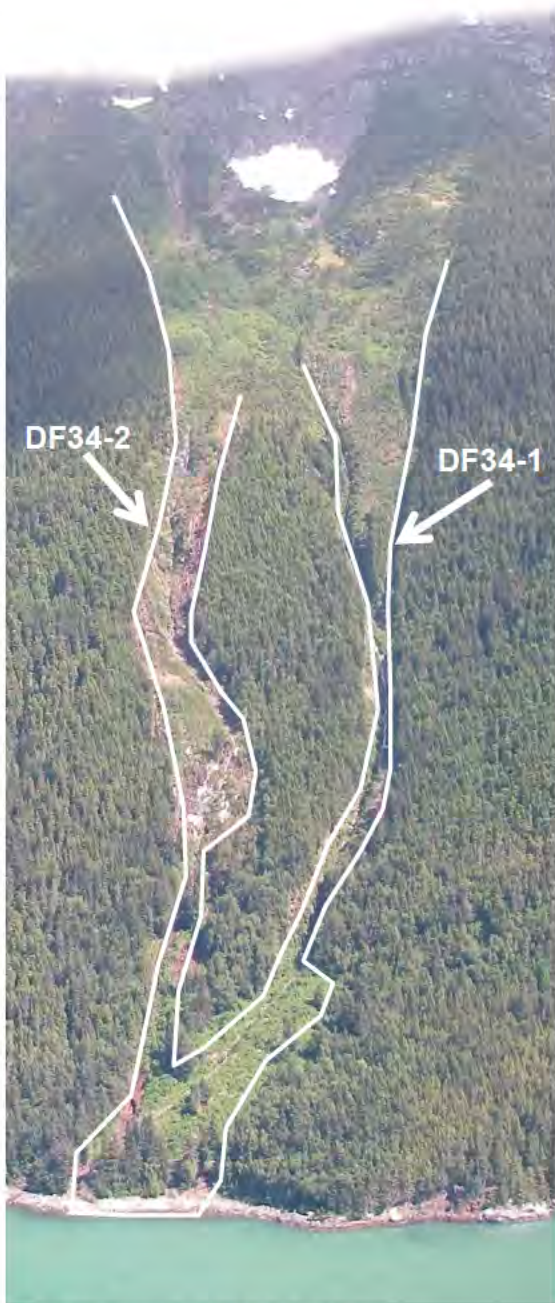
DF 34-1 and DH34-1. View east/upslope at debris flow channels and avalanche paths.

Hazard ID #:	DF34-1
Hazard Type:	debris_flow
HIN:	129
Rating:	B
2012 SEIS Alignment Location:	2282
Frequency (yrs):	1-5
Predictability:	high
Material Volume (CY):	10-100
Clast Size (ft):	1-2
Source Elev. (ft):	>1000
Centerline Slope:	single_channel
Alignment Location:	path
Impact Alignment:	yes
Alignment Exposure (ft):	50-200
Vegetation:	denuded
Deciduous Trees:	yes
2012 SEIS Alignment South Margin:	2281+60
2012 SEIS Alignment North Margin:	2282+50
Photo #:	3527, 3528

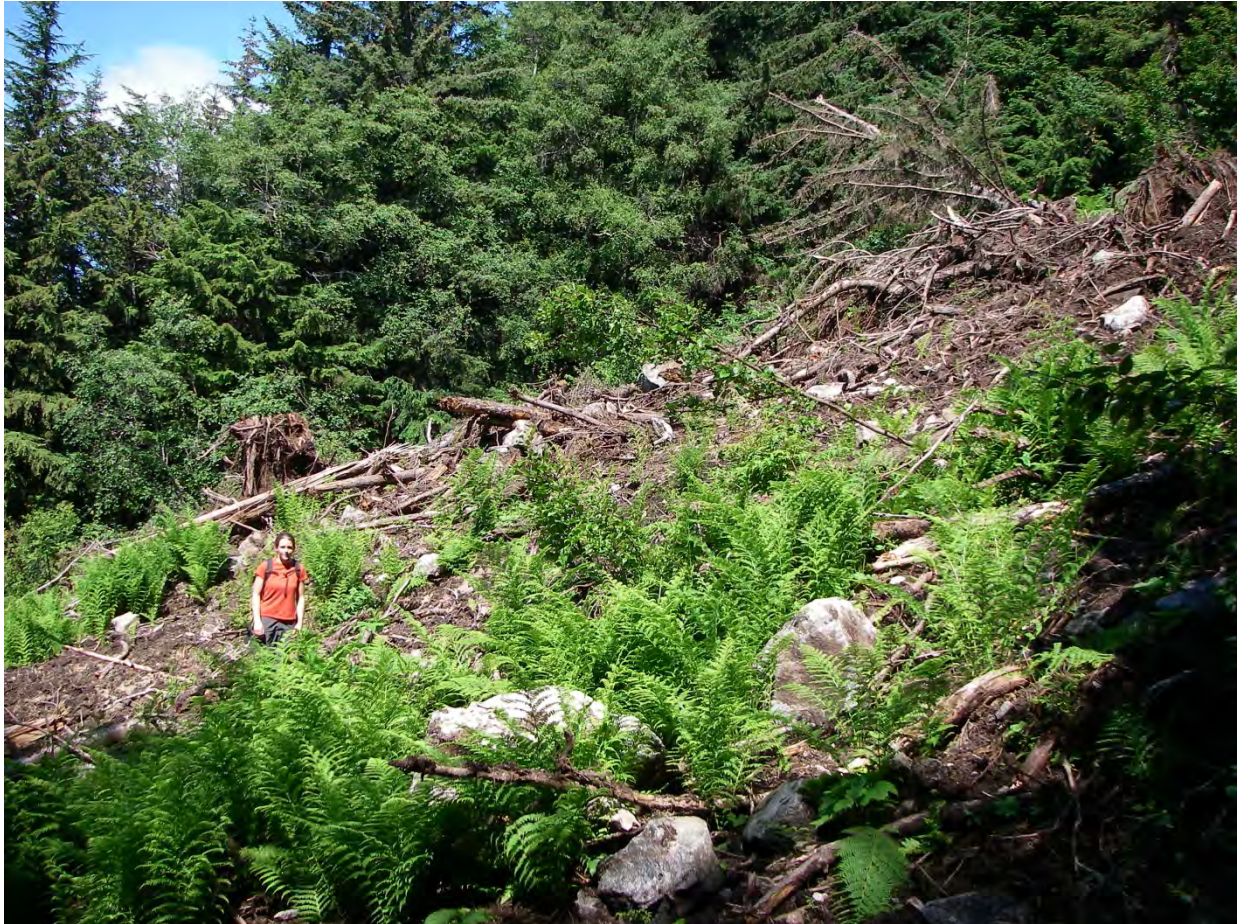
Hazard ID #:	DF34-2
Hazard Type:	debris_flow
HIN:	129
Rating:	B
2012 SEIS Alignment Location:	2284
Frequency (yrs):	1-5
Predictability:	high
Material Volume (CY):	10-100
Clast Size (ft):	1-2
Source Elev. (ft):	>1000
Centerline Slope:	single_channel
Alignment Location:	path
Impact Alignment:	yes
Alignment Exposure (ft):	50-200
Vegetation:	denuded
Deciduous Trees:	yes
2012 SEIS Alignment South Margin:	2283+50
2012 SEIS Alignment North Margin:	2284+20
Photo #:	3527, 3528

DF34-2. View north/up alignment at debris flow channel/avalanche path.

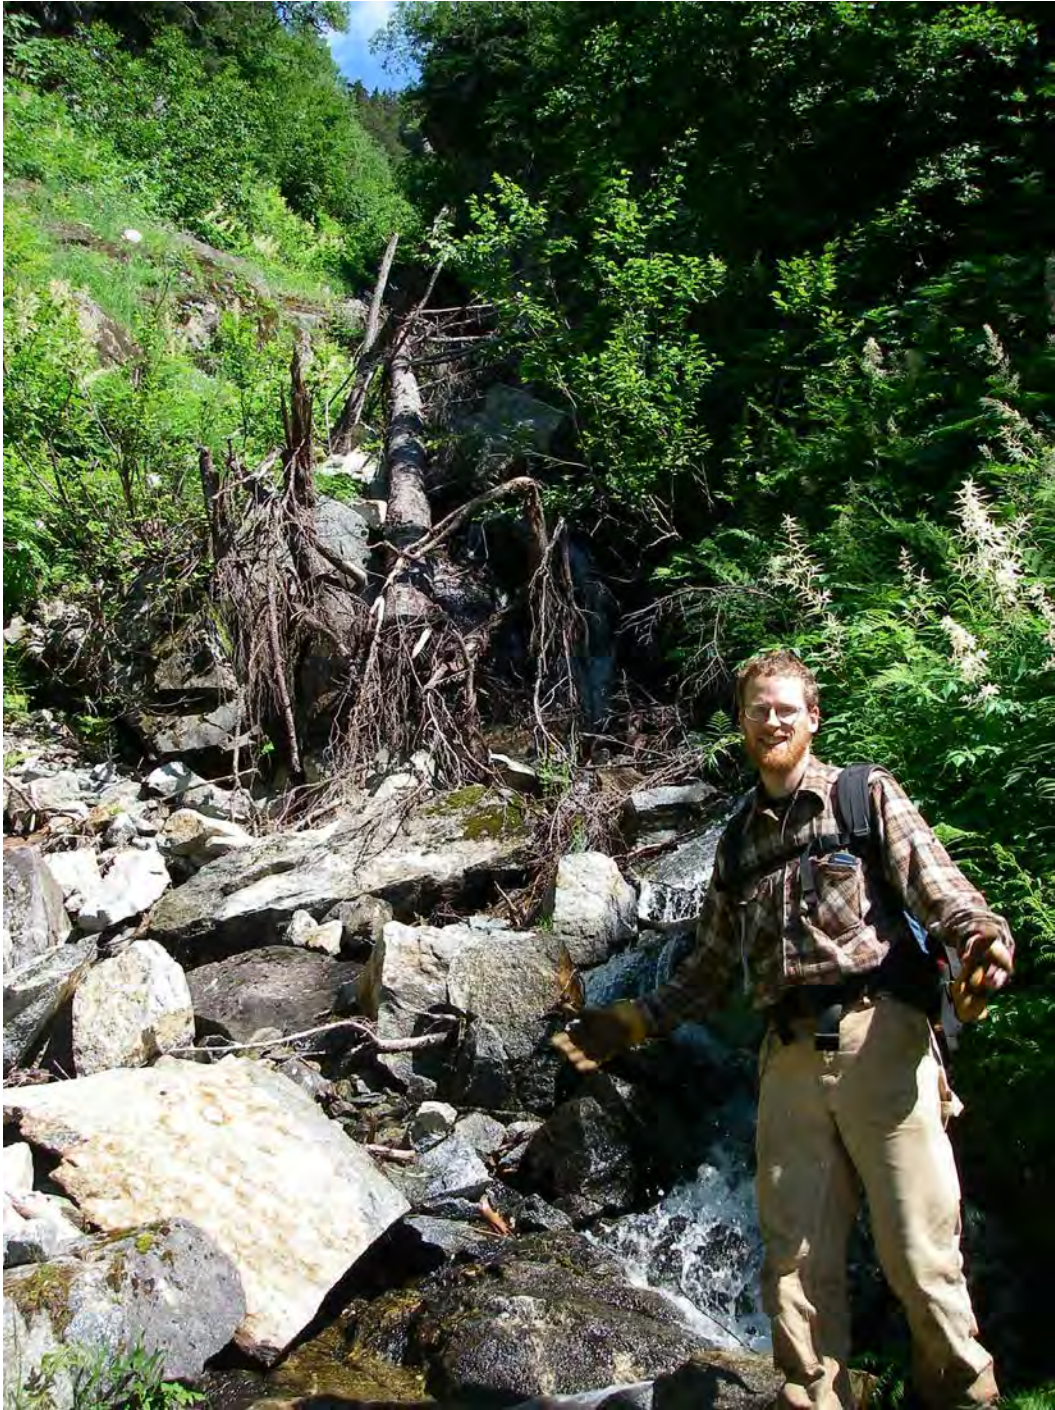
DF35. View east/upslope of debris flow channel and avalanche path.

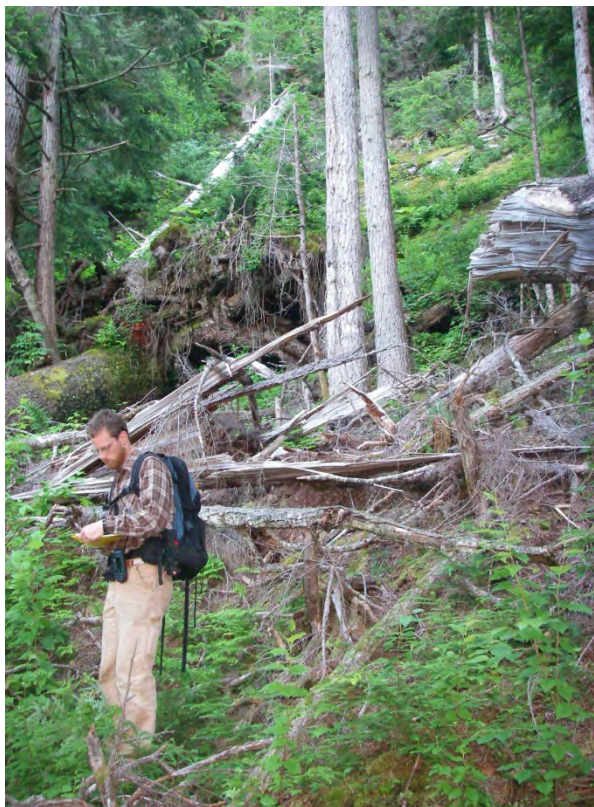
LS03. View north/up alignment at landslide.

Hazard ID #:	LS03
Hazard Type:	translational_slide
HIN:	105
Rating:	B
2012 SEIS Alignment Location:	2299
Frequency (yrs):	25+
Predictability:	unpredictable
Material Volume (CY):	10-100
Clast Size (ft):	1-2
Source Elev. (ft):	<100
Centerline Slope:	-
Alignment Location:	deposition_zone
Impact Alignment:	yes
Alignment Exposure (ft):	50-200
Vegetation:	disturbed
Deciduous Trees:	yes
2012 SEIS Alignment South Margin:	2298+50
2012 SEIS Alignment North Margin:	2299+10
Photo #:	5269, 5946

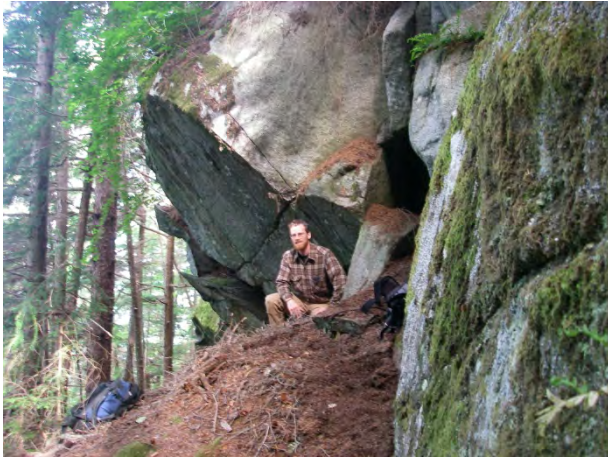
RF26. View north/up alignment at rockfall hazard.

Hazard ID #:	RF26
Hazard Type:	rockfall
HIN:	111
Rating:	B
2012 SEIS Alignment Location:	2300
Frequency (yrs):	unknown (5-25?)
Predictability:	unpredictable
Material Volume (CY):	10-100
Clast Size (ft):	4+
Source Elev. (ft):	<100
Centerline Slope:	-
Alignment Location:	path
Impact Alignment:	yes
Alignment Exposure (ft):	50-200
Vegetation:	undisturbed
Deciduous Trees:	no
2012 SEIS Alignment South Margin:	2299+60
2012 SEIS Alignment North Margin:	2300+70
Photo #:	3559, 3560, 5946

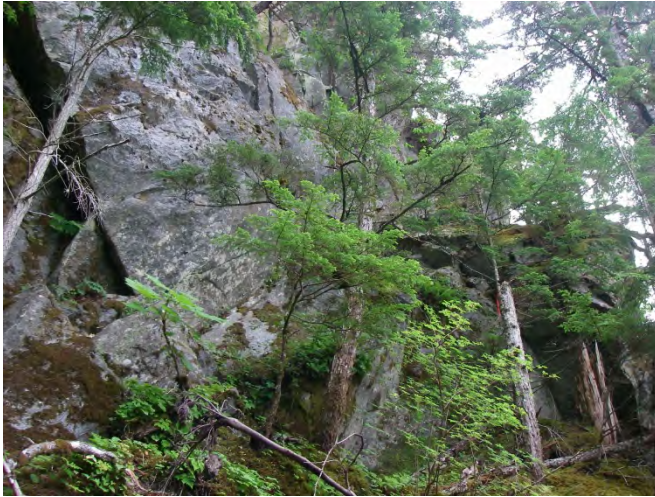
RF27. View south/down alignment at rockfall hazard.

Hazard ID #:	RF27
Hazard Type:	rockfall
HIN:	219
Rating:	B
2012 SEIS Alignment Location:	2305
Frequency (yrs):	1-5
Predictability:	unpredictable
Material Volume (CY):	<10
Clast Size (ft):	2-3
Source Elev. (ft):	500-1000
Centerline Slope:	fan
Alignment Location:	deposition_zone
Impact Alignment:	yes
Alignment Exposure (ft):	>500
Vegetation:	disturbed
Deciduous Trees:	yes
2012 SEIS Alignment South Margin:	2302+70
2012 SEIS Alignment North Margin:	2307+90
Photo #:	3561

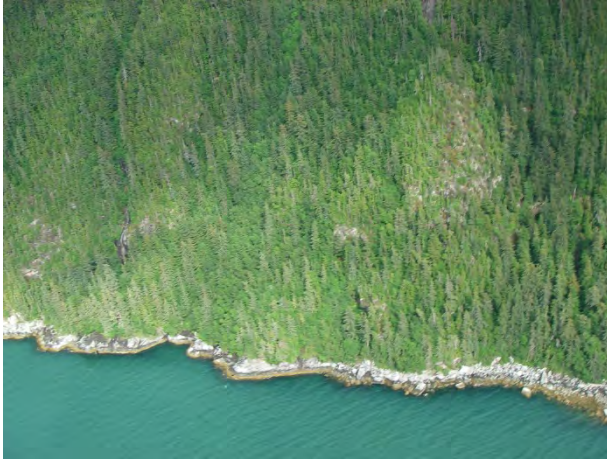
DF36. View east/upslope at debris flow channel.

Hazard ID #:	DF36
Hazard Type:	debris_flow
HIN:	123
Rating:	B
2012 SEIS Alignment Location:	2311
Frequency (yrs):	1-5
Predictability:	high
Material Volume (CY):	10-100
Clast Size (ft):	0-1
Source Elev. (ft):	1000-2000
Centerline Slope:	fan
Alignment Location:	path
Impact Alignment:	yes
Alignment Exposure (ft):	<50
Vegetation:	denuded
Deciduous Trees:	yes
2012 SEIS Alignment South Margin:	2310+65
2012 SEIS Alignment North Margin:	2311+15
Photo #:	3562

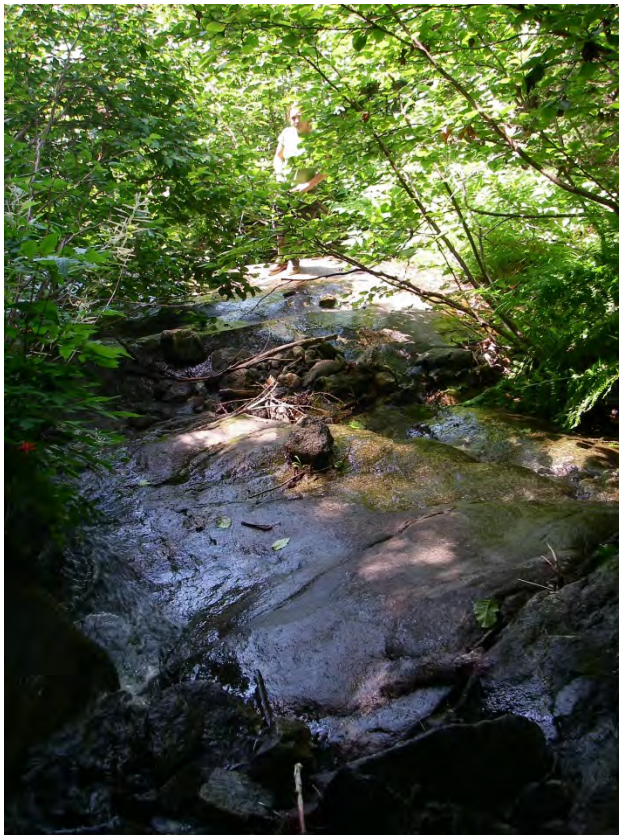
DF36. View west/downslope at debris flow channel scoured to gneiss bedrock.

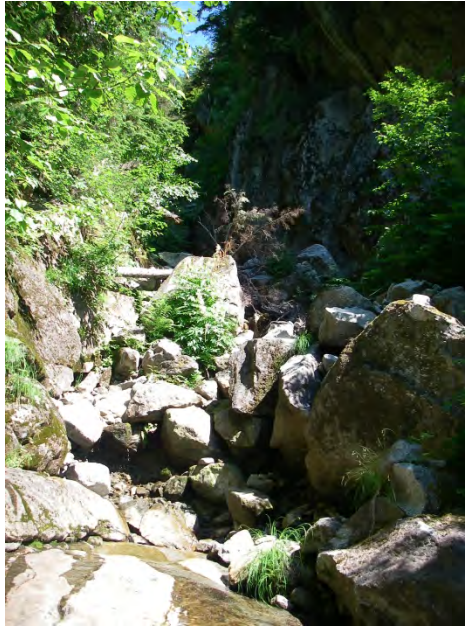
DF37. View east/upslope at debris flow channel with extreme cliffs to south (down alignment).

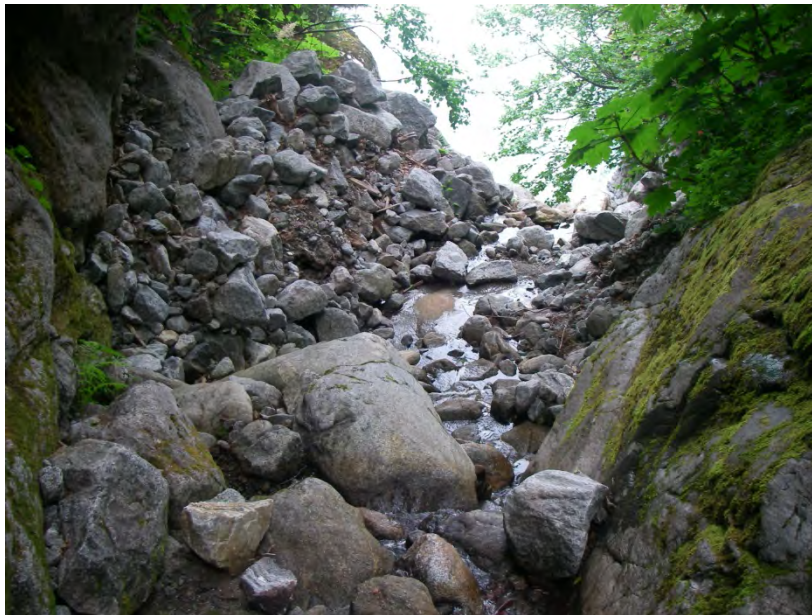
DF37. View east/downslope at boulders deposited by debris flow.

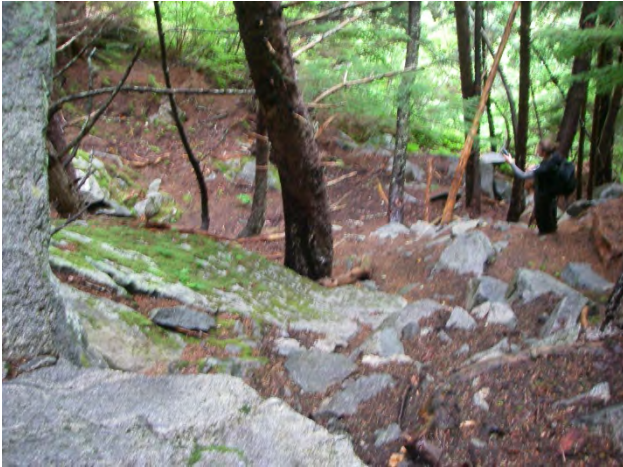
RF28. View east/downslope at rockfall hazard.

Hazard ID #:	RF28
Hazard Type:	rockfall
HIN:	183
Rating:	A
2012 SEIS Alignment Location:	2322
Frequency (yrs):	0-1
Predictability:	unpredictable
Material Volume (CY):	<10
Clast Size (ft):	1-2
Source Elev. (ft):	100-500
Centerline Slope:	single_channel
Alignment Location:	path
Impact Alignment:	yes
Alignment Exposure (ft):	50-200
Vegetation:	disturbed
Deciduous Trees:	yes
2012 SEIS Alignment South Margin:	2321+60
2012 SEIS Alignment North Margin:	2322+25
Photo #:	3891, 5948, 6254

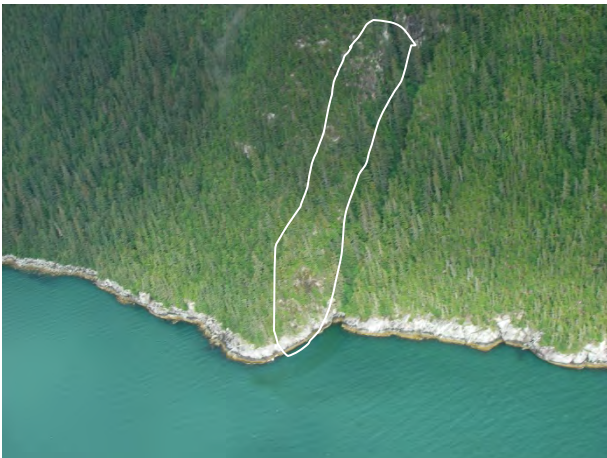
RF28. View east/downslope at rockfall hazard area.

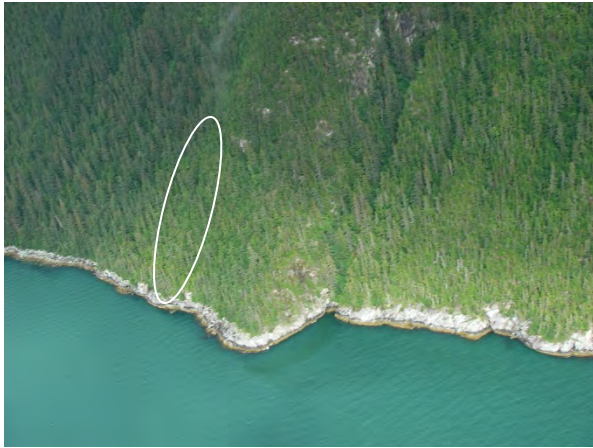
RF29. View northeast (up alignment and upslope) at rockfall area across 2012 SEIS alignment.

Hazard ID #:	RF29
Hazard Type:	rockfall
HIN:	99
Rating:	B
2012 SEIS Alignment Location:	2328
Frequency (yrs):	25+
Predictability:	unpredictable
Material Volume (CY):	<10
Clast Size (ft):	3-4
Source Elev. (ft):	<100
Centerline Slope:	open_soil_slope
Alignment Location:	path
Impact Alignment:	yes
Alignment Exposure (ft):	50-200
Vegetation:	disturbed
Deciduous Trees:	no
2012 SEIS Alignment South Margin:	2327+30
2012 SEIS Alignment North Margin:	2328+50
Photo #:	6140

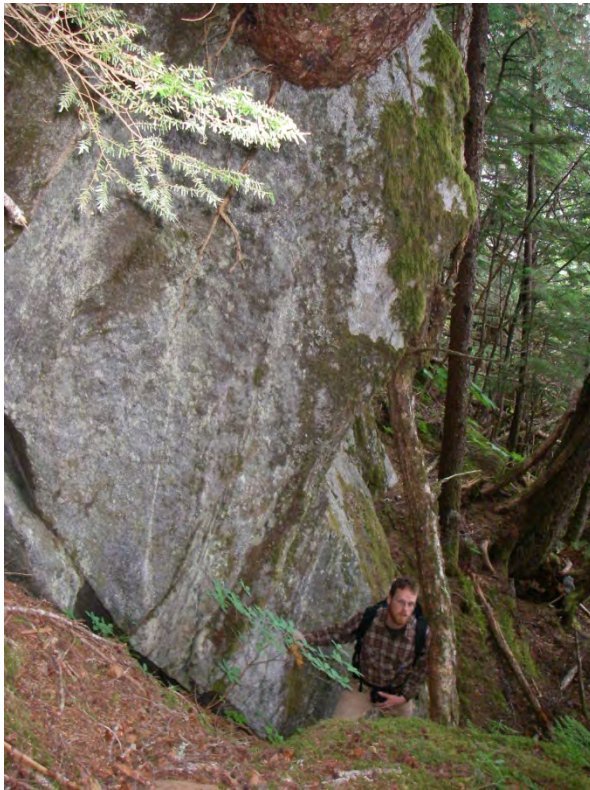
RF20. View west/downslope at rockfall hazard.

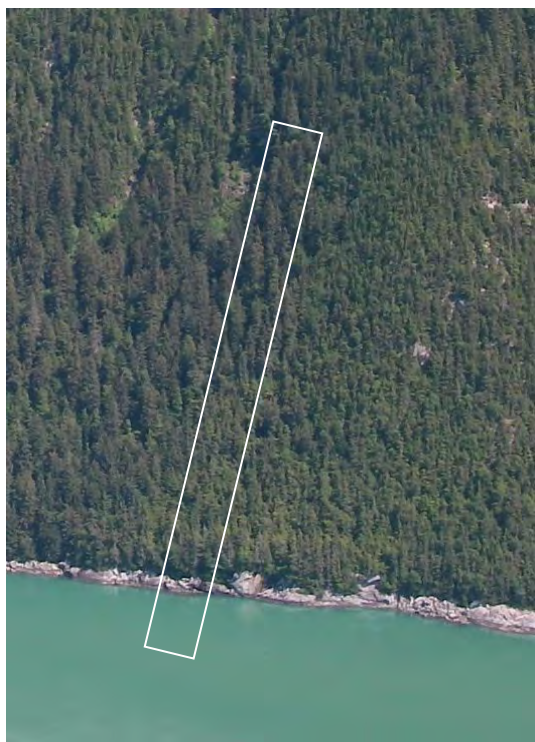
RF30. View east/upslope at rockfall hazard.

Hazard ID #:	RF30
Hazard Type:	rockfall
HIN:	135
Rating:	B
2012 SEIS Alignment Location:	2332
Frequency (yrs):	5-25
Predictability:	unpredictable
Material Volume (CY):	10-100
Clast Size (ft):	4+
Source Elev. (ft):	500-1000
Centerline Slope:	open_soil_slope
Alignment Location:	path
Impact Alignment:	yes
Alignment Exposure (ft):	50-200
Vegetation:	disturbed
Deciduous Trees:	no
2012 SEIS Alignment South Margin:	2331+00
2012 SEIS Alignment North Margin:	2332+20
Photo #:	6142, 6143
