**GEOLOGIC HAZARD SUMMARY**  
**ARRANGED BY 2012 SEIS STATIONING**  
 LYNN CANAL HIGHWAY PHASE 2  
 2012 SEIS ALIGNMENT HAZARD REVISIONS

HDR / 2012 SEIS JUNEAU ACCESS / AK

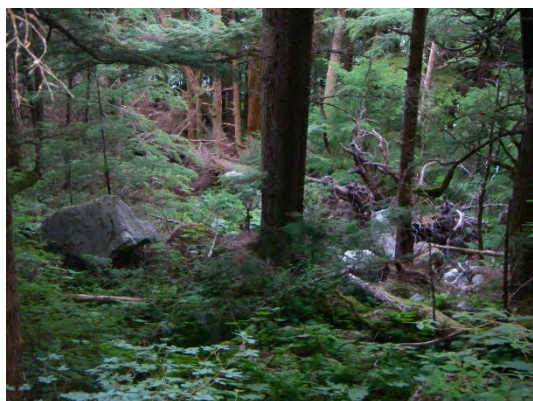
RF30. View west/downslope at rockfall hazard.

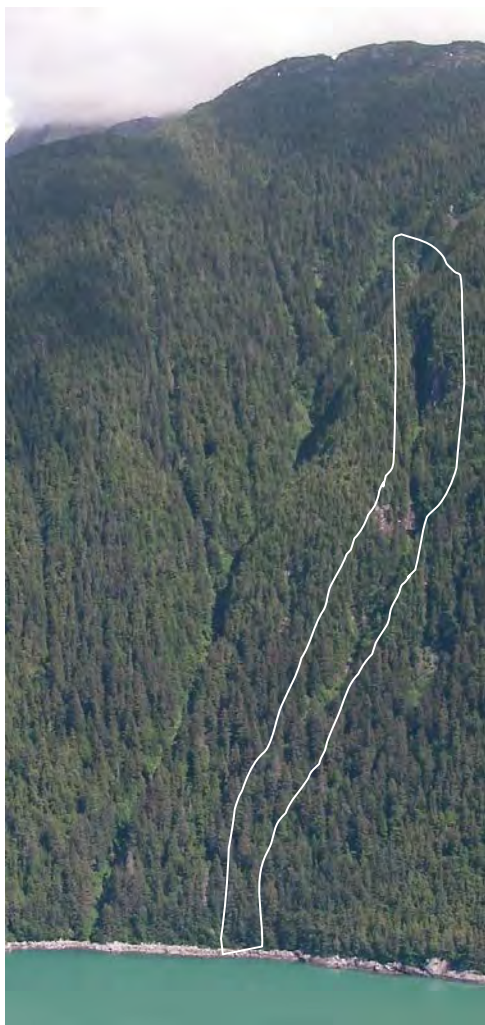
RF31. View east/upslope at rockfall hazard and avalanche path.

Hazard ID #:	RF31
Hazard Type:	rockfall
HIN:	177
Rating:	A
2012 SEIS Alignment Location:	2334
Frequency (yrs):	5-25
Predictability:	unpredictable
Material Volume (CY):	<10
Clast Size (ft):	4+
Source Elev. (ft):	>1000
Centerline Slope:	single_channel
Alignment Location:	path
Impact Alignment:	yes
Alignment Exposure (ft):	<50
Vegetation:	denuded
Deciduous Trees:	yes
2012 SEIS Alignment South Margin:	2334+40
2012 SEIS Alignment North Margin:	2334+90
Photo #:	6144, 6145

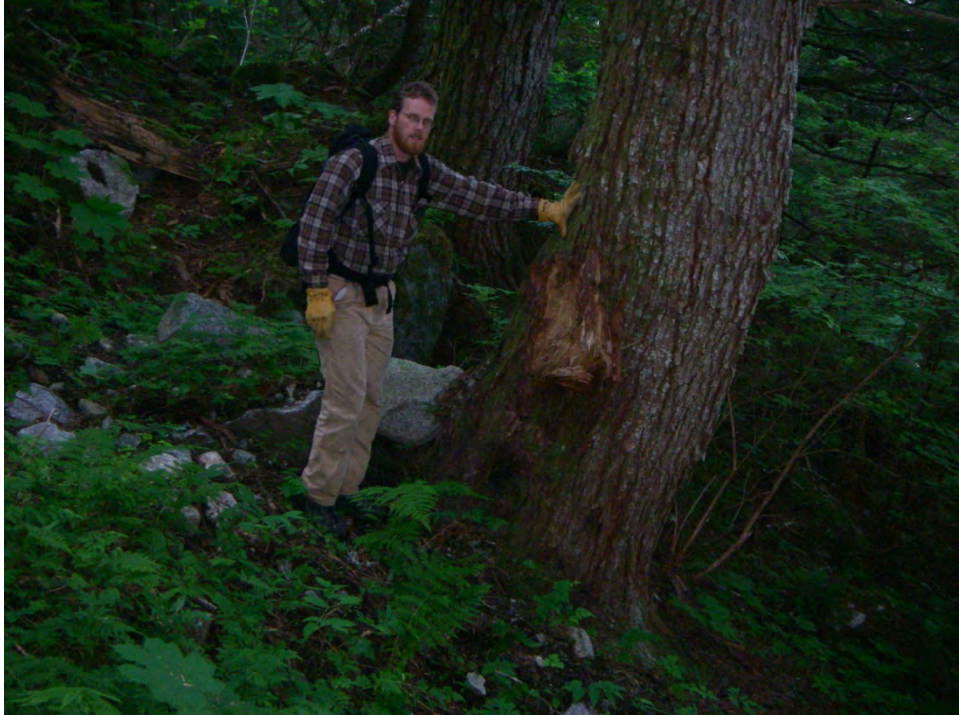
RF31. View south/down alignment at rockfall with freshly gouged trees.

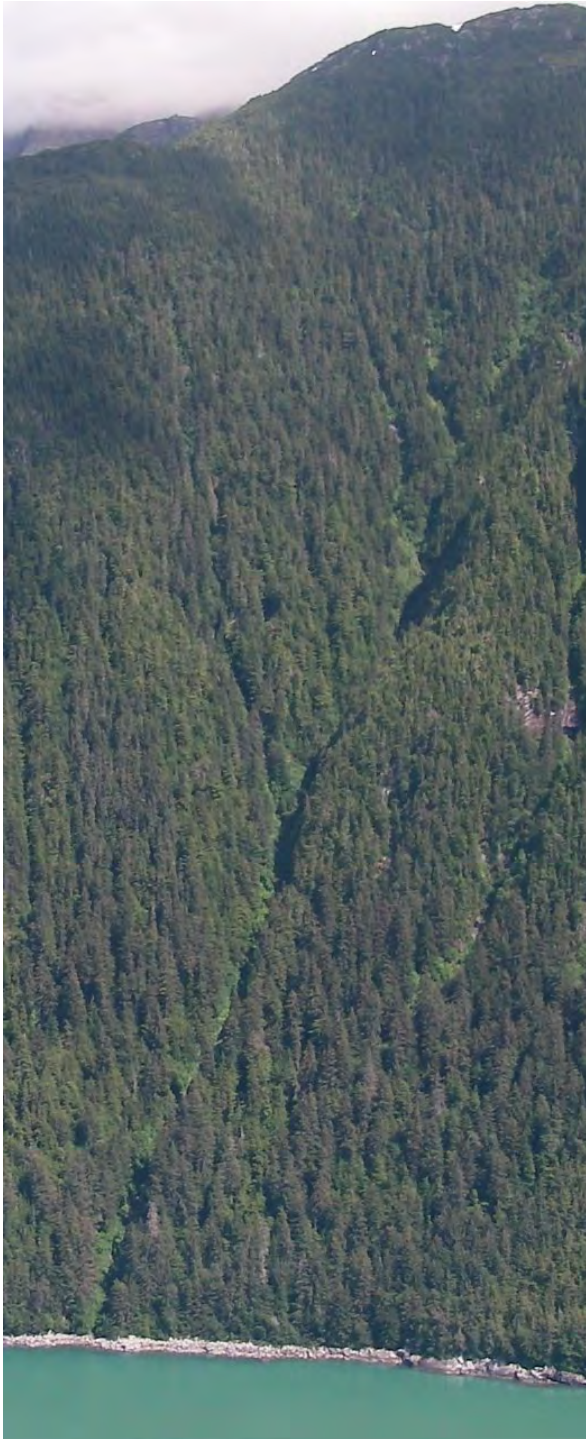
DF38. View east/upslope at debris flow channel and avalanche path.

Hazard ID #:	DF38
Hazard Type:	debris_flow
HIN:	129
Rating:	A
2012 SEIS Alignment Location:	2338
Frequency (yrs):	1-5
Predictability:	high
Material Volume (CY):	10-100
Clast Size (ft):	0-1
Source Elev. (ft):	2000-3000
Centerline Slope:	single_channel
Alignment Location:	path
Impact Alignment:	yes
Alignment Exposure (ft):	50-200
Vegetation:	denuded
Deciduous Trees:	no
2012 SEIS Alignment South Margin:	2337+80
2012 SEIS Alignment North Margin:	2338+60
Photo #:	6146

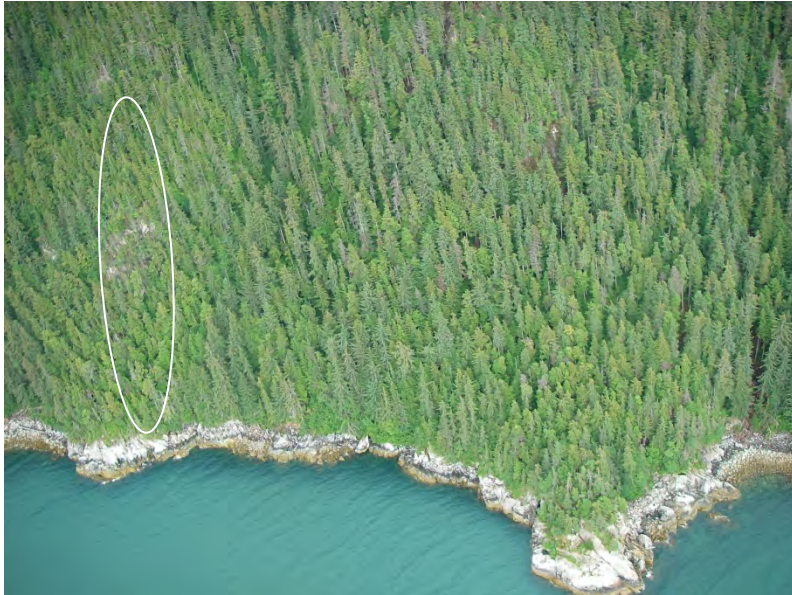
Hazard ID #:	RF36
Hazard Type:	rockfall
HIN:	129
Rating:	B
2012 SEIS Alignment Location:	2462
Frequency (yrs):	1-5
Predictability:	unpredictable
Material Volume (CY):	<10
Clast Size (ft):	3-4
Source Elev. (ft):	100-500
Centerline Slope:	-
Alignment Location:	path
Impact Alignment:	yes
Alignment Exposure (ft):	50-200
Vegetation:	denuded
Deciduous Trees:	yes
2012 SEIS Alignment South Margin:	2461+50
2012 SEIS Alignment North Margin:	2462+20
Photo #:	3609, 5960

RF36. View east/upslope at rockfall hazard.

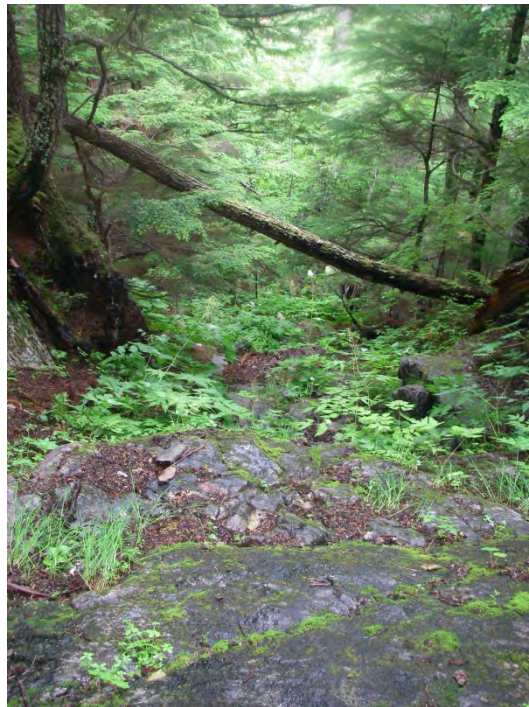
RF36. View west/downslope at rockfall chute.

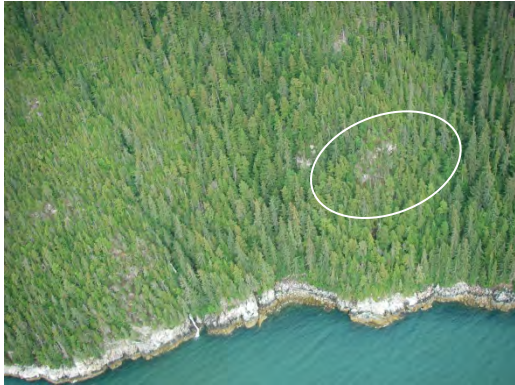
LS05. View east/upslope at landslide.

Hazard ID #:	LS05
Hazard Type:	translational_slide
HIN:	111
Rating:	C
2012 SEIS Alignment Location:	2466
Frequency (yrs):	5-25
Predictability:	unpredictable
Material Volume (CY):	<10
Clast Size (ft):	3-4
Source Elev. (ft):	100-500
Centerline Slope:	-
Alignment Location:	below_deposition_zone
Impact Alignment:	no
Alignment Exposure (ft):	50-200
Vegetation:	disturbed
Deciduous Trees:	yes
2012 SEIS Alignment South Margin:	2465+00
2012 SEIS Alignment North Margin:	2466+50
Photo #:	3615, 5961, 6077

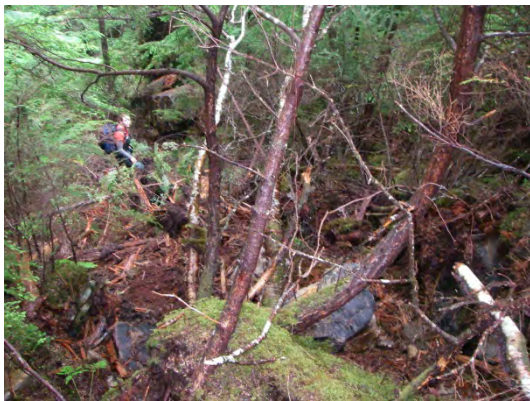
LS05. View west/downslope at landslide.

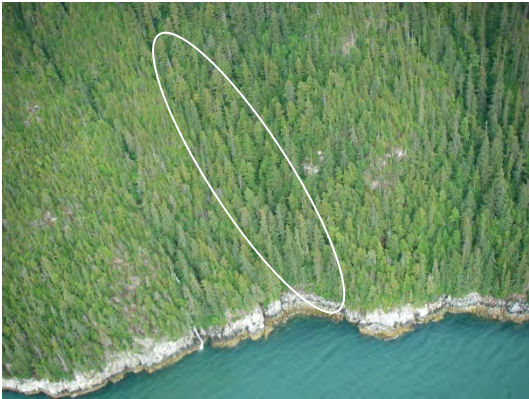
DF40. View east/upslope at debris flow channel.

Hazard ID #:	DF40
Hazard Type:	debris_flow
HIN:	135
Rating:	B
2012 SEIS Alignment Location:	2467
Frequency (yrs):	5-25
Predictability:	low
Material Volume (CY):	10-100
Clast Size (ft):	0-1
Source Elev. (ft):	>1000
Centerline Slope:	fan
Alignment Location:	deposition_zone
Impact Alignment:	yes
Alignment Exposure (ft):	50-200
Vegetation:	denuded
Deciduous Trees:	no
2012 SEIS Alignment South Margin:	2466+65
2012 SEIS Alignment North Margin:	2467+45
Photo #:	3616, 5180, 5961

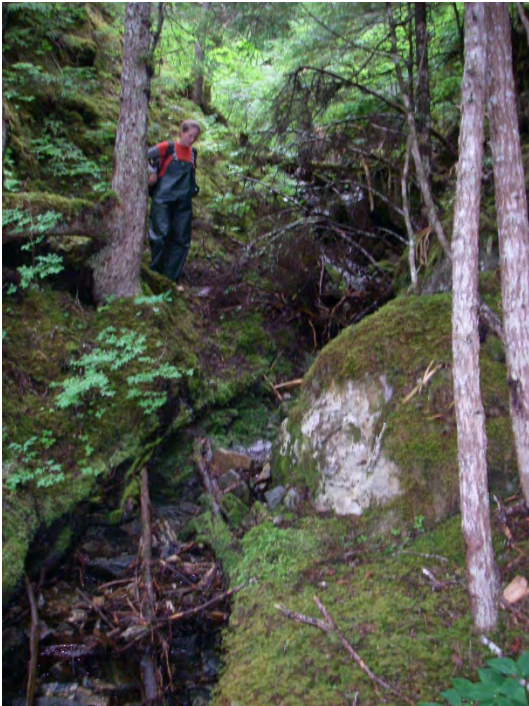
DF40. View west/upslope at debris flow channel.

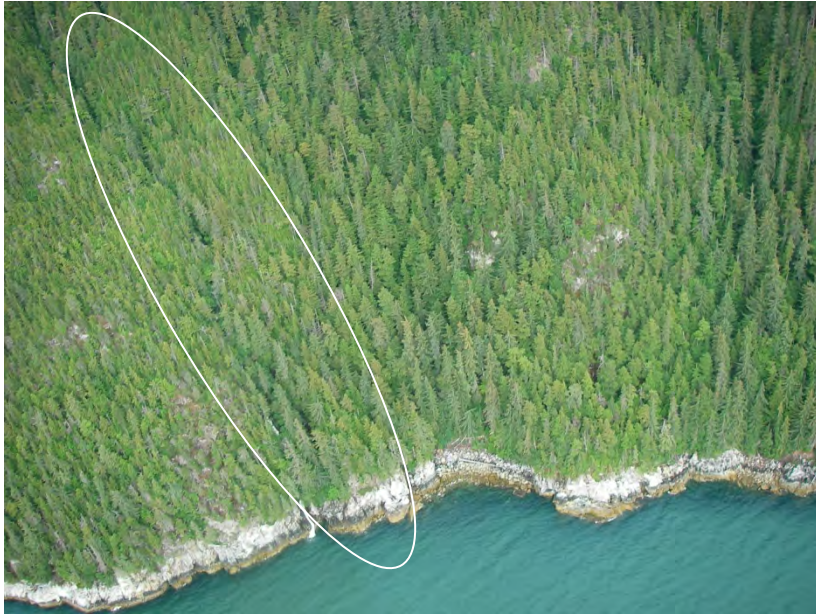
Hazard ID #:	DF41
Hazard Type:	debris_flow
HIN:	129
Rating:	B
2012 SEIS Alignment Location:	2468
Frequency (yrs):	1-5
Predictability:	high
Material Volume (CY):	10-100
Clast Size (ft):	0-1
Source Elev. (ft):	3000+
Centerline Slope:	fan
Alignment Location:	deposition_zone
Impact Alignment:	yes
Alignment Exposure (ft):	50-200
Vegetation:	denuded
Deciduous Trees:	yes
2012 SEIS Alignment South Margin:	2468+15
2012 SEIS Alignment North Margin:	2468+75
Photo #:	3616

DF41. View east/upslope at debris flow channel.

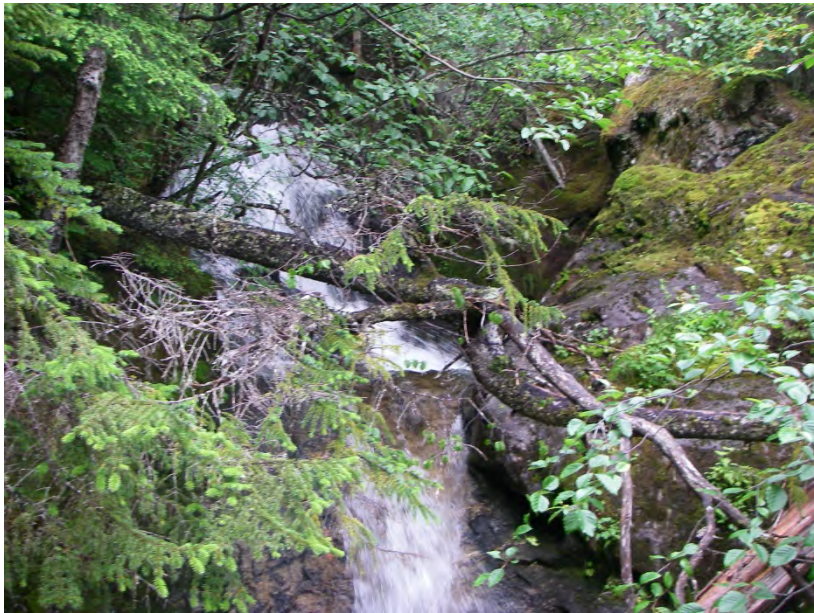
DF41. View east/upslope at debris flow chute with active stream.

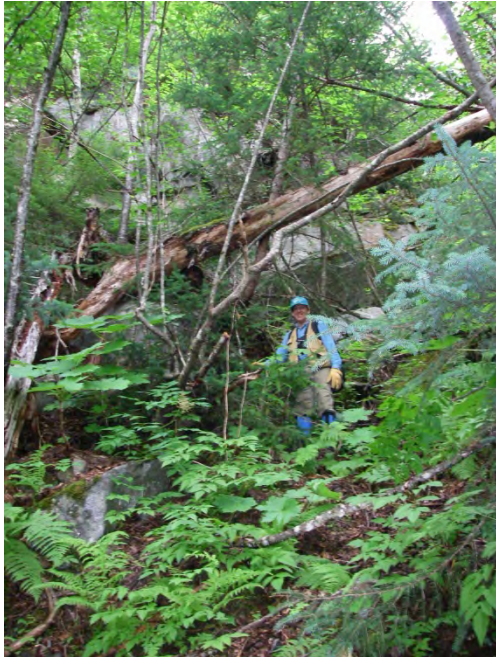
RF37. View east/upslope at rockfall area.

Hazard ID #:	RF37
Hazard Type:	rockfall
HIN:	69
Rating:	B
2012 SEIS Alignment Location:	2476
Frequency (yrs):	1-5
Predictability:	high
Material Volume (CY):	<10
Clast Size (ft):	4+
Source Elev. (ft):	100-500
Centerline Slope:	open_soil_slope
Alignment Location:	path
Impact Alignment:	yes
Alignment Exposure (ft):	200-500
Vegetation:	disturbed
Deciduous Trees:	yes
2012 SEIS Alignment South Margin:	2474+00
2012 SEIS Alignment North Margin:	2477+90
Photo #:	3637, 5181, 5962
