# *June 2013 Update*

## *Copper River Highway*

### *Bridge 339, Cordova Alaska*

AKSAS Project # 60555

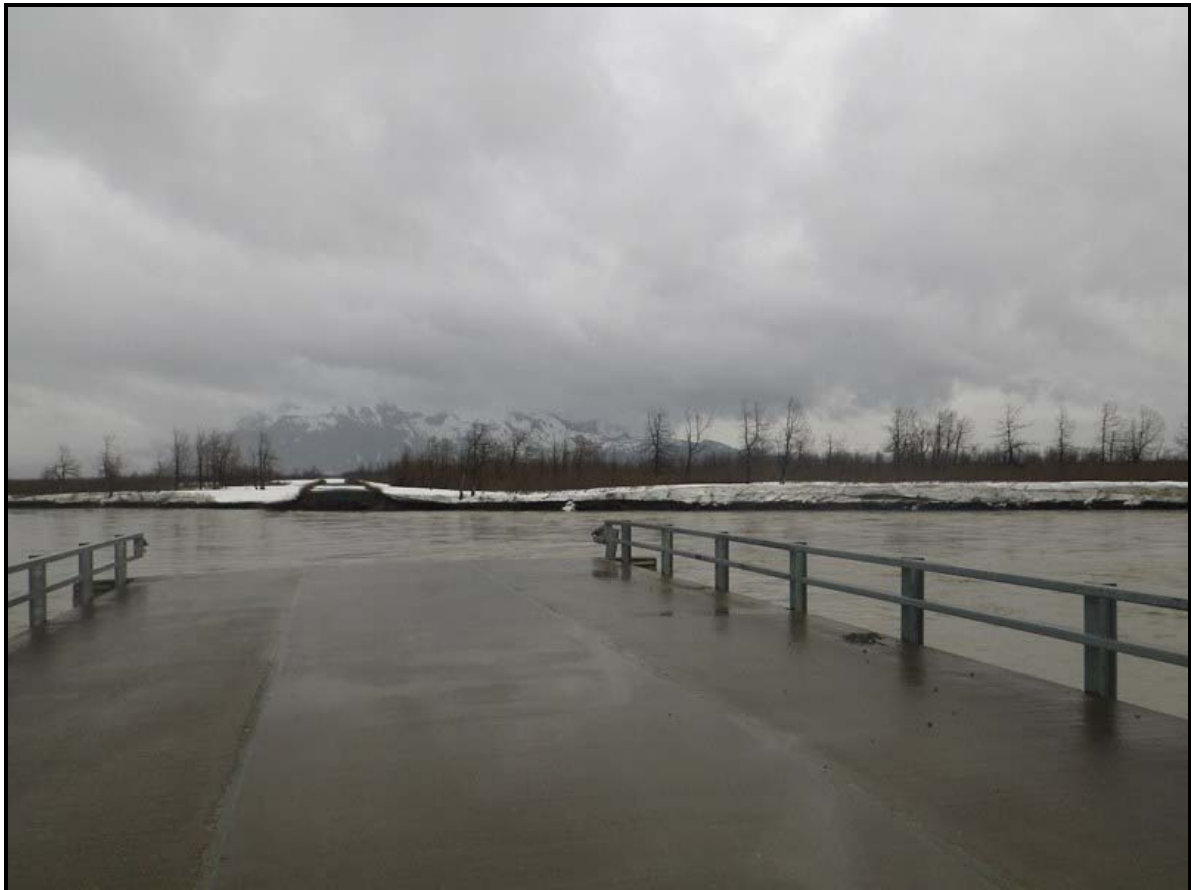
**Figure 1** – Road breach looking east June 4, 2013

1. This spring (2013) eastward migration of the Copper River's main channel and erosion of the road has accelerated:
  - a. The road breach on the east side of Bridge 339 has grown from 185 feet last fall (2012) and is now approaching 800 feet in width
  - b. On May 30, 2013 a camera mounted on Bridge 339 captured over 50 feet of road erosion in a 24-hour period
2. Sonar equipment mounted on the bridge indicates the deep scour hole at piers 4 and 5 is filling in. This was predicted because the road breach has created a larger opening for water to flow. This large opening slows down water velocities resulting in the river dropping its bed load.

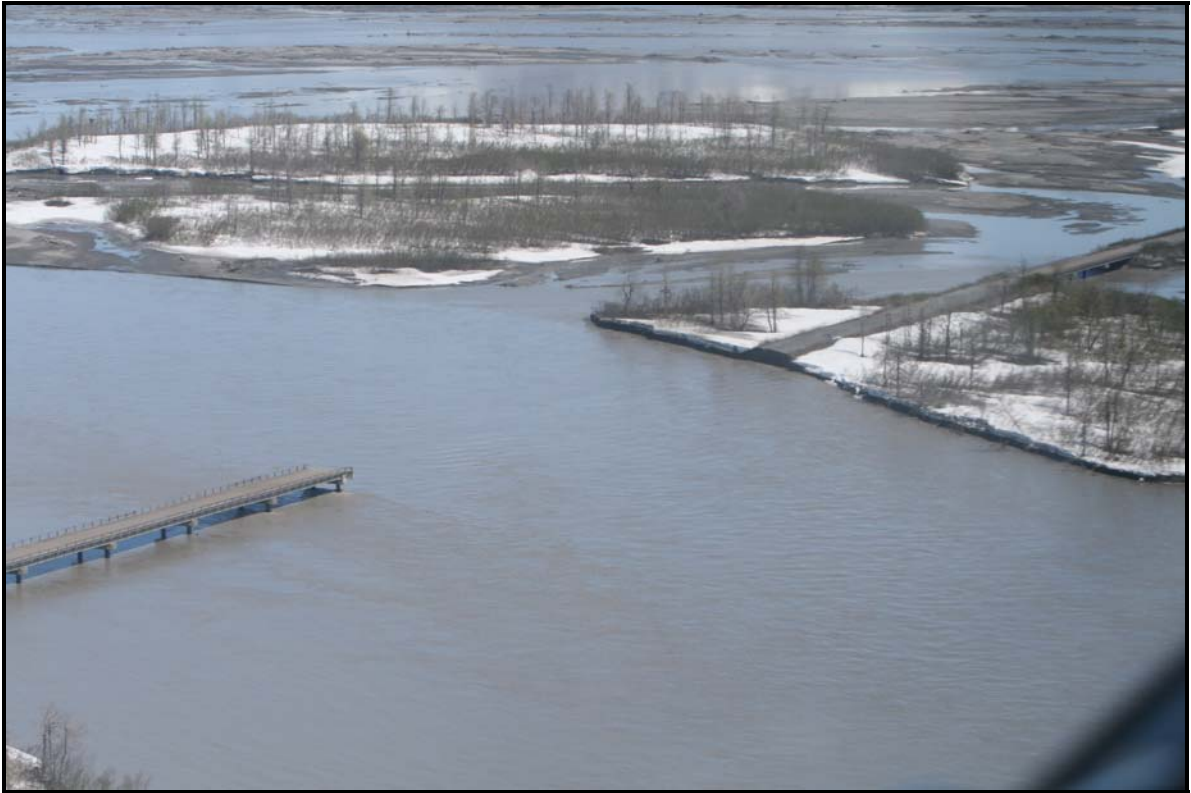
**Figure 2** – Road breach east side of Bridge 339 June 9, 2013
