APPENDIX G

Bald Eagle Consultation and Conservation Measures

**AN ASSESSMENT OF PERCH USE
AND POSSIBLE IMPACTS OF
PROPOSED HAINES HIGHWAY
REALIGNMENTS ON BALD EAGLES
DURING FALL AND WINTER,
CHILKAT RIVER, ALASKA**

STATE OF ALASKA
 DEPARTMENT OF TRANSPORTATION
 AND PUBLIC FACILITIES
 DOT & PF Project No. 68606
 HAINES HIGHWAY
 MILEPOST 3.5 - 25.3
 Haines, Alaska

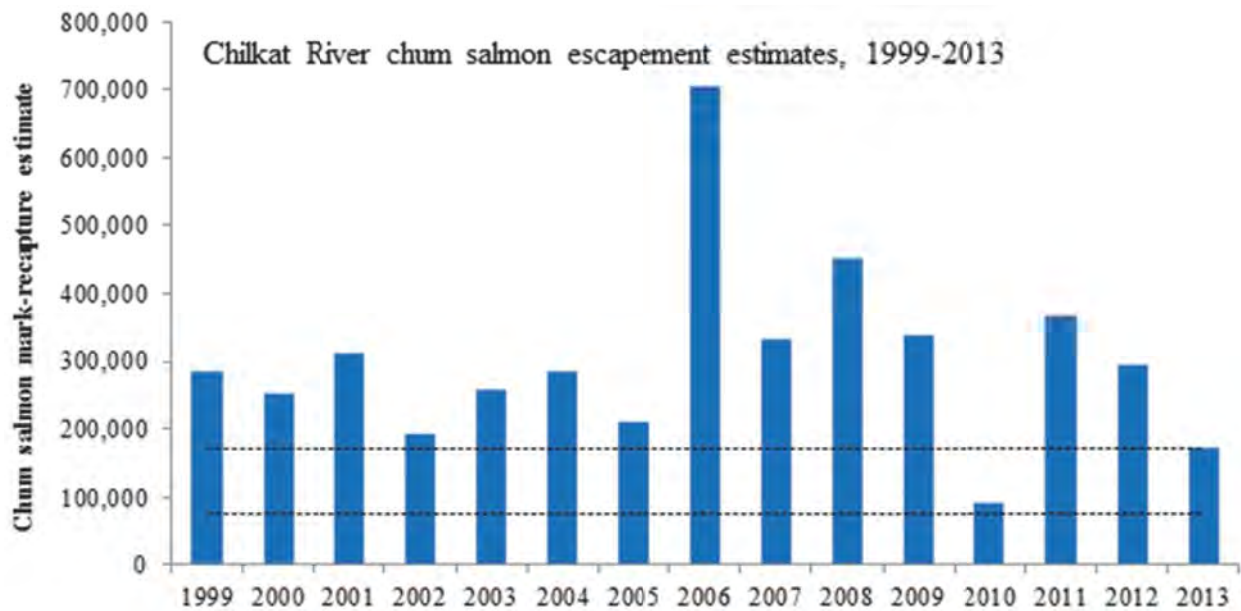
Figure 8. Chilkat River chum salmon escapement estimates, 1999–2013 (Data from D. Bachman, Alaska Department of Fish and Game, Haines, AK).
