Technical Report No. 11-10

Haines Highway Mile 25 to the Border: 10-Year Mitigation Monitoring

Alaska Department of Fish and Game

Division of Habitat

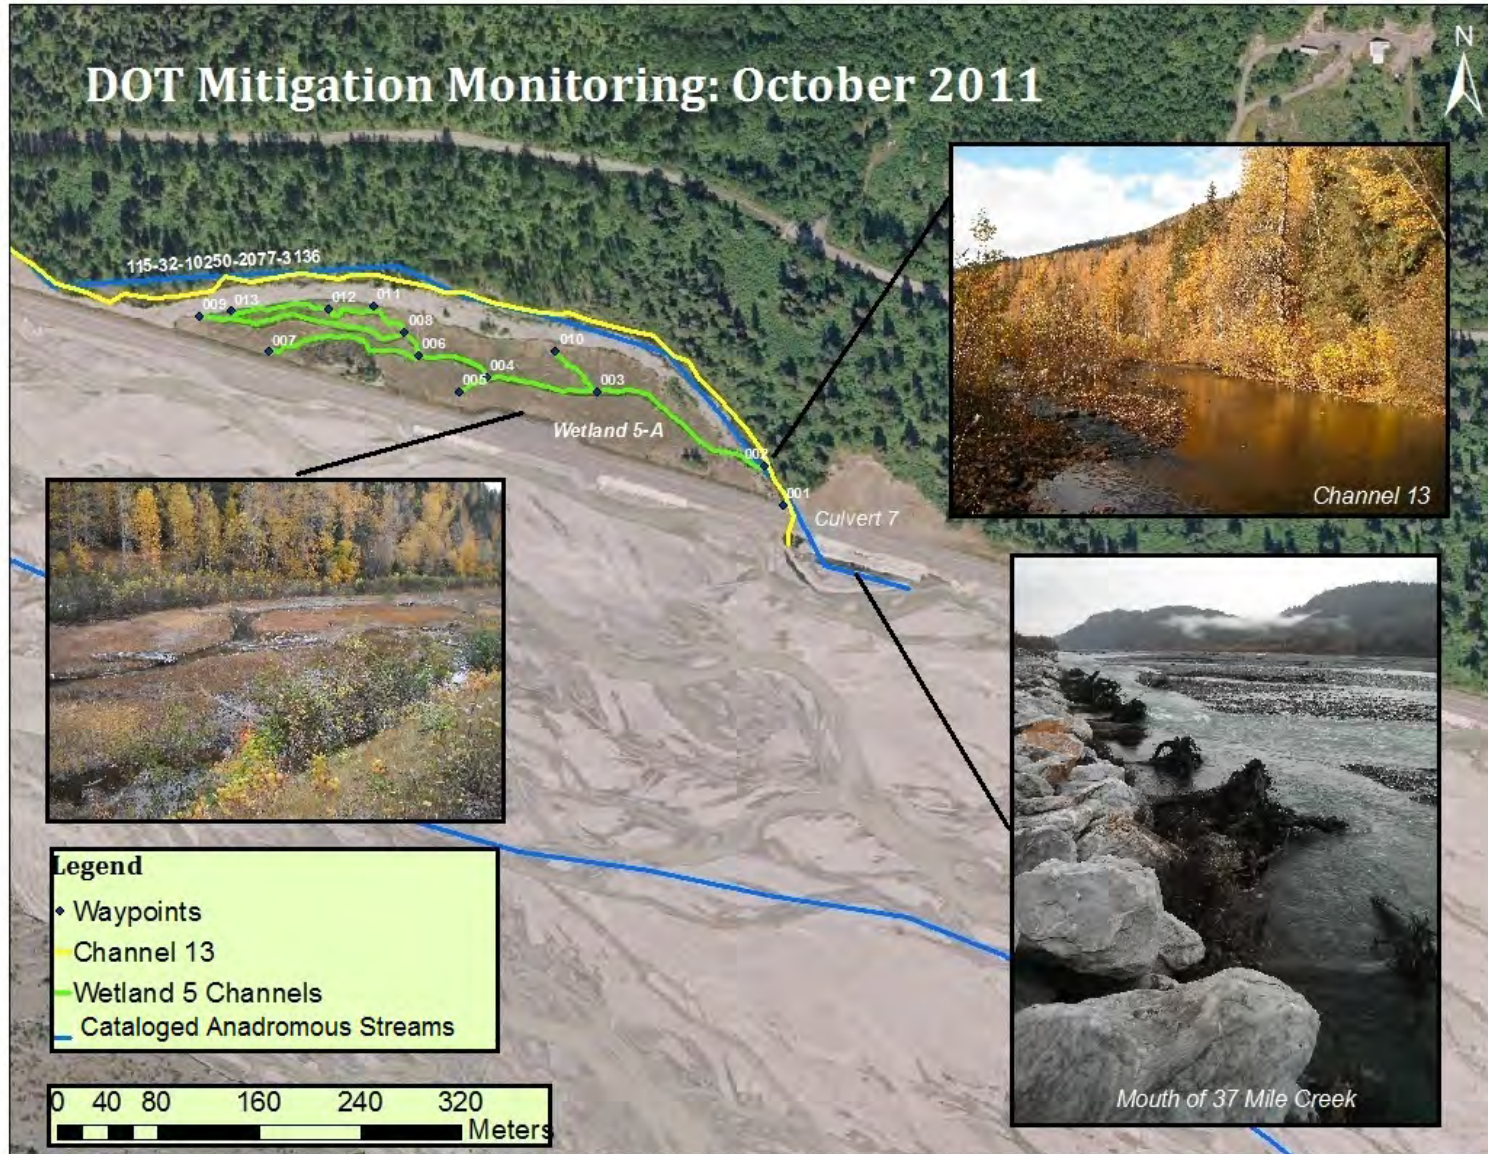
Figure 3.-WT-5 Section A map.

Wetland WT-5 is split into four sections: wetland 5-A (Figure 2 and 3), wetland 5-B (Figure 4), wetland 5-C (Figure 5), and wetland 5-D (Figure 5 and 6). These sections combine to create 15.7 acres of wetland located between the new highway alignment and the north valley wall of the old Klehini River floodplain. These wetlands were created by excavating portions of the Klehini River floodplain to the surface of the low water table during the growing season. One foot of specified wetland soil was placed on this surface after grading, and planted with wetland seed mix. The 37 Mile Creek (Stream No. 115-32-10250-2077-3136) flows along the north perimeter of all four sections of WT-5. To separate 37 Mile Creek from WT-5, a large riparian berm has been constructed along much of the perimeter.

Approximately 18,000 linear feet of small channels (Figure 2, 3, 4, 5, and 6) were constructed within the wetlands. Groundwater from the wetland areas flow through these channels into 37 Mile Creek. These channels are all uniform in their construction (4–5 feet wide, 1–2 feet deep), and the streambed material consists of a mix of small gravel, sand, and organics. Large woody debris has been placed throughout the channels, and logs have been used to stabilize various sections of the streambank. Small shrubs and wetland grasses have also been planted along the riparian area of these channels (refer to Appendix A for specific plant species information). Other manmade features in the channels include small pools and riffles.

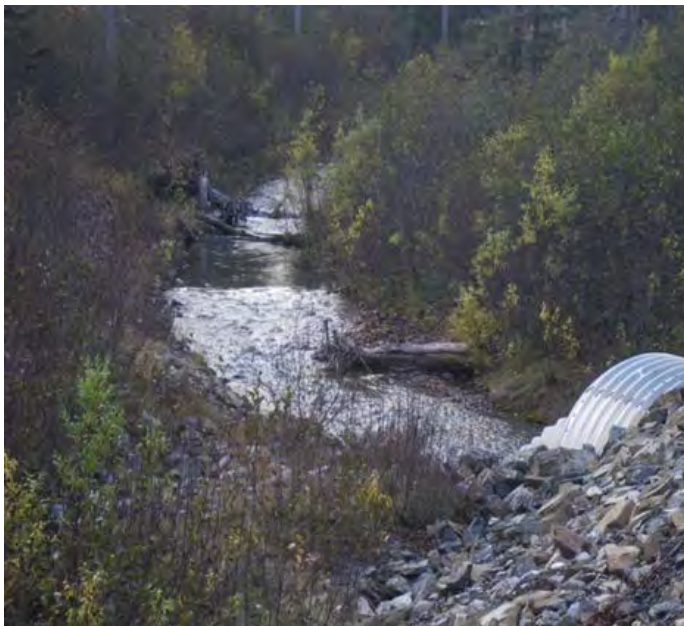
Large woody debris within CH-15 appears to be stable and provides habitat diversity with areas of slower moving water where we observed juvenile salmonids. The streambed material is also stable. Pool/riffle habitat CH-15 is as specified in the design plans, as seen in Figure 14. We observed adult Dolly Varden char in CH-15, especially near the inlet to culvert CV-9. Minnow trapping near the inlet of culvert CV-9 produced 4 Dolly Varden char and 3 juvenile coho salmon ranging in size from 40 to 150 mm (trap set for 24 hours). We also observed multiple juvenile salmonids throughout CH-15 during the survey. However, we did not observe adult coho salmon or redds in CH-15 during our survey.

Figure 14.—Stream channel CH-15.

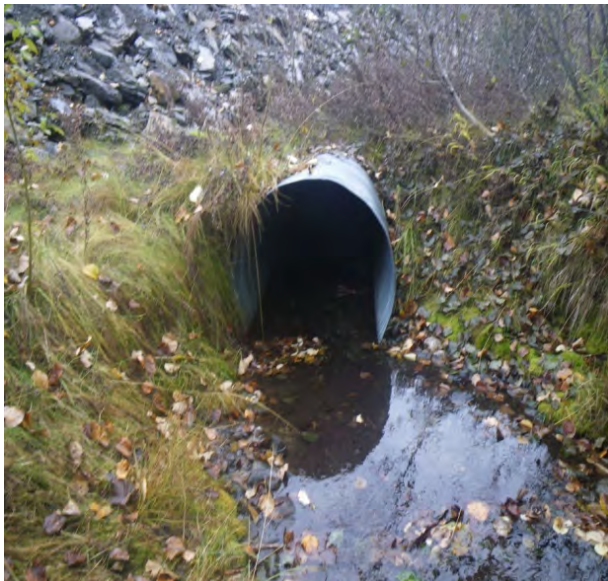
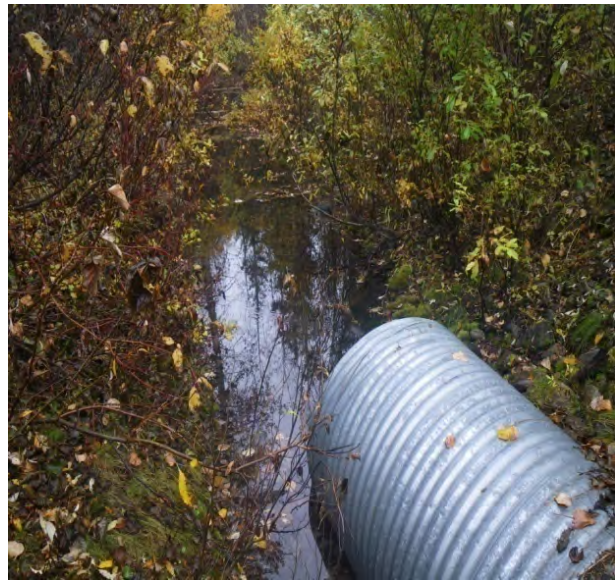
Streambed material within culvert CV-8 (Figure 26 and 27) is comprised of sand and organics, and appears to be stable. The culvert is the appropriate size for the stream, and water velocity through the culvert does not appear to change or represent a fish passage barrier. We set baited minnow traps near the culvert inlet and outlet for 24 hours and captured 5 Dolly Varden char (45–100 mm) and 2 coho salmon (50 mm) near the inlet, and 41 coho salmon (40–75 mm) near the outlet.

Figure 26.–Culvert CV-8 inlet.

Figure 27.–Culvert CV-8 outlet.

The mitigation objective for culvert CV-8 has been achieved. The culvert provides fish passage, and currently there are no recommendations to modify the CMP.

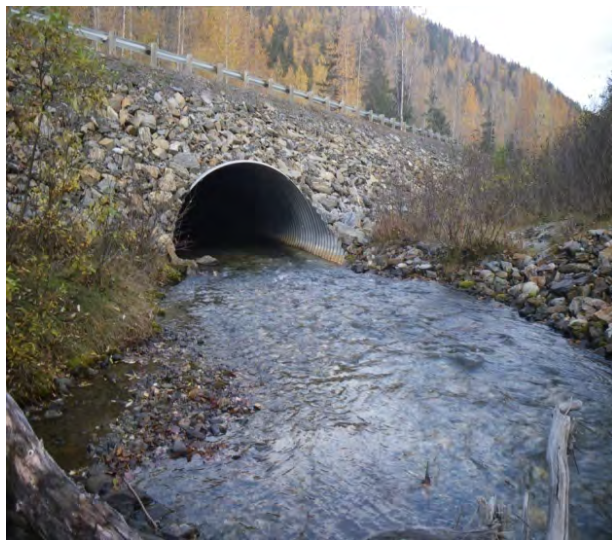
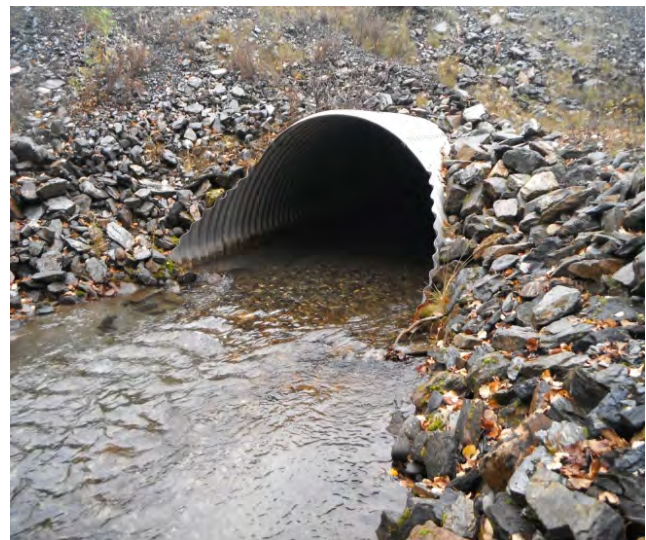
Culvert CV-9 is a 126-foot long by 14-foot 3-inch wide by 9-foot 7-inch high aluminum structural plate pipe arch culvert (Figure 28 and 29). The culvert is located on 37 Mile Creek, connecting stream channels CH-14 and CH-15. ADOT&PF placed approximately 1 foot 6 inches of class I riprap topped with 6 inches of gravel in the culvert. A bypass channel located near the inlet to CV-9 (stream channel CH-15) limits flood flows through the culvert.

Figure 28.–Culvert CV-9 inlet.

Figure 29.–Culvert CV-9 outlet.

The mitigation objective for culvert CV-9 has been achieved. There is a potential for increased water velocity during high water to limit juvenile fish passage through the culvert. We recommend habitat biologists return to culvert CV-9 during high flows to re-survey the culvert.

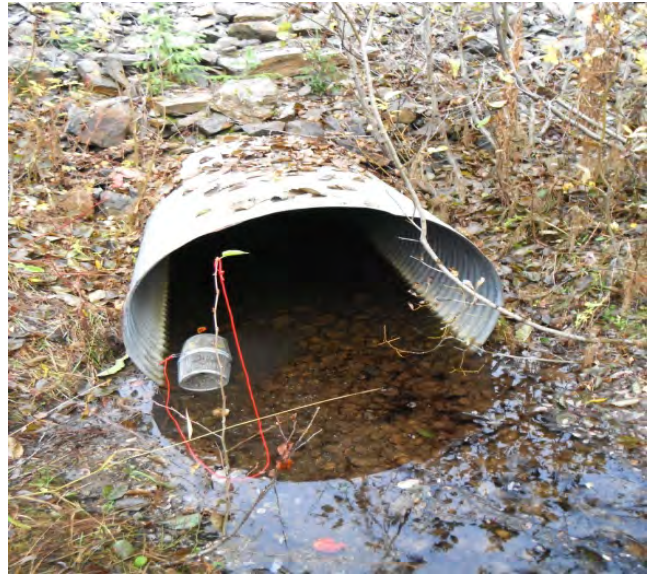
Culvert CV-10 is a 100-foot long by 54-inch wide CMP (Figure 30 and 31). The culvert is located on 37½ Mile Creek, directly downstream of stream channel CH-18. ADOT&PF placed approximately 1 foot of class I riprap topped with 6 inches of gravel in the culvert.

Figure 30.–Culvert CV-10 inlet.

Figure 31.–Culvert CV-10 outlet.

During our survey we were unable to determine if the mitigation objective for culvert CV-10 has been achieved. We recommend habitat biologists return to survey the culvert when water levels are higher.

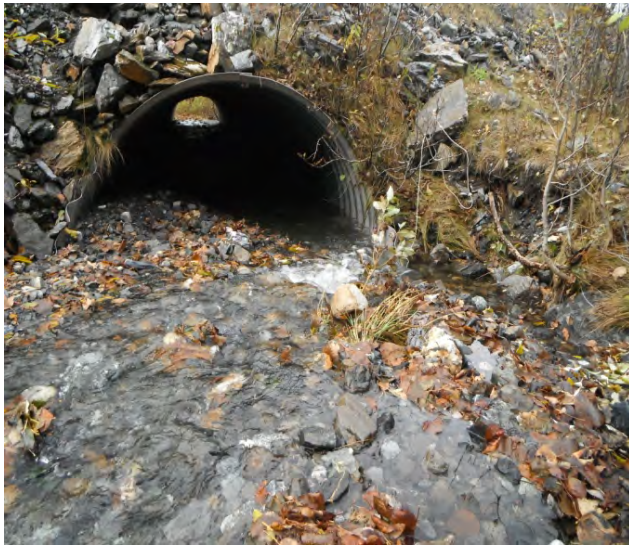
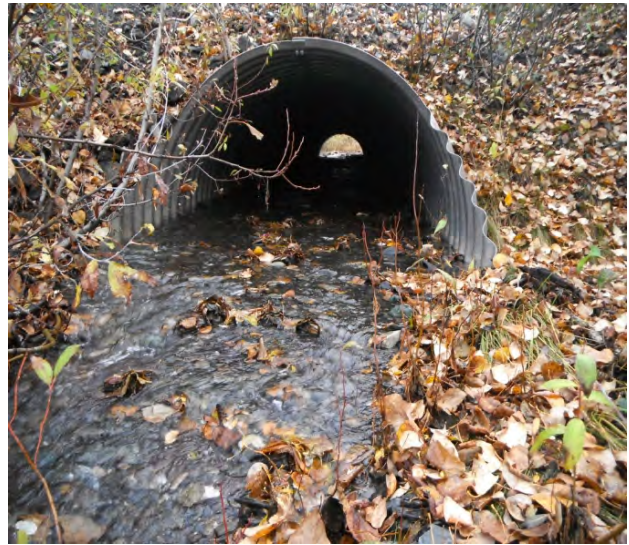
Culvert CV-11 is a 100-foot long by 9-foot wide CMP (Figure 32 and 33). The culvert is located on 37 Mile Creek, adjacent to wetland WT-6. ADOT&PF placed approximately 2 feet of class I riprap topped with gravel in the culvert.

Figure 32.—Culvert CV-11 inlet.

Figure 33.—Culvert CV-11 outlet.

During our survey we were unable to determine if the mitigation objective for culvert CV-11 has been achieved. We recommend habitat biologists return to the site to survey the culvert again before we determine if the mitigation objective has been met.

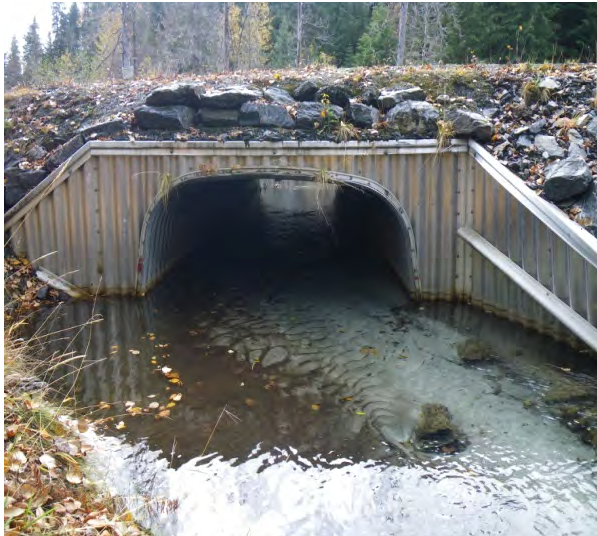
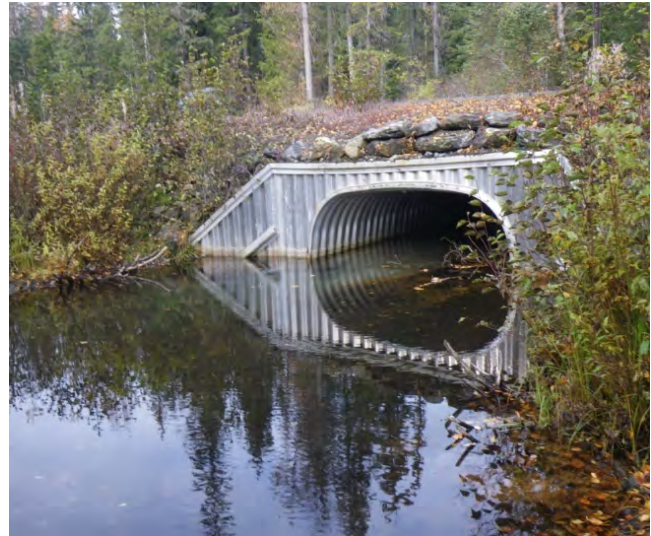
Culvert CV-12 is an aluminum box culvert (Figure 34 and 35) 58-foot 6-inch long by 13-foot 3-inch wide by 6-foot 9-inch high. The culvert is located on Stream No. 115-32-10250-2077-3136-4053. ADOT&PF placed approximately 1 foot of streambed material in the culvert.

Figure 34.–Culvert CV-12 inlet.

Figure 35.–Culvert CV-12 outlet.

During our survey we were unable to determine if the mitigation objective for culvert CV-12 have been achieved. We recommend habitat biologists return to the site to survey the culvert again before we determine if the mitigation objective has been met.

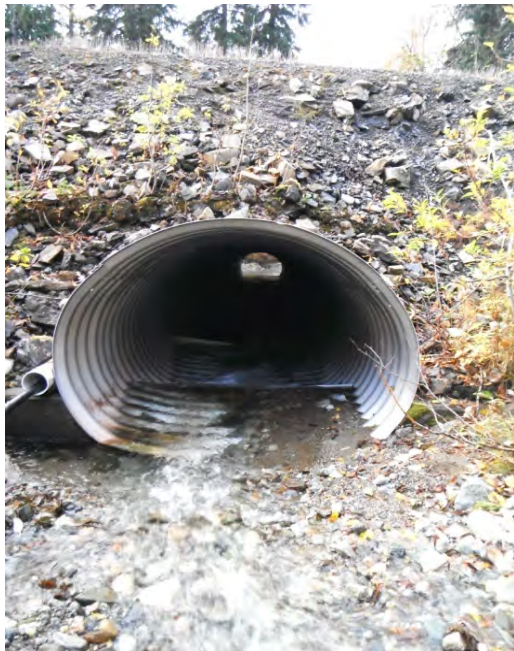
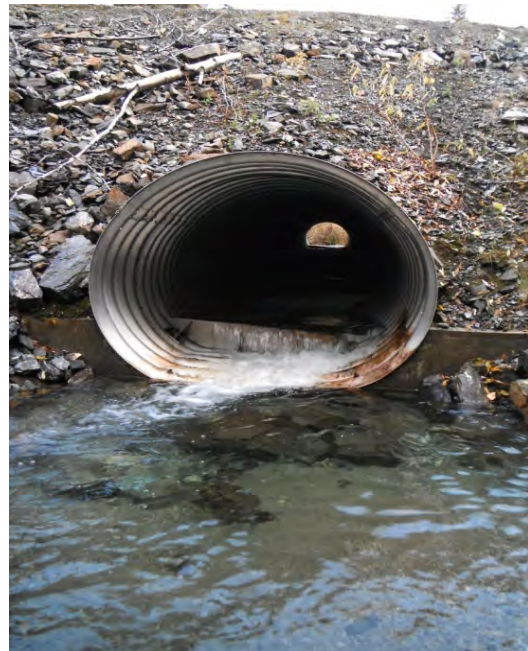
Figure 36.–Culvert CV-13 inlet.

Figure 37.–Culvert CV-13 outlet.

During our survey we were unable to determine if the mitigation objective for culvert CV-12 has been achieved. The culvert does appear to be installed to the design specifications; however fish passage cannot be confirmed. We recommend that habitat biologists return to survey the culvert so we can determine if the mitigation objective has been met.

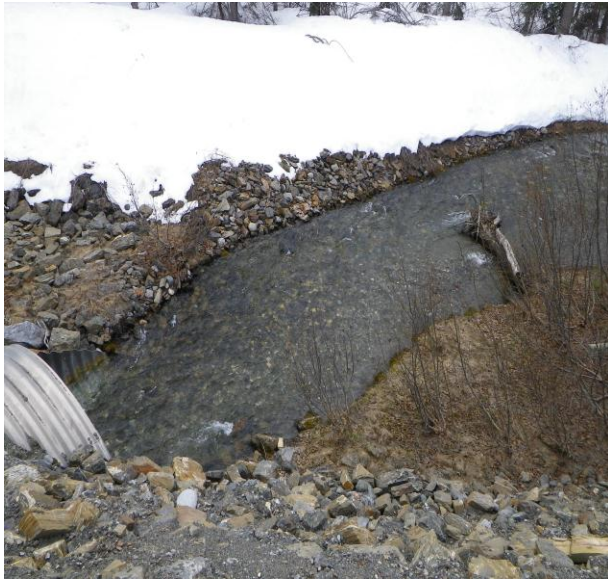
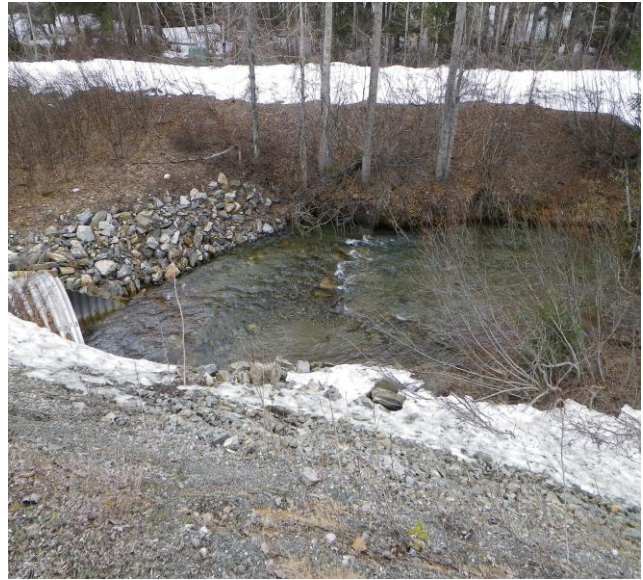
The water level in culvert CV-9 was higher during our 5/10/12 survey than it was during the 2011 survey. Water velocity appeared to increase through the culvert; however, it was not measured. Streambed material within culvert CV-9 is stable and is comprised of spawning sized gravel (Kondolf and Wolman, 1993) and no evidence of streambed scouring was observed. The average bank-full width measured above culvert CV-9 is 19.6 ft (Figure 6). The average bank-full width measured below culvert CV-9 is 25 ft (Figure 7). These values were calculated from measurements taken at 20, 40, and 60 ft above and below culvert CV-9.

Figure 6.—Culvert CV-9 inlet 5/10/12.

Figure 7.—Culvert CV-9 outlet 5/10/12.
