**HYDROLOGY REPORT  
FOR  
SEWARD AIRPORT MASTER PLAN  
PHASE II**

**FOR  
DEPARTMENT OF TRANSPORTATION  
AND  
PUBLIC FACILITIES**

**JULY 25, 2006**

**DOT&PF Project No. 56525**

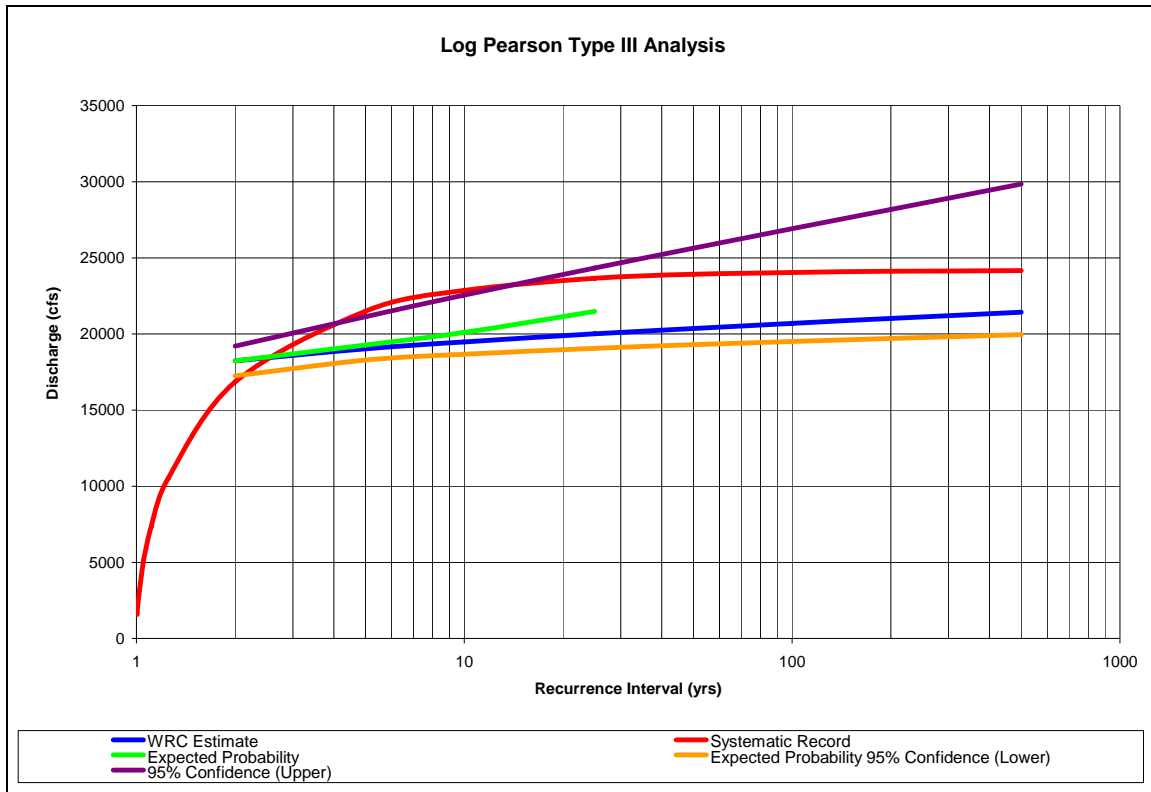
**Figure 33: Log Pearson Type III Analysis for the Resurrection River at Seward.**

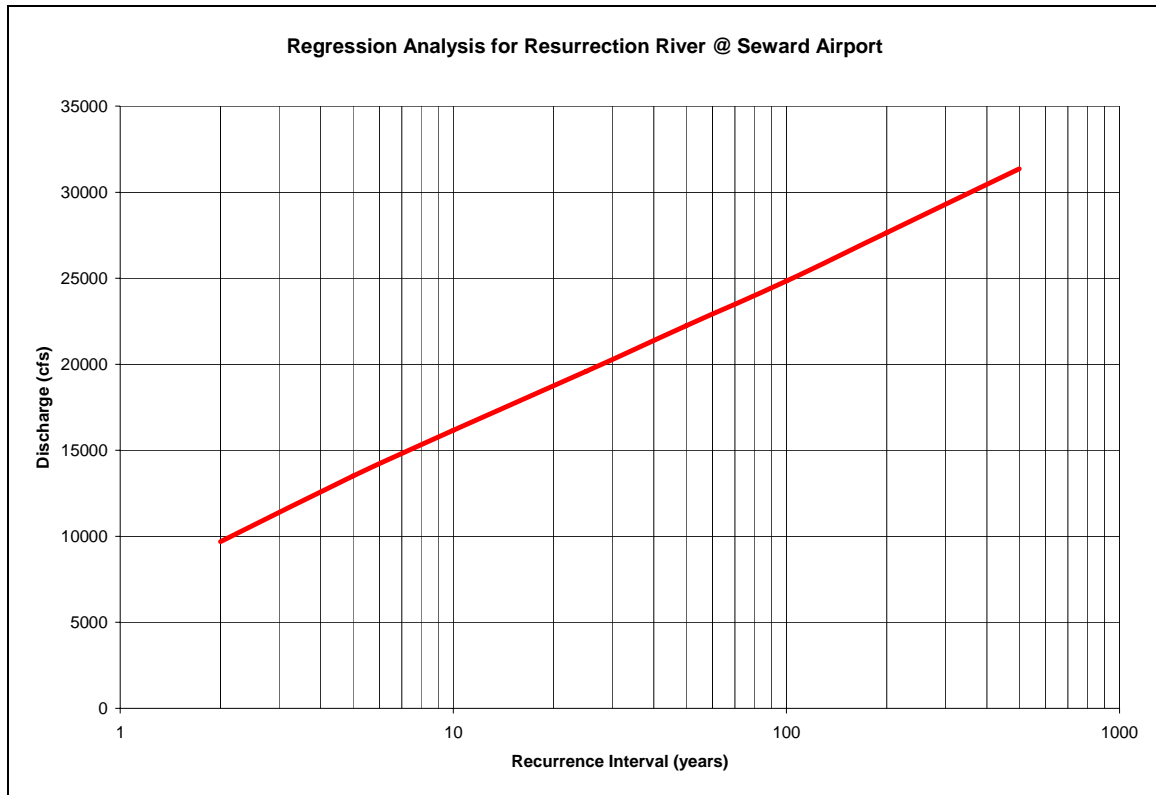
$Q_2 = 9,696$ cfs	$Q_5 = 13,499$ cfs	$Q_{10} = 16,163$ cfs
$Q_{25} = 19,584$ cfs	$Q_{50} = 22,236$ cfs	$Q_{100} = 24,840$ cfs
$Q_{200} = 27,649$ cfs	$Q_{500} = 31,354$ cfs

**Figure 34: Regression Analysis for Resurrection River at Seward Airport.**

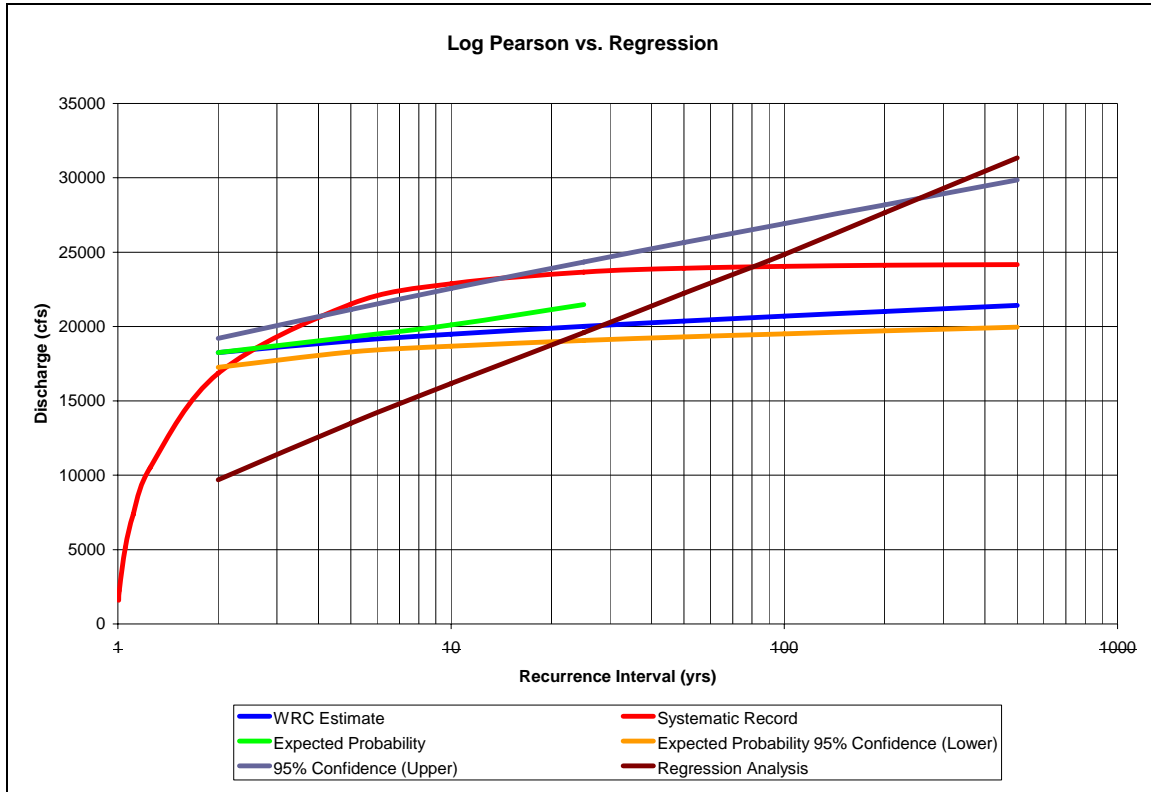
**Figure 35: Comparison between Log Pearson Type III and Regression Analysis**

Therefore, for the purposes of this report, the following Regression Analysis was used to determine the Design High Water (DHW) elevations for the  $Q_{25}$ ,  $Q_{50}$ , and  $Q_{100}$ .

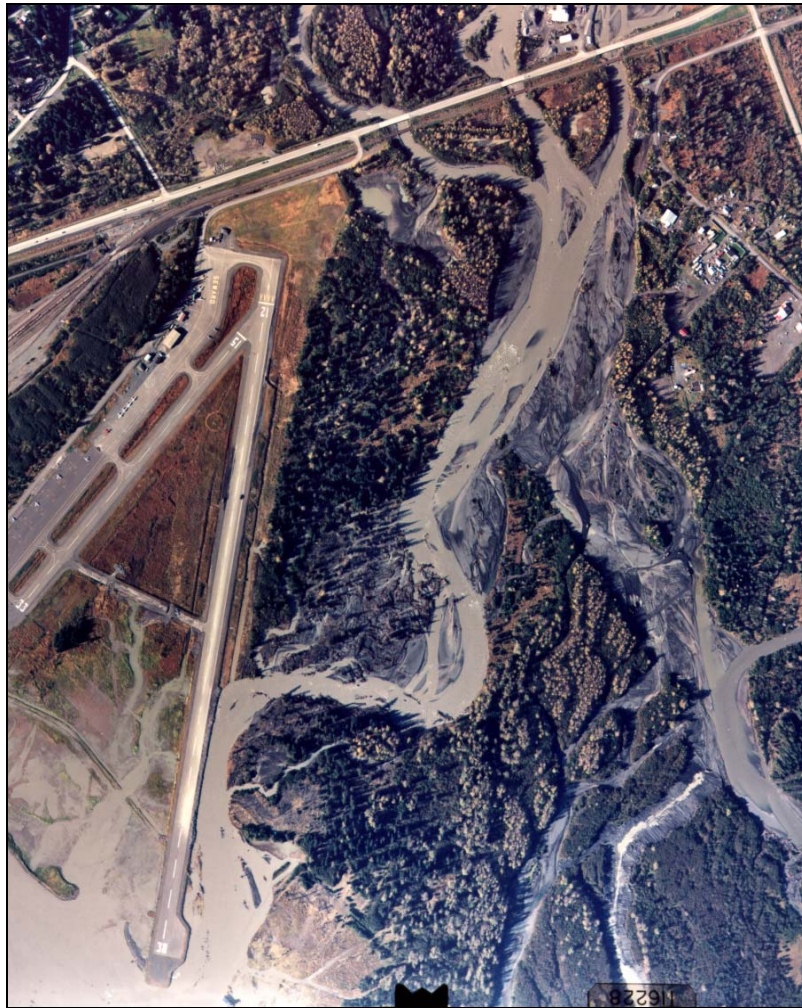
**Figure 36: Aerial photograph taken after the October 1995 flood event.**

Figure 36 shows the Resurrection River has established a new channel alongside the embankment of the Seward Airport abandoning its traditional channel. In fact, there was no flow in the old traditional channel at the time this aerial photograph was taken. After the 1986 flood event, using construction equipment, the Department of Transportation and Public Facilities moved in excess of 350,000 cubic yards of material to reestablish 75 percent of the Resurrection River's flow to its traditional channel. As a condition of the Title 16 Department of Fish and Game habitat permit, 25 percent of the flow remained in the newly established channel along the Seward Airport's east embankment.

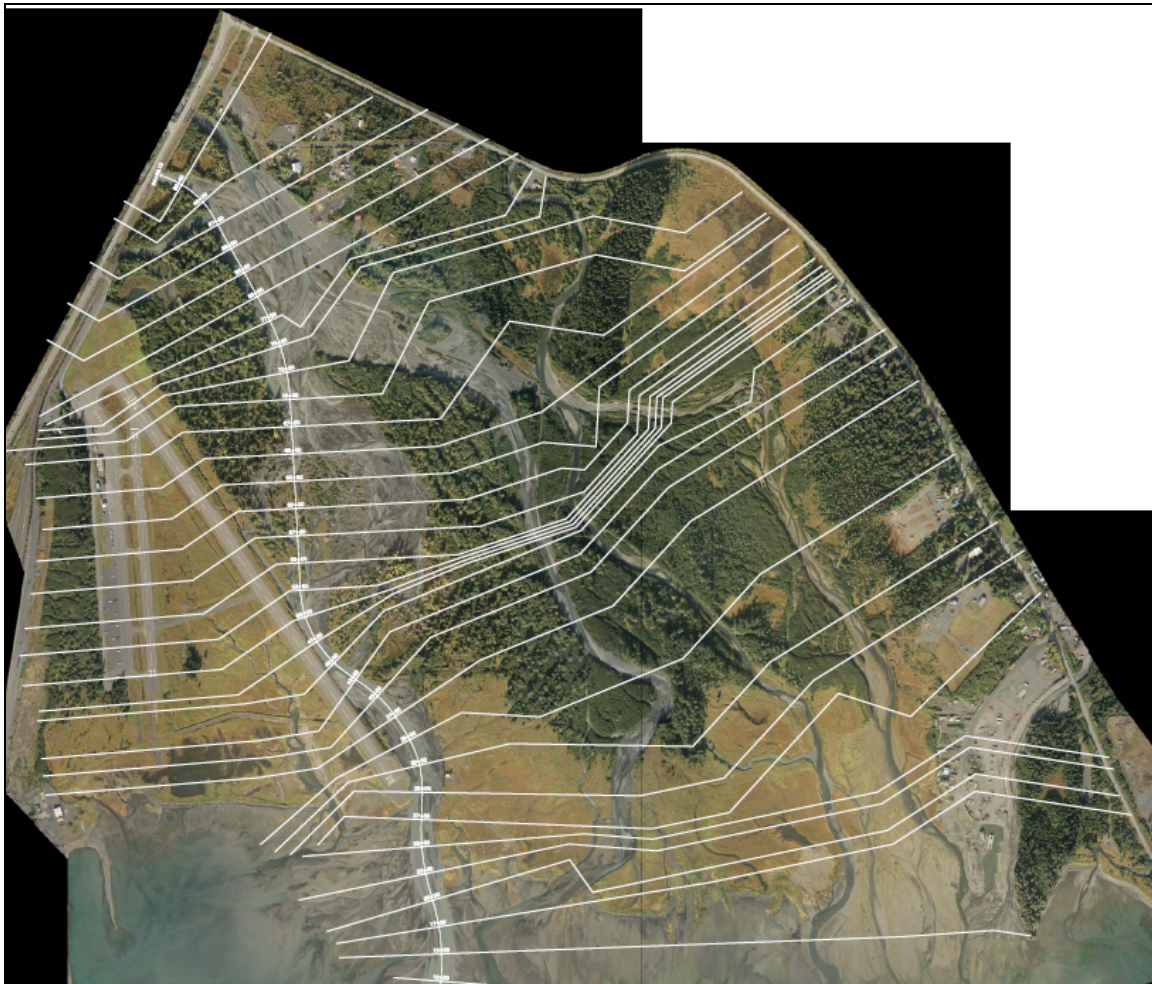
**Figure 39: Aerial Photograph of Resurrection River Delta showing the location of hydraulic cross-sections.**

Figure 39 shows the location of hydraulic cross-sections generated for the initial HEC-RAS evaluation. Although the HEC-RAS model was not used in this analysis, the cross-sections were used in the calculation of the conveyance for the stage discharge curves in Figure 41.

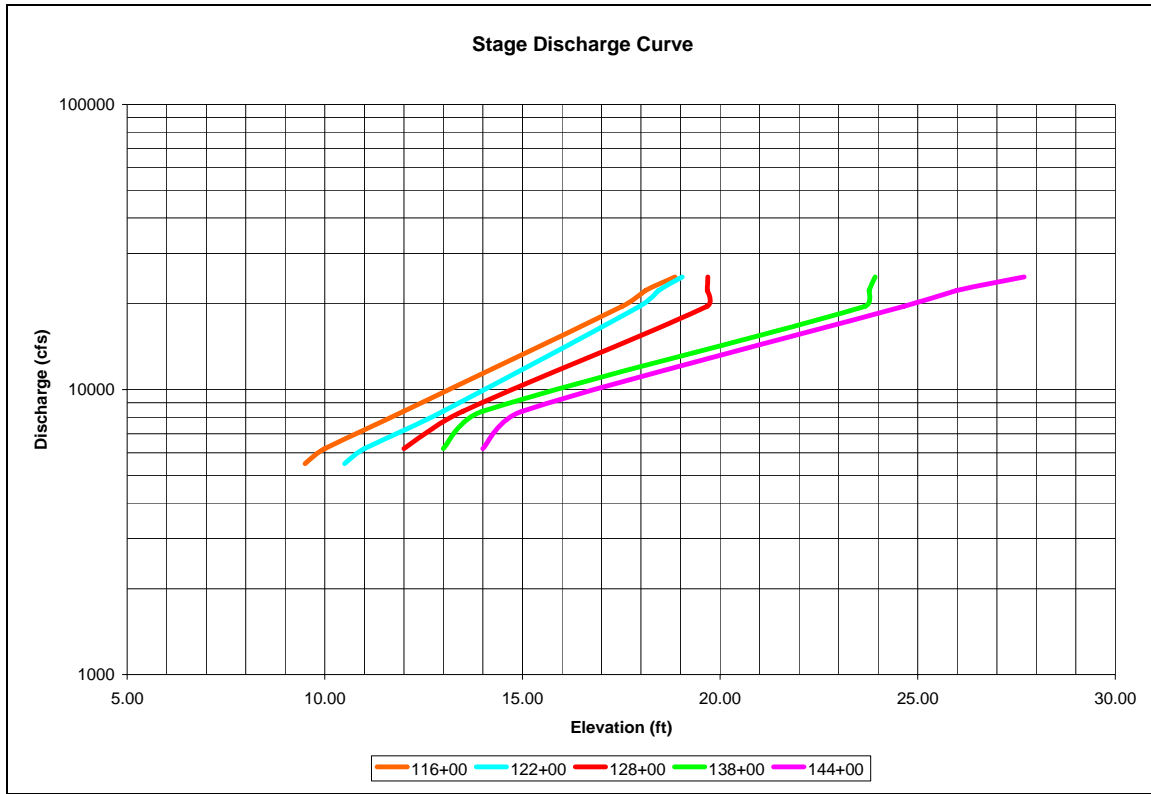
**Figure 41: Stage Discharge Curve**

Figure 41 is a graphical representation of the Stage Discharge Curve at Stations 116+00, 122+00, 128+00, 138+00, and 144+00. In order to construct the stage discharge curve, it was necessary to take known discharge information at the Seward Highway and at the same time document the water surface elevation at Stations 116+00, 122+00, 128+00, 138+00, and 144+00. It was assumed that the discharge at the Seward Highway remained static through the reach.

It should be noted that the stage discharge curve tends to make a radical upward climb for the  $Q_{100}$  for the stage discharge curves for Stations 128+00 and 138+00. It is believed the reason for this is the elevations where the channels to the east (Nash Road side of the delta) begin to carry a significant percentage of the design flood.

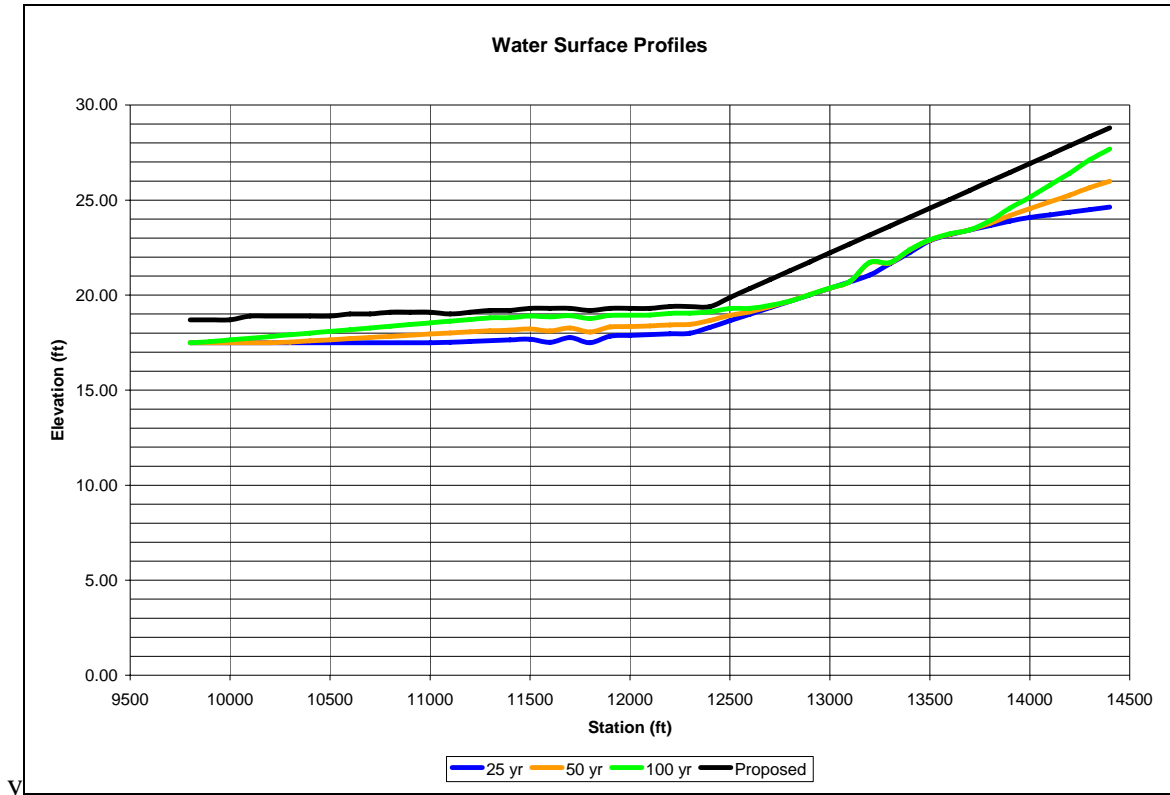
**Figure 42: Projected Water Surface for Q<sub>25</sub>, Q<sub>50</sub>, and Q<sub>100</sub>**

The water surface profiles represent conditions as of 2004 when field data was collected. Based on trends, it is reasonable to assume that these profiles will accurately predict the water surface within a plus or minus by one foot over the 25 year design life required for the design for the Seward Airport. It is reasonable to expect the Resurrection River will continue to move towards the west because the distance from the Seward Highway crossings over the Resurrection River is significantly shorter to tidewater, than the old traditional channels. It is also reasonable to assume that the deposition directly downstream from the Nash Road crossing over the Salmon River will continue to deposit a significant amount of material in

Using the water surface profiles in Figure 42, an inundation map was created for the  $Q_{25}$  (25-year) flood event. Areas in red indicate that the area is flooded. This design event was requested by the Federal Aviation Administration as the design standard to be used for this report.

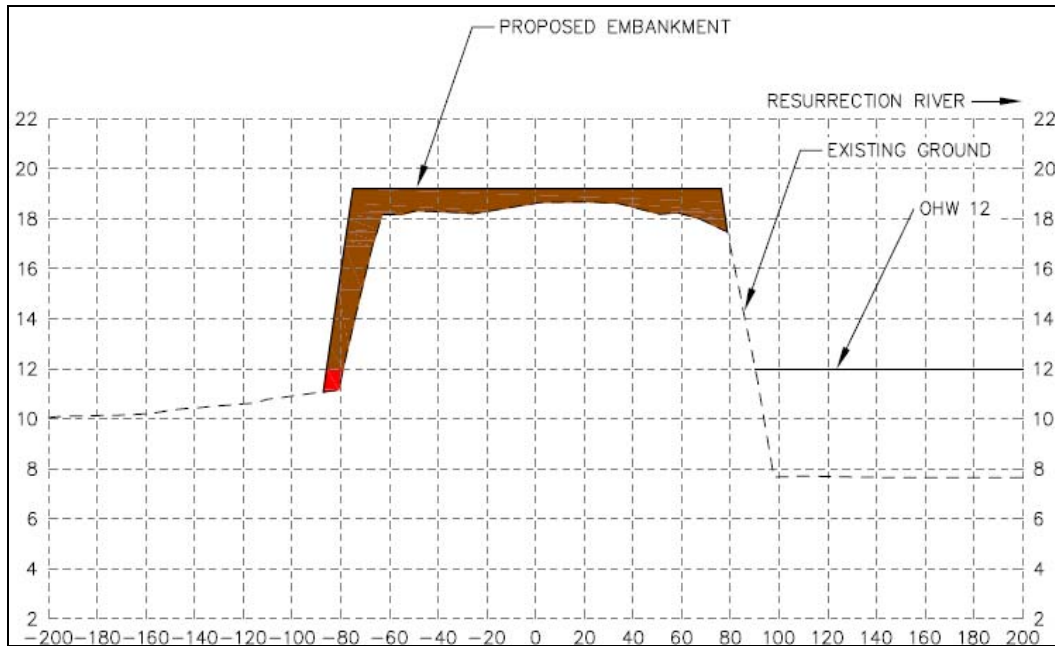
**Figure 49: Alternative No. 2 Typical Section A-A.**

Figures 49, 50, 51, 52, and 53 are typical sections showing a graphical representation required fill for Alternative No. 2 in below total fill required in Alternative No. 2 and fill below Ordinary High Water. The location of these sections is shown on Figures 47 and 48.

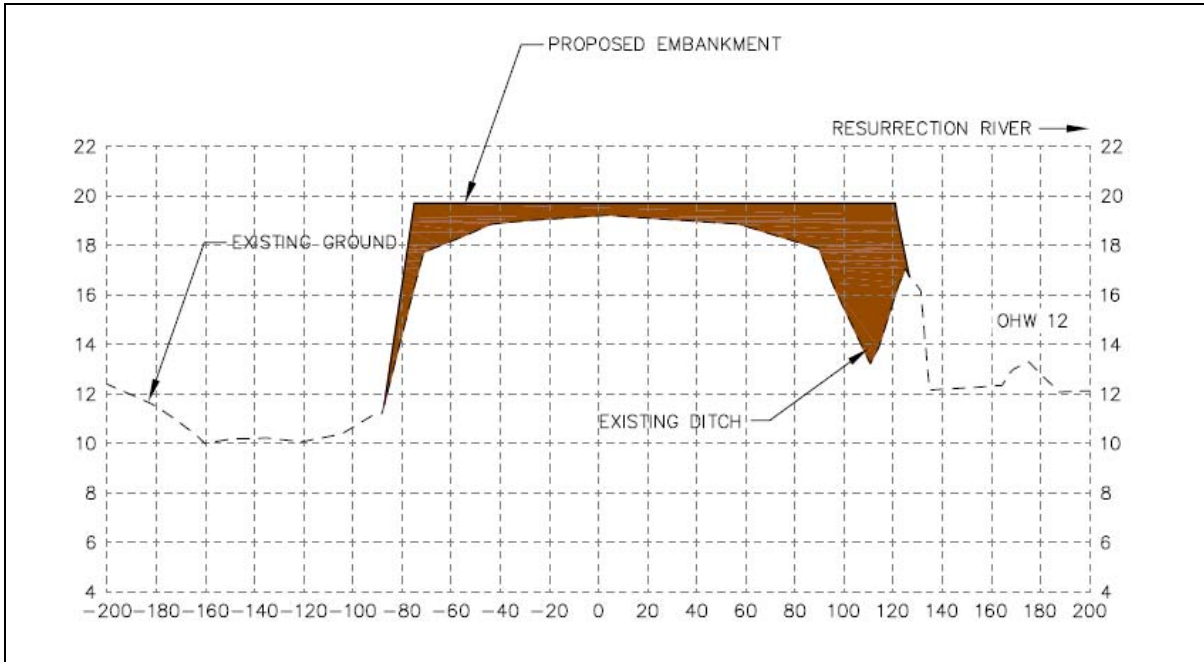
**Figure 51: Alternative No. 2 Typical Section C-C.**

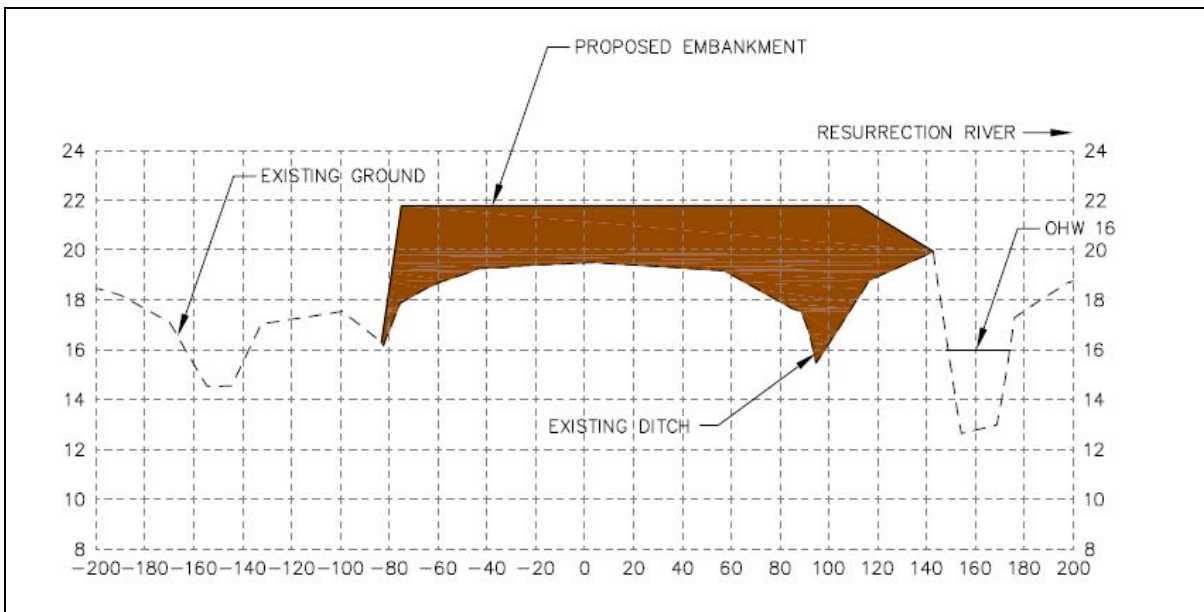
**Figure 52: Alternative No. 2 Typical Section D-D.**

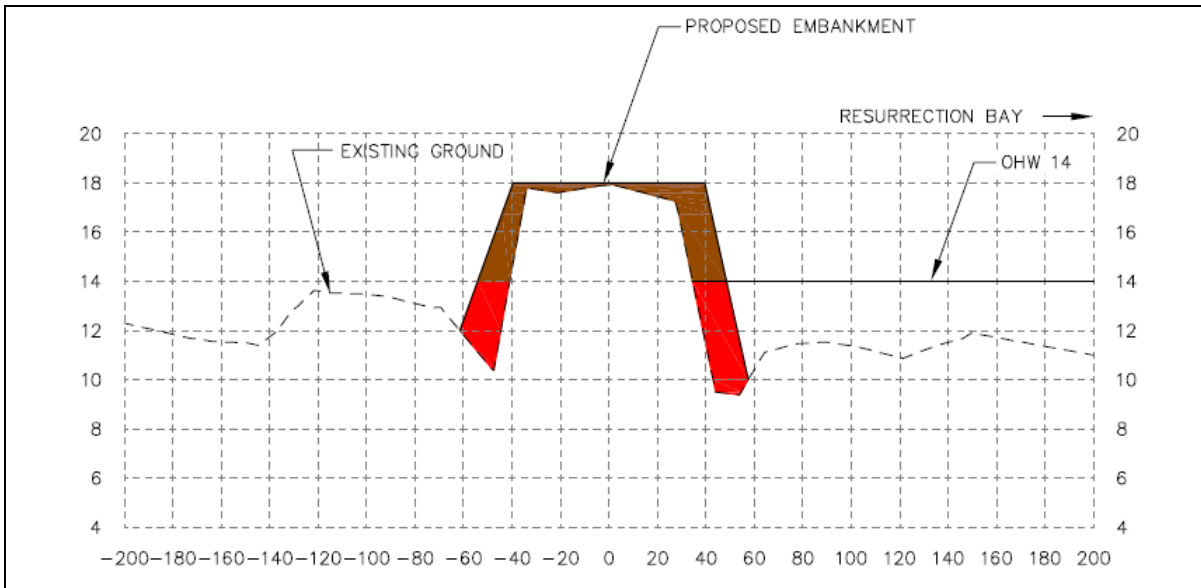
**Figure 59: Typical Section F-F for Taxiway**
