Essential Fish Habitat Assessment

DRAFT
ESSENTIAL FISH HABITAT ASSESSMENT
HAINES HIGHWAY FROM MP 3.5 TO 25.3
HAINES, ALASKA

DOT&PF Project No. 68606
Federal Project No. SHAK-095-6(28)

DOWL HKM
4041 B Street
Anchorage, Alaska 99503
(907) 562-2000

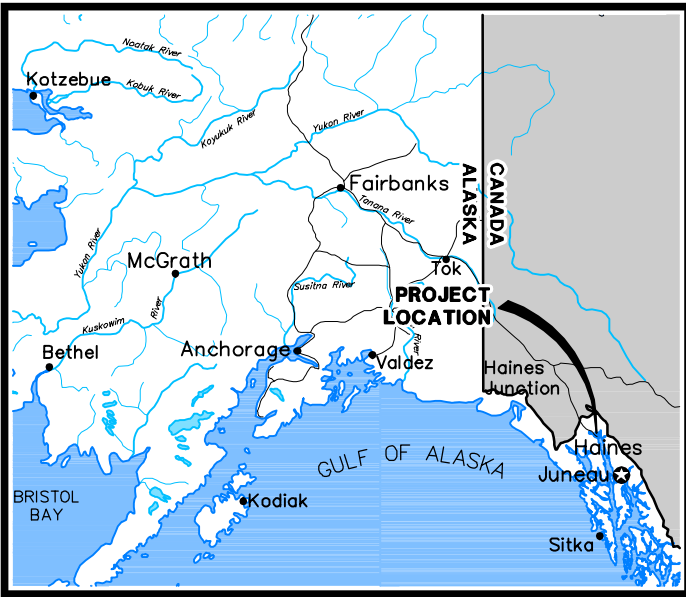
Project Location
and
Vicinity Map

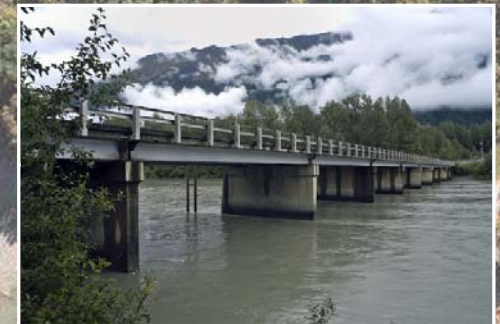
Proposed New Chilkat River Bridge Alignment

The installation of the new Chilkat River Bridge and removal of the Haines-Fairbanks pipeline crossing would reduce the number of structures in the river from nine pier groups to six, reducing safety hazards associated with debris blockage around the piers.

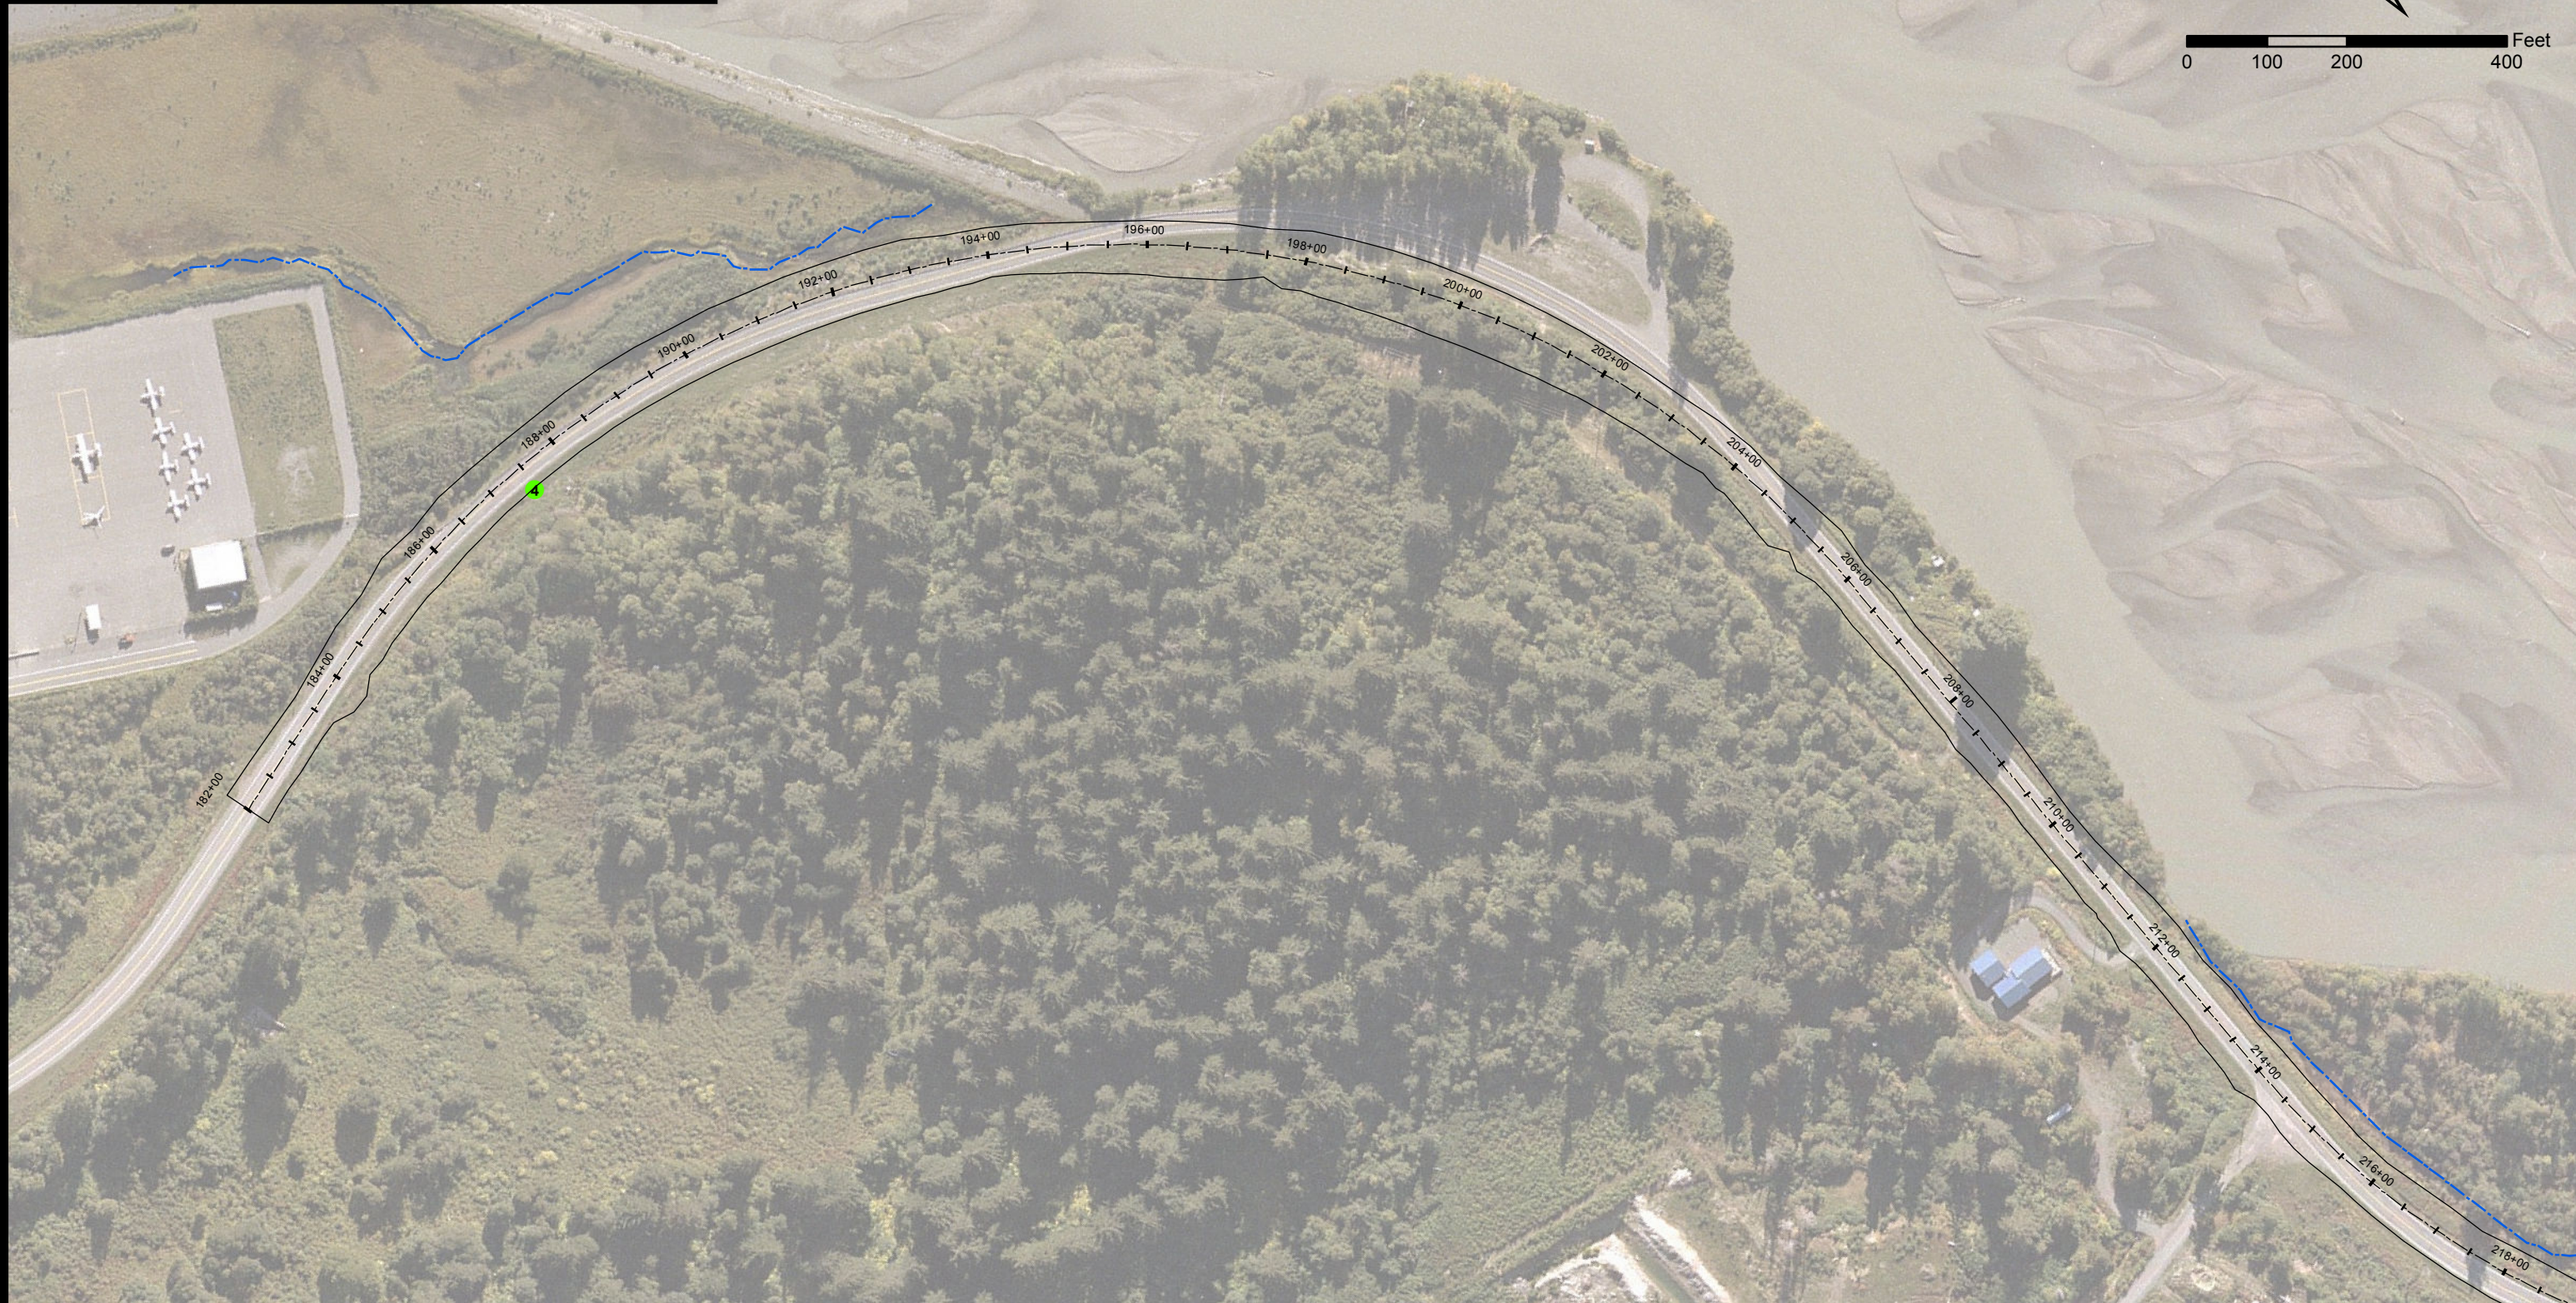
DATE: May 03, 2012 FIGURE SET 1 (01 OF 34)

CHILKAT RIVER IMPACTS

The function that would be most impacted by activities associated with the proposed project is the provision of habitat. Areas where fill is proposed to be placed in the main stem of the Chilkat River or in its side channels or backwaters are depicted on Figure Set 1 and the accompanying table in Appendix A. The proposed fill is estimated at 7.4 acres (323,008 square feet) along 14,244 linear feet of river. Twenty-four culverts are proposed to be replaced in 23 tributary channels as shown in Figure Set 1 (Appendix A) and the table in Appendix D.

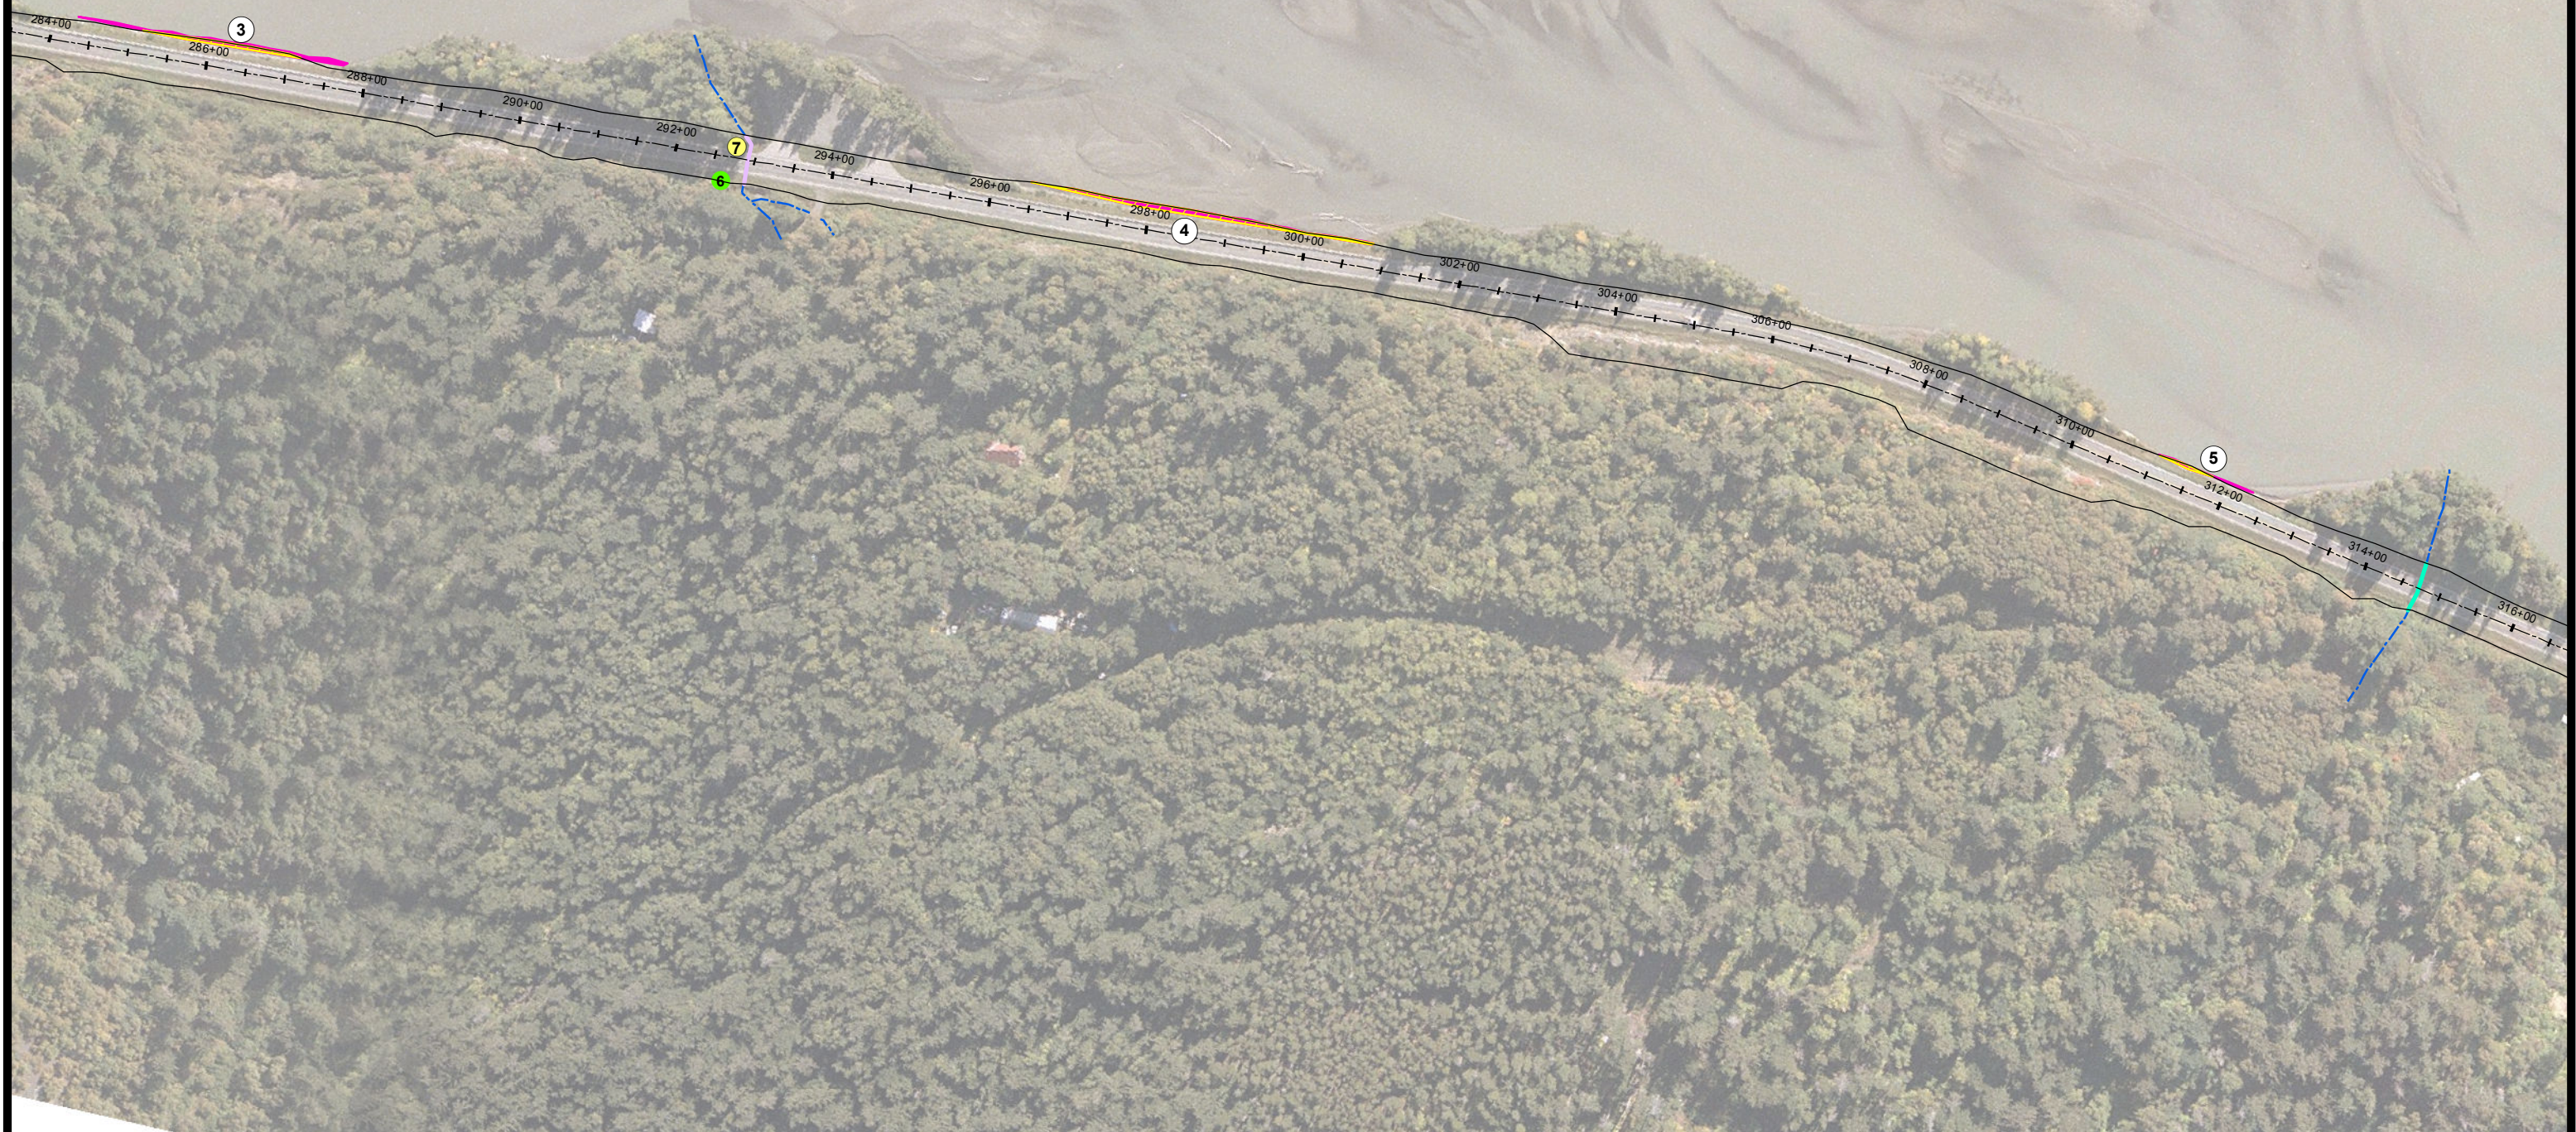
DATE: May 03, 2012 FIGURE SET 1 (04 OF 34)

CHILKAT RIVER IMPACTS

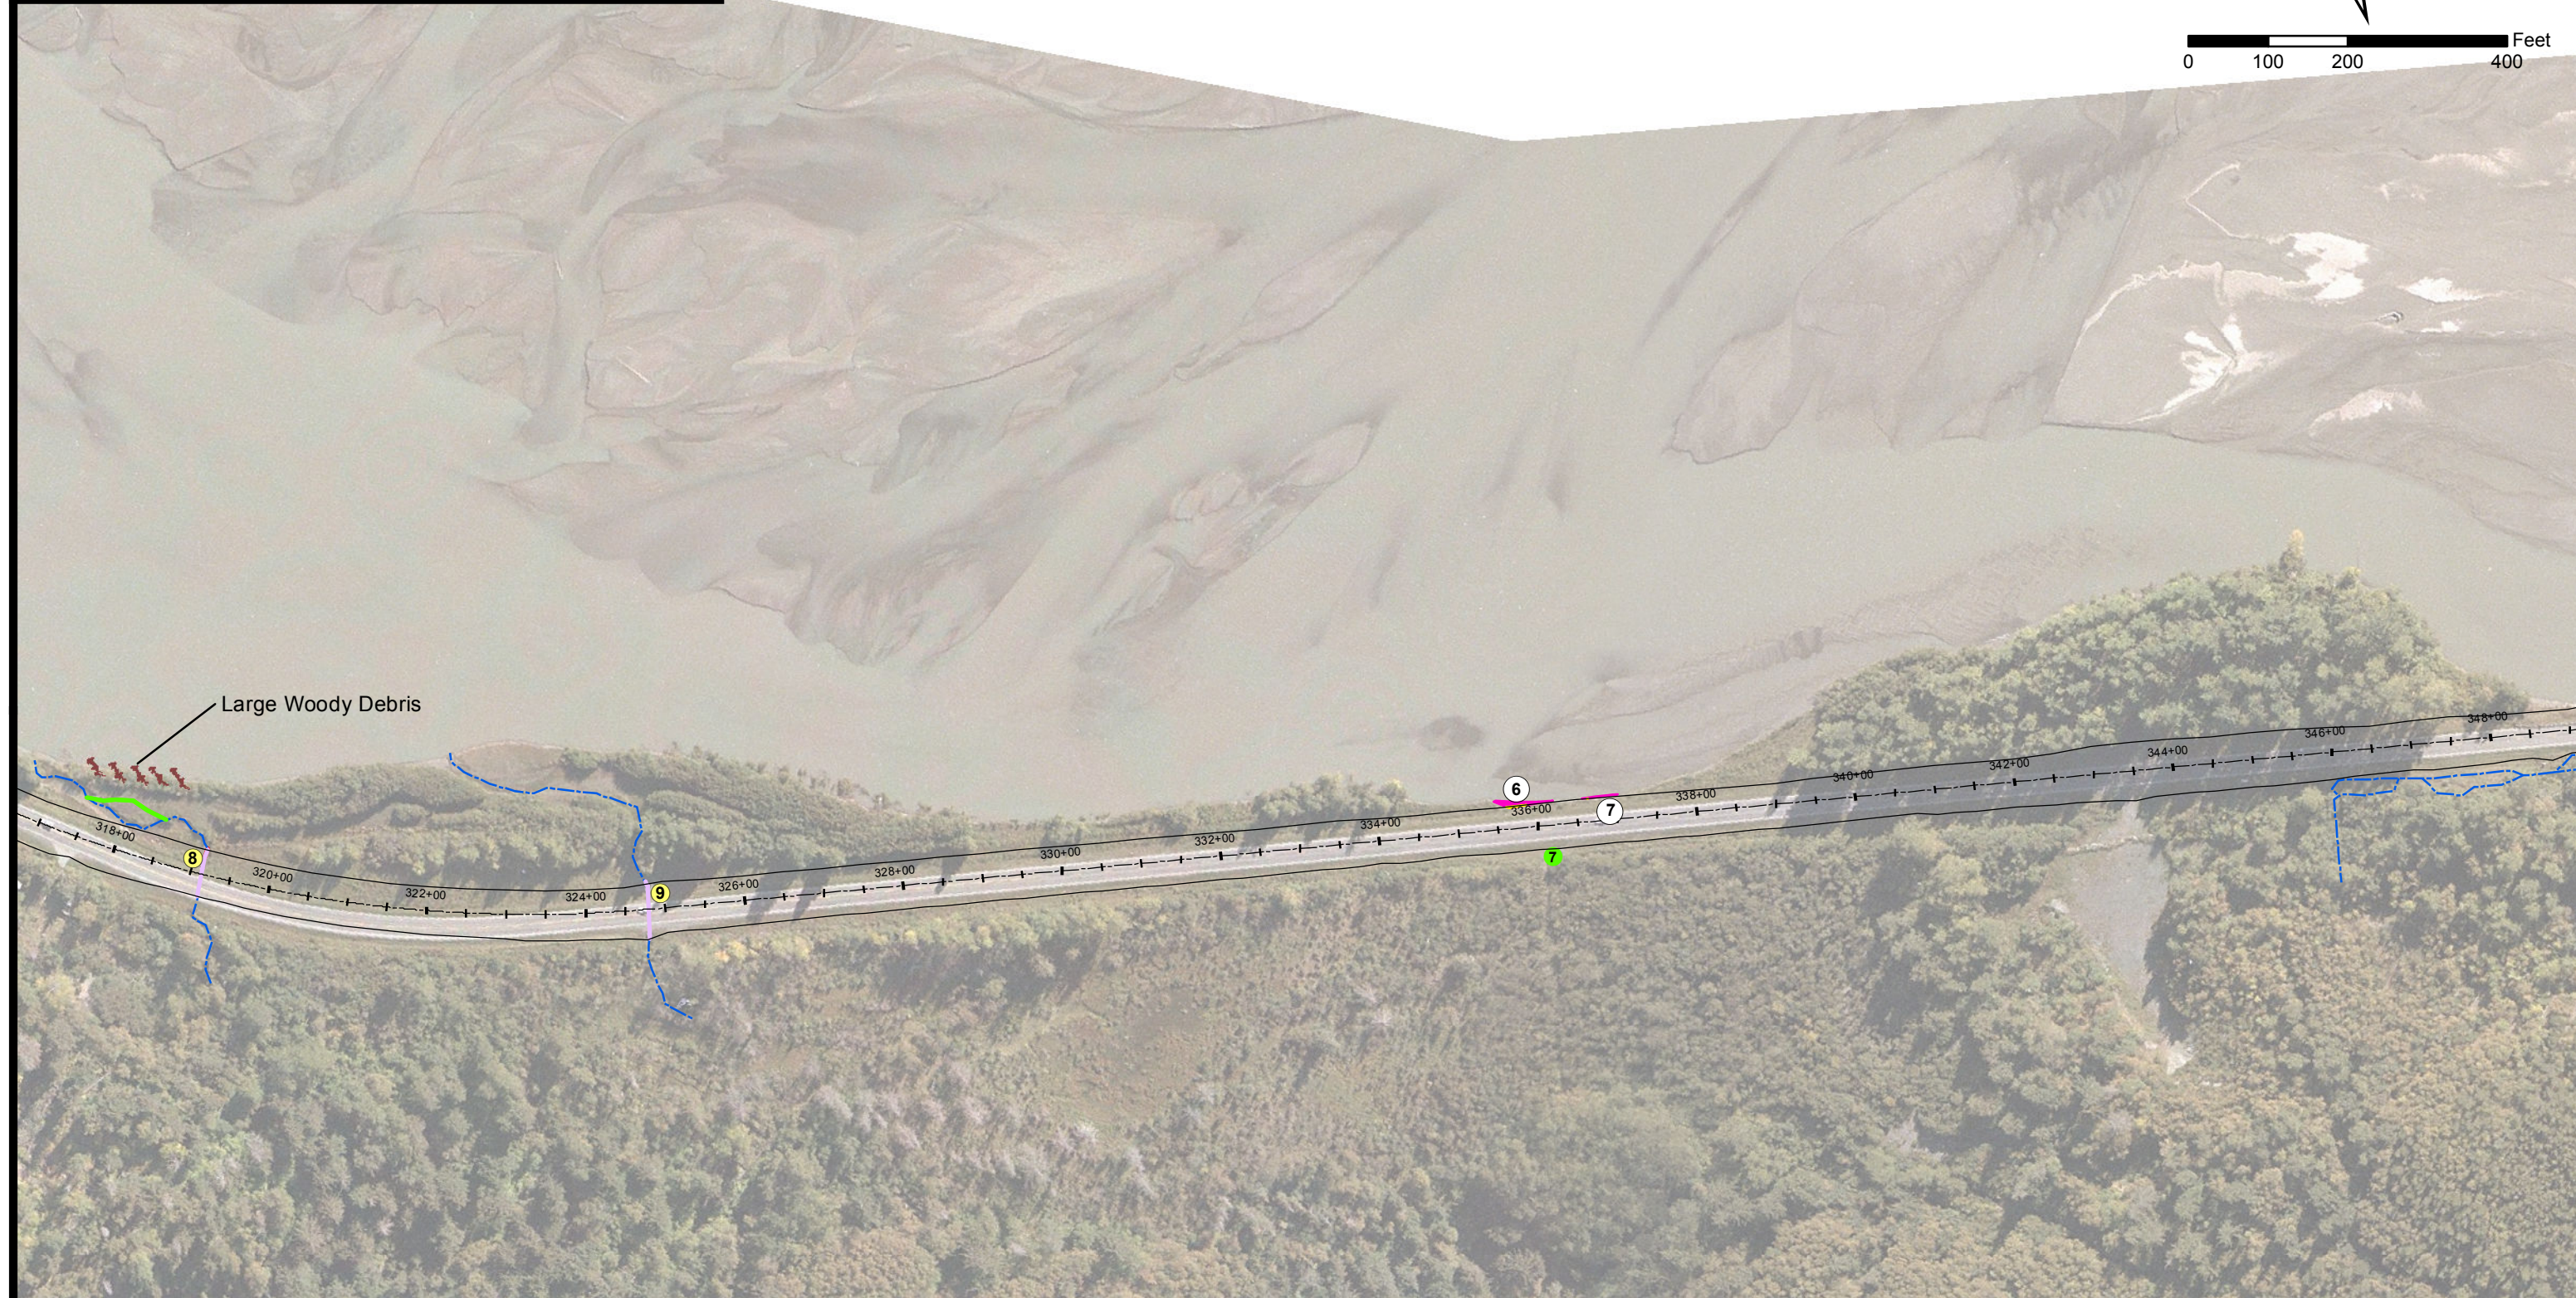
DATE: May 03, 2012 FIGURE SET 1 (05 OF 34)

CHILKAT RIVER IMPACTS

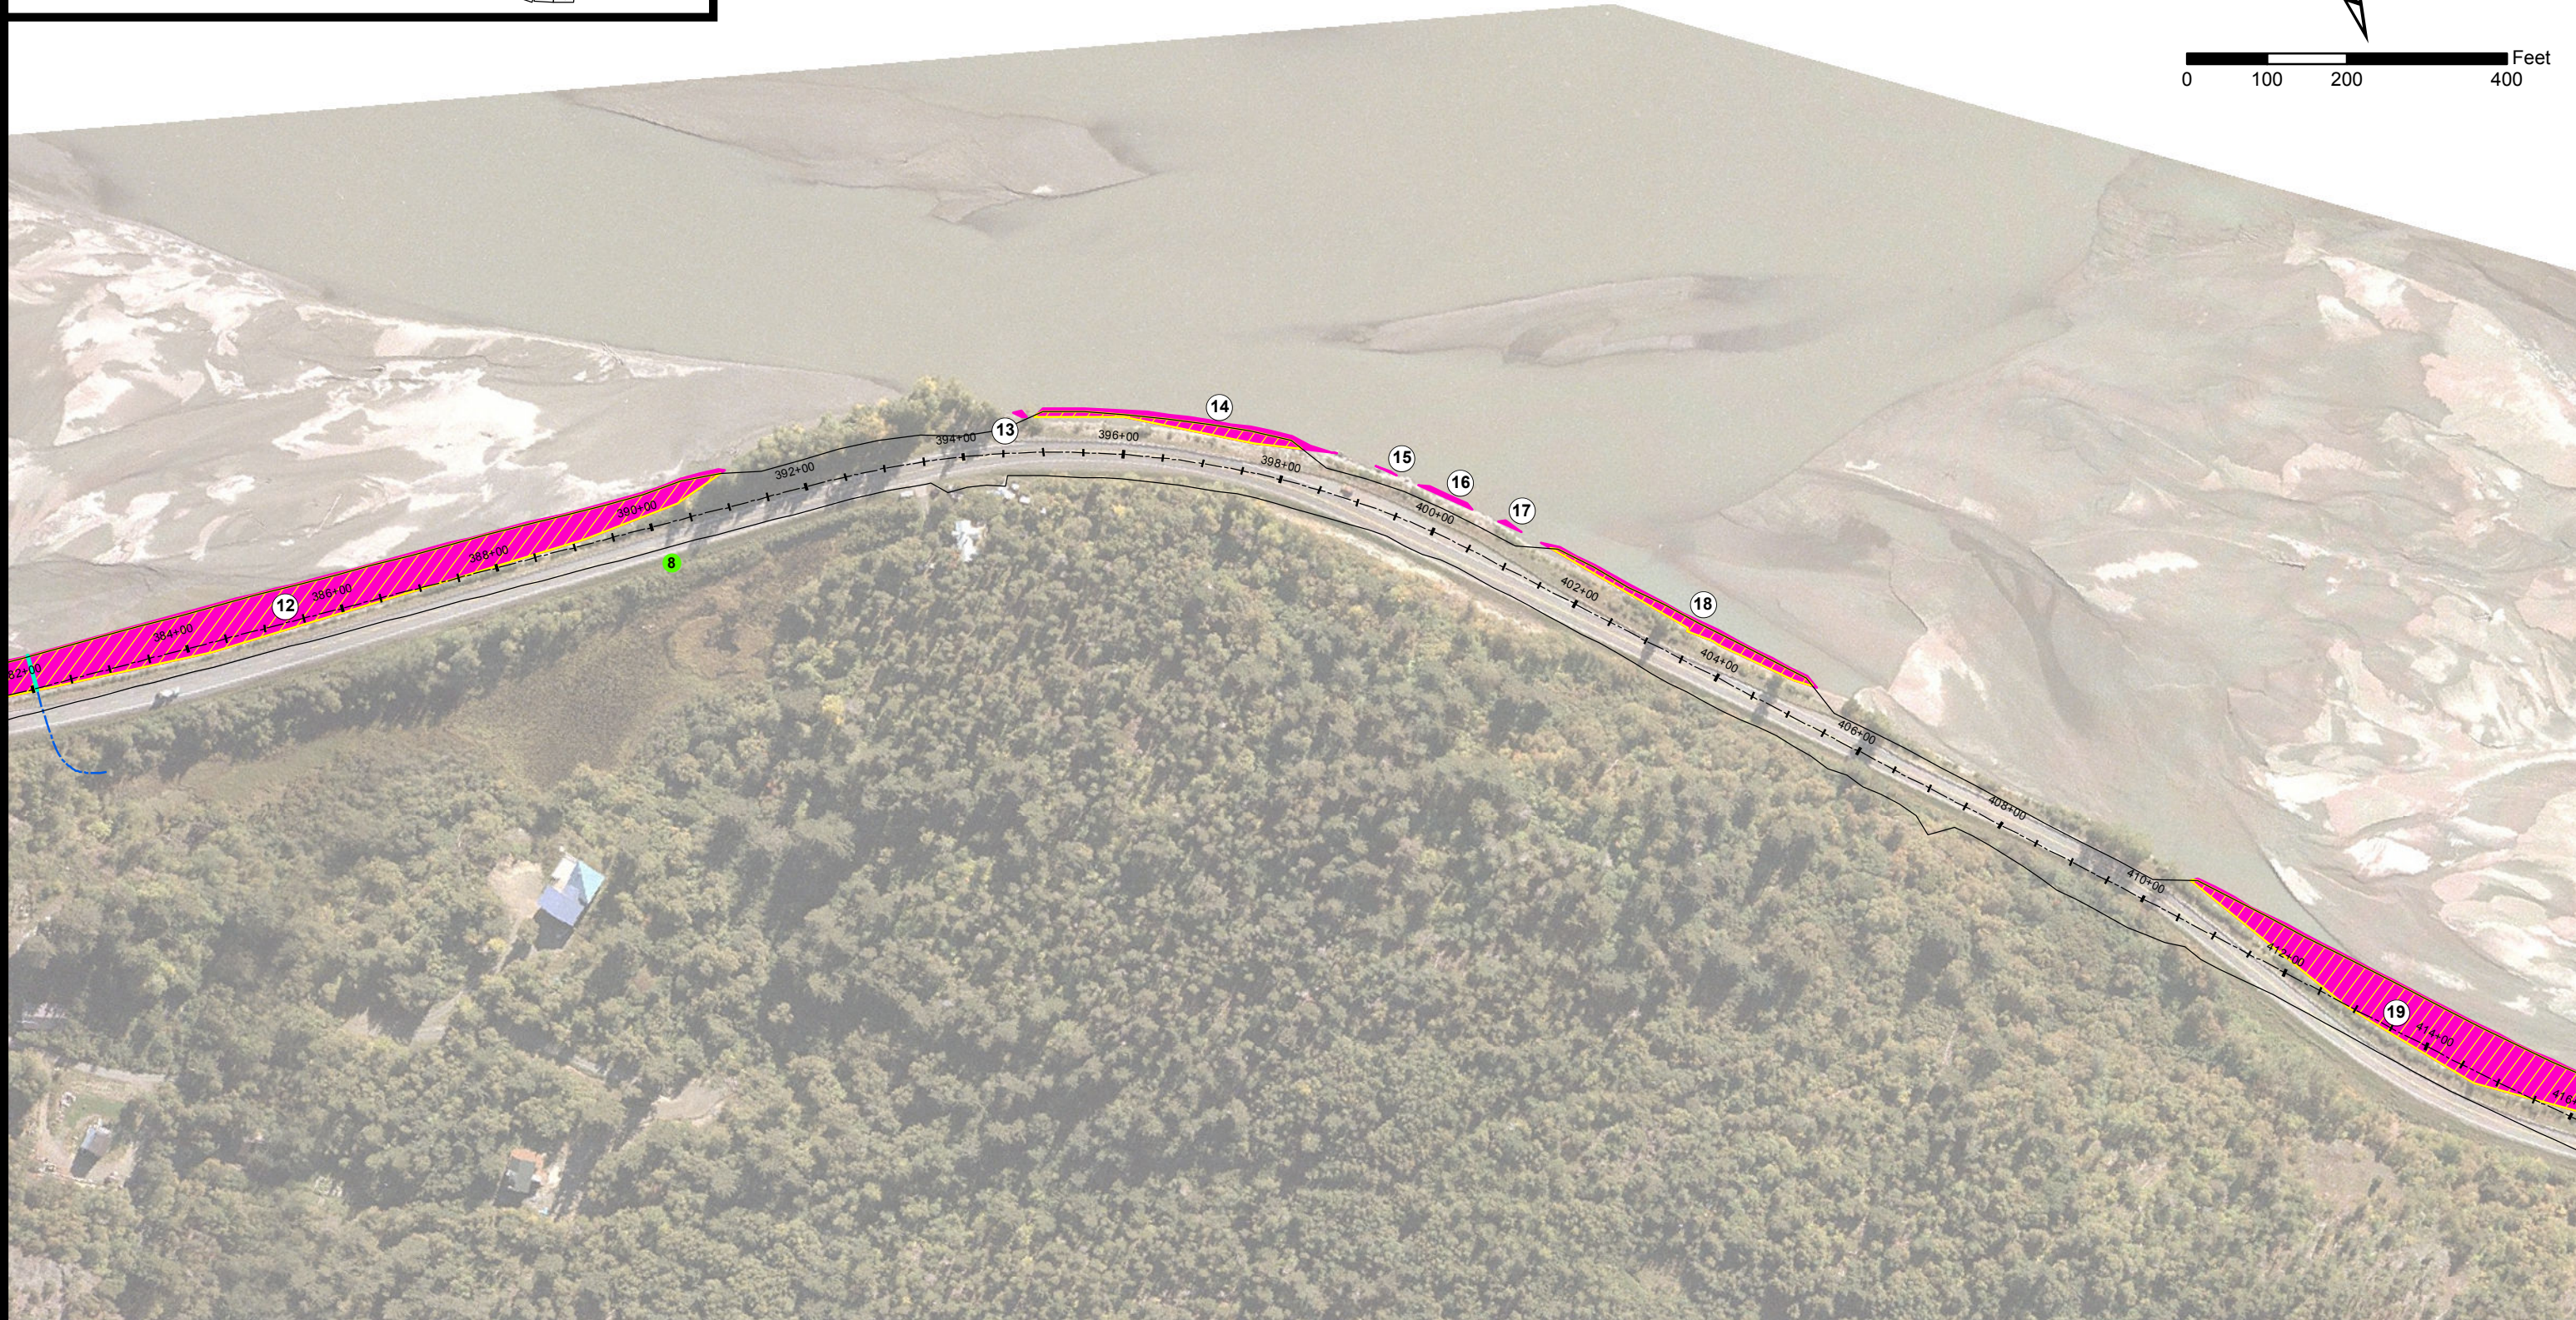
DATE: May 03, 2012 FIGURE SET 1 (08 OF 34)

CHILKAT RIVER IMPACTS

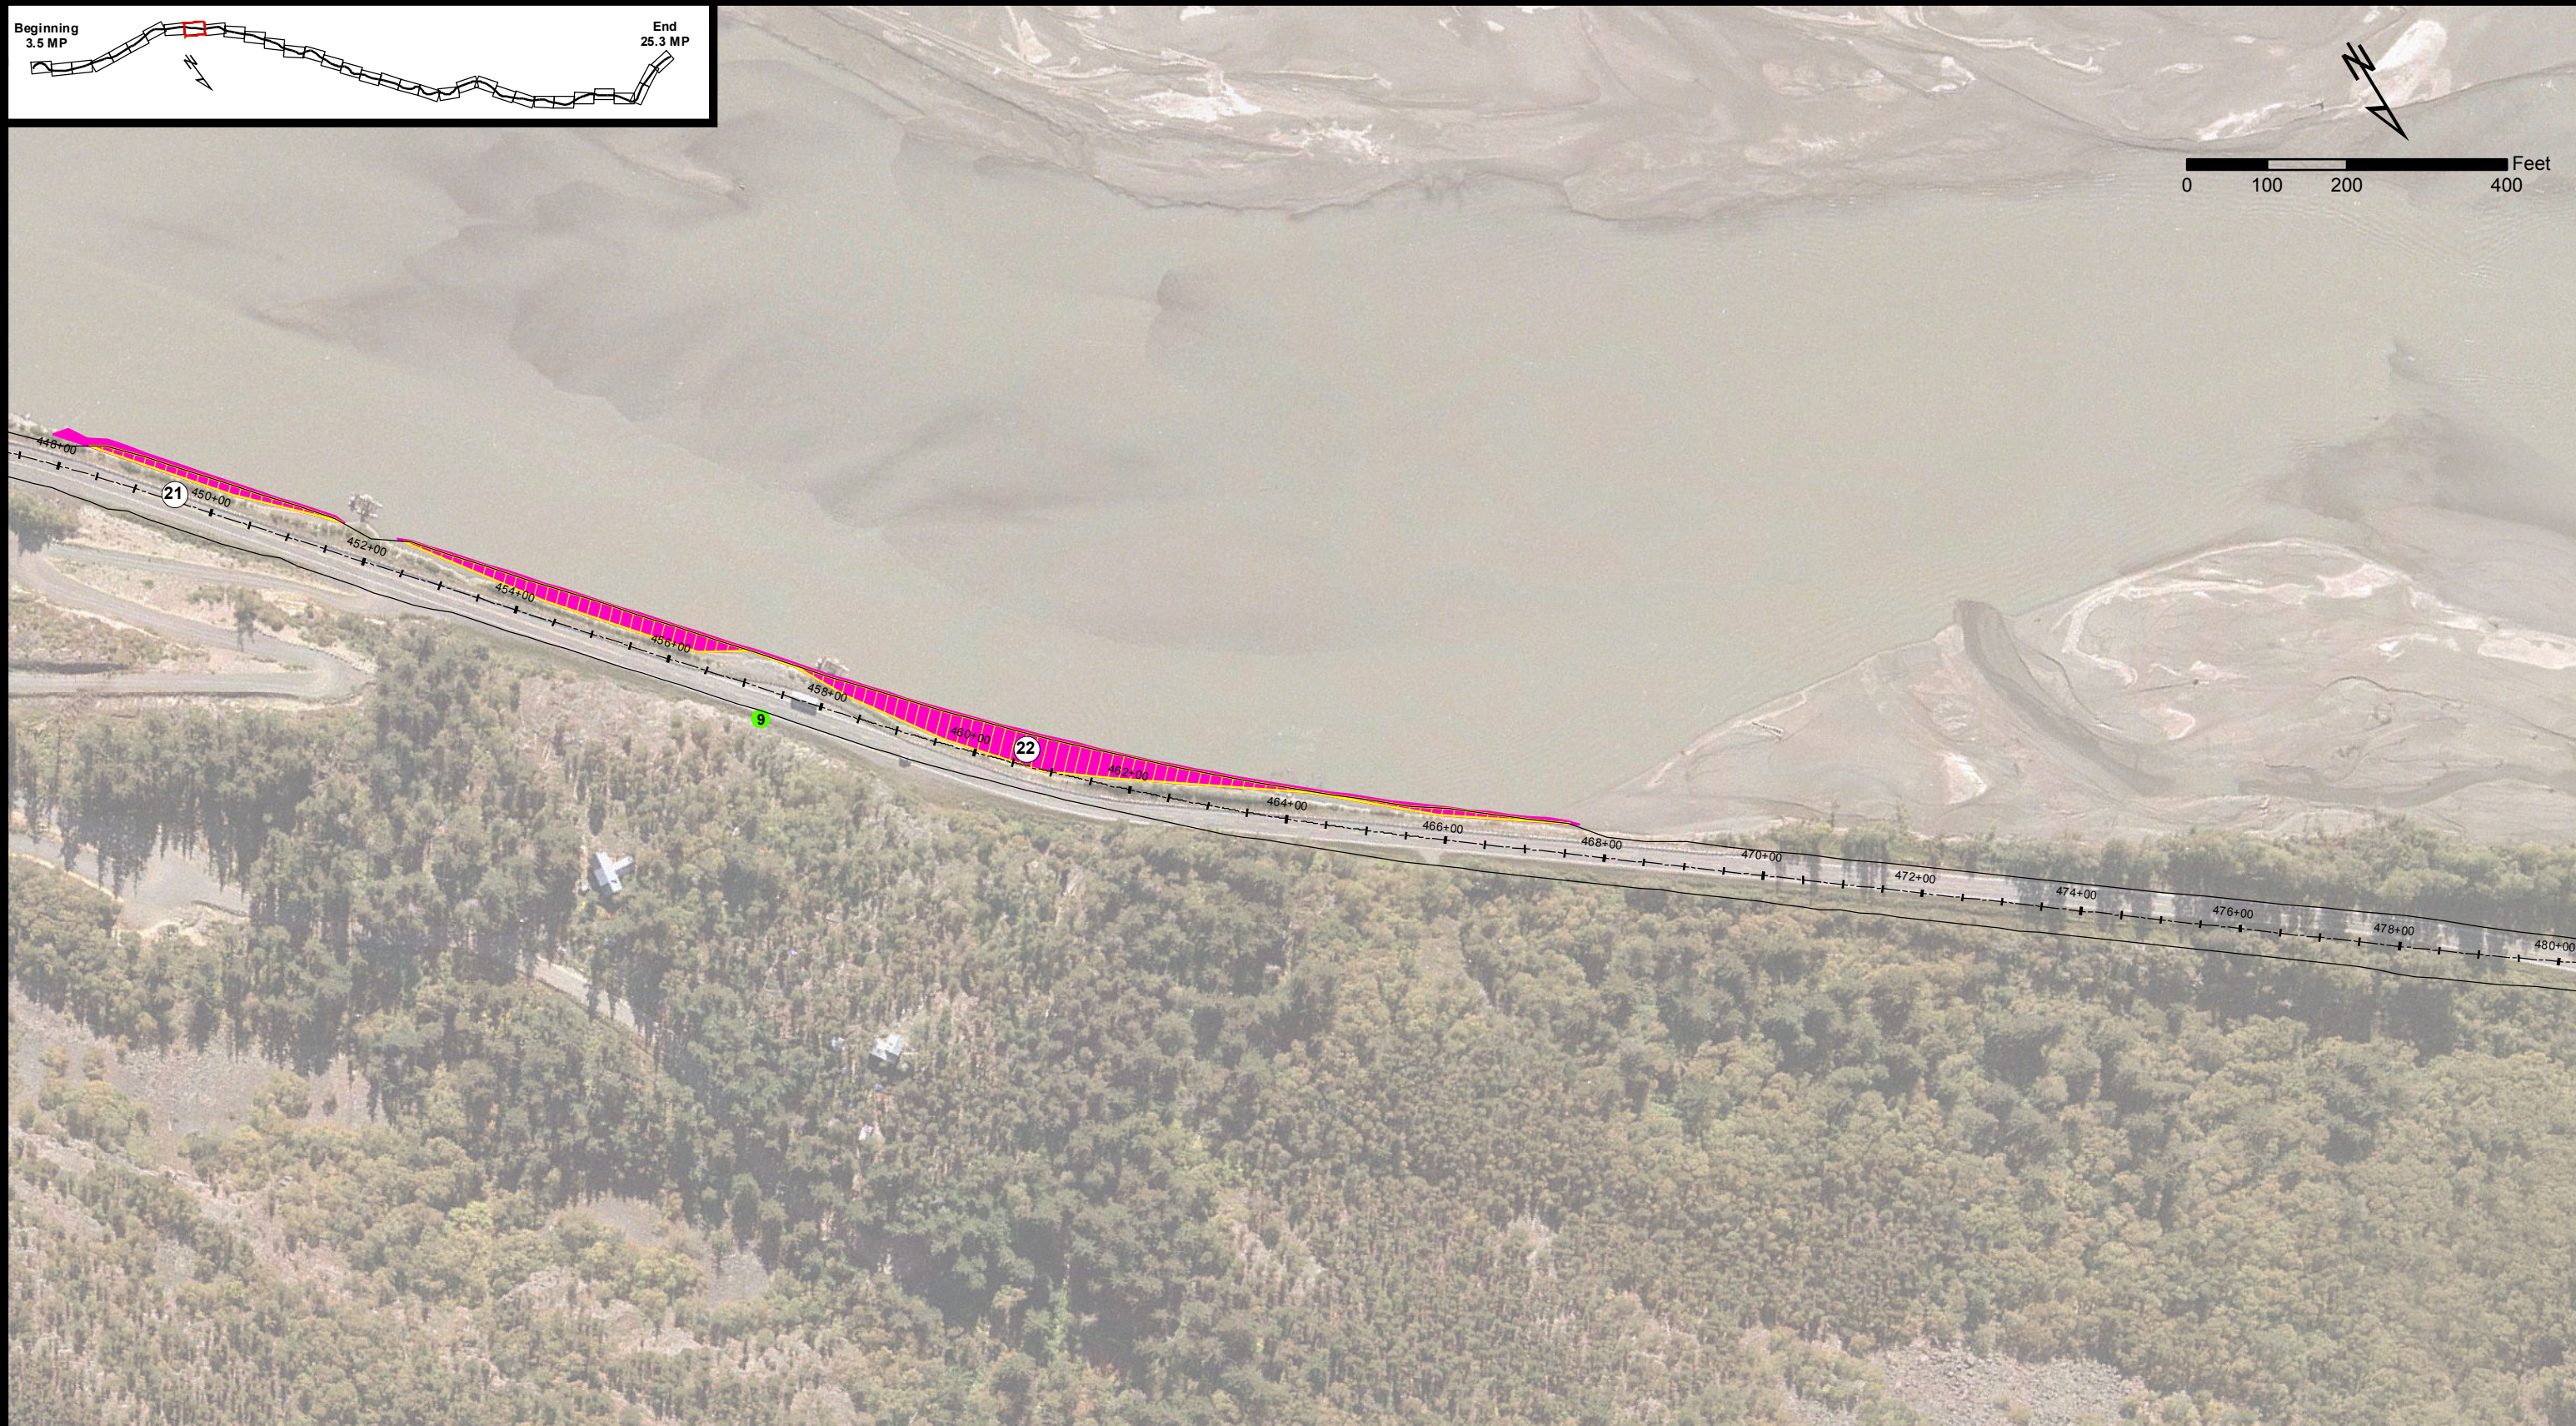
DATE: May 03, 2012 FIGURE SET 1 (09 OF 34)

CHILKAT RIVER IMPACTS

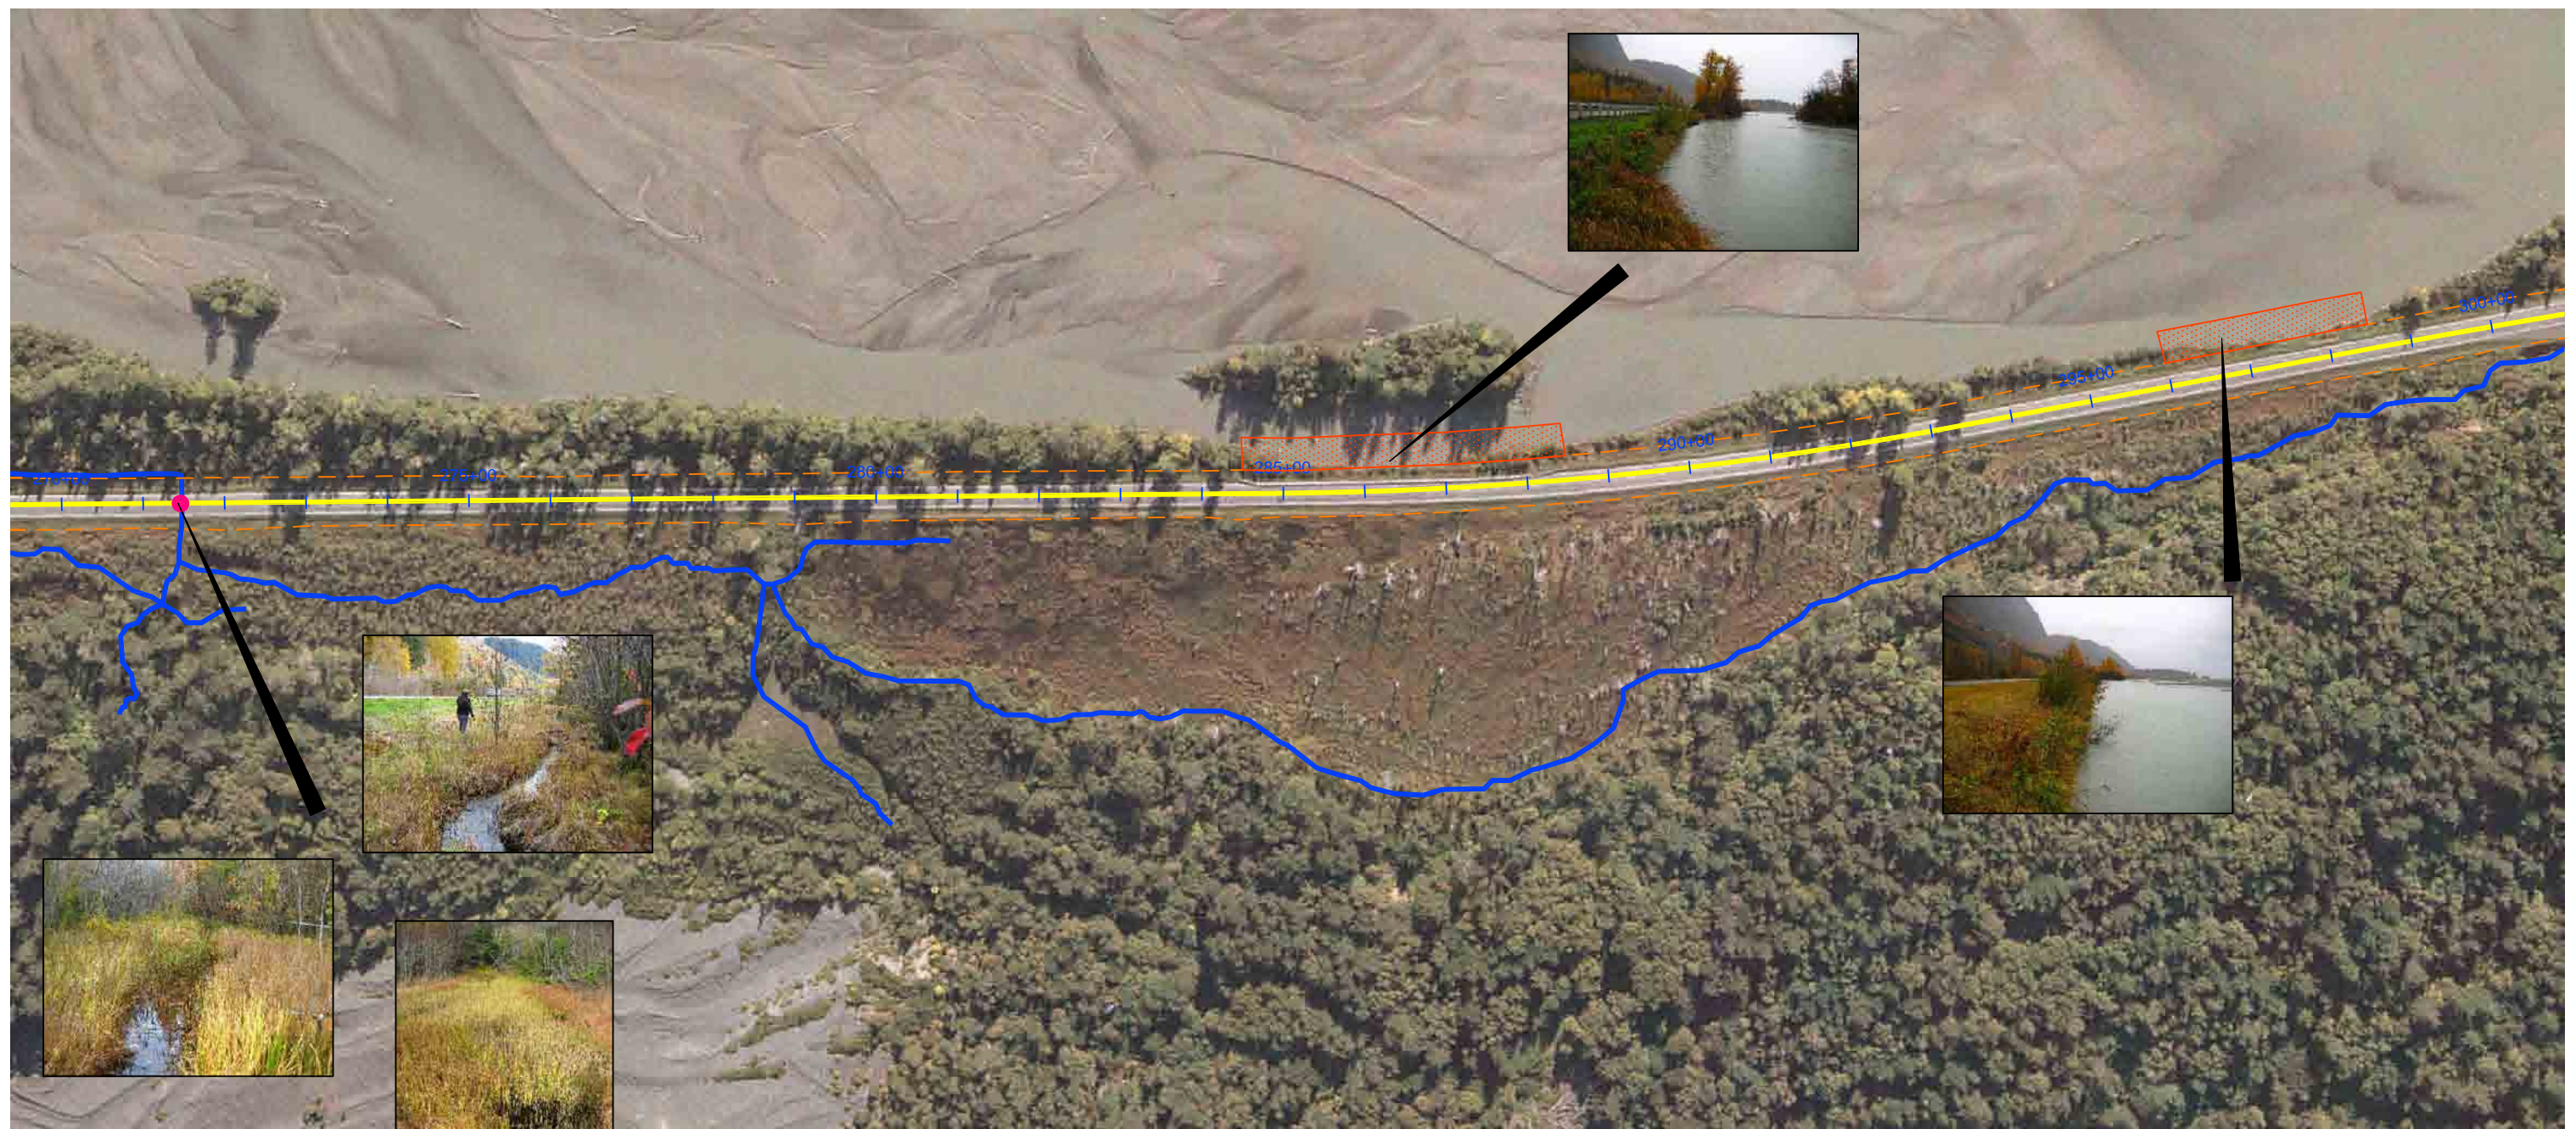
Stream and Habitat Inventory
 Plan View: 240+00 to 270+00

BANK STATION 284+50 TO 288+50:
EULACHON SPAWNING

BANK STATION 296+00 TO 298+50:
EULACHON SPAWNING
