Essential Fish Habitat Assessment

DRAFT
ESSENTIAL FISH HABITAT ASSESSMENT
HAINES HIGHWAY FROM MP 3.5 TO 25.3
HAINES, ALASKA

DOT&PF Project No. 68606
Federal Project No. SHAK-095-6(28)

DOWL HKM
4041 B Street
Anchorage, Alaska 99503
(907) 562-2000

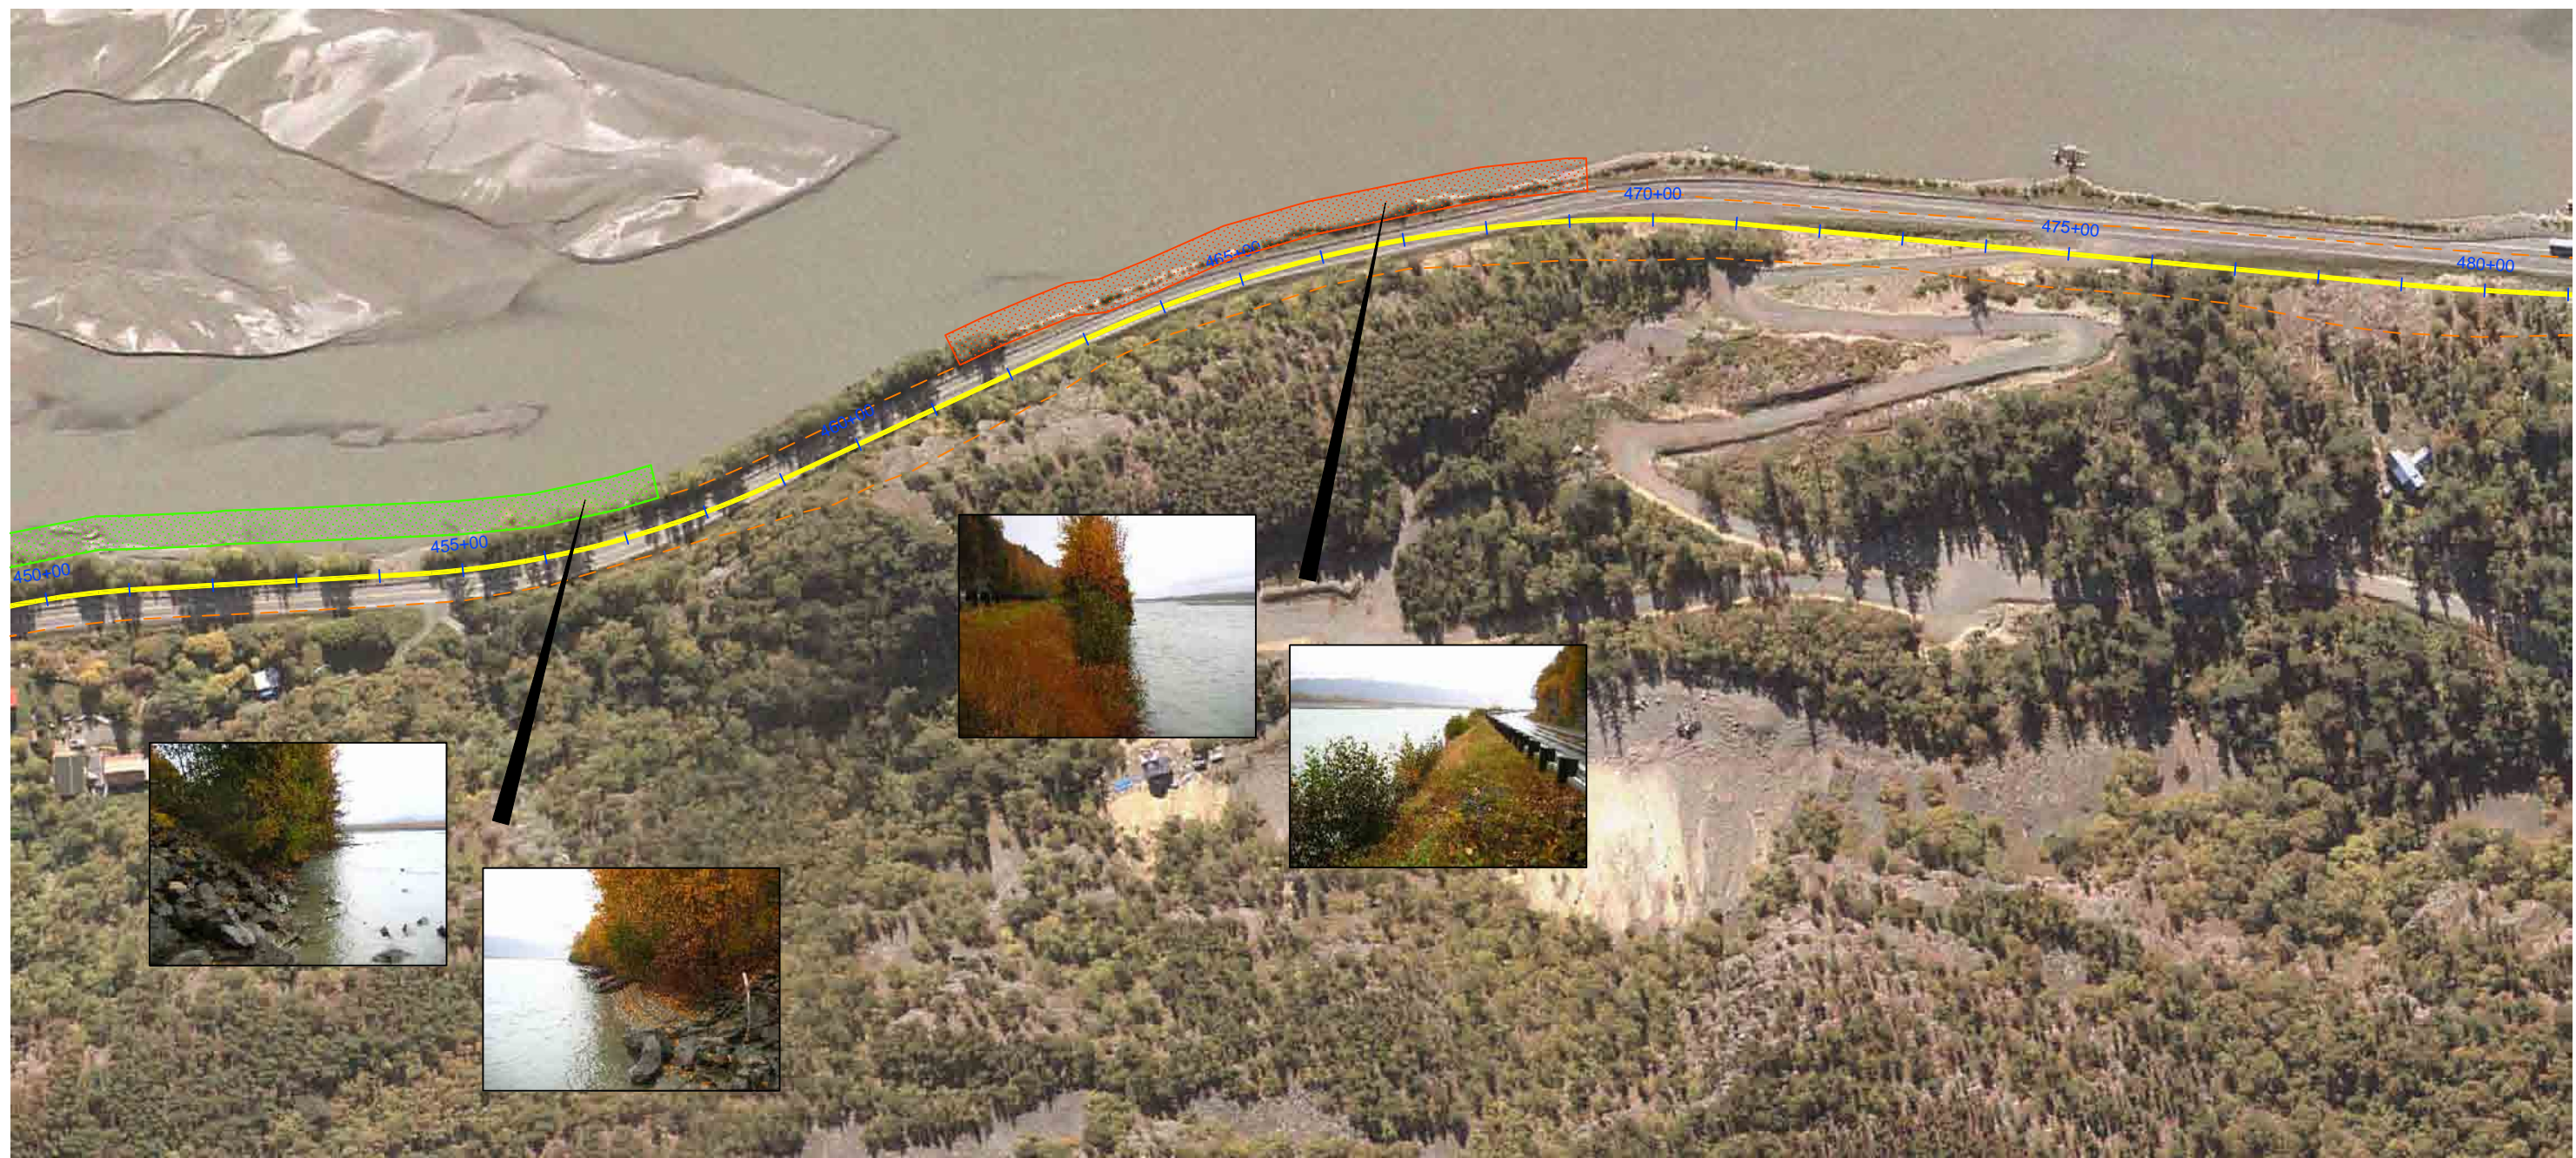
Stream and Habitat Inventory
Plan View: 420+00 to 450+00

BANK STATION 444+50
TO 457+50

BANK STATION 461+50
TO 469+25

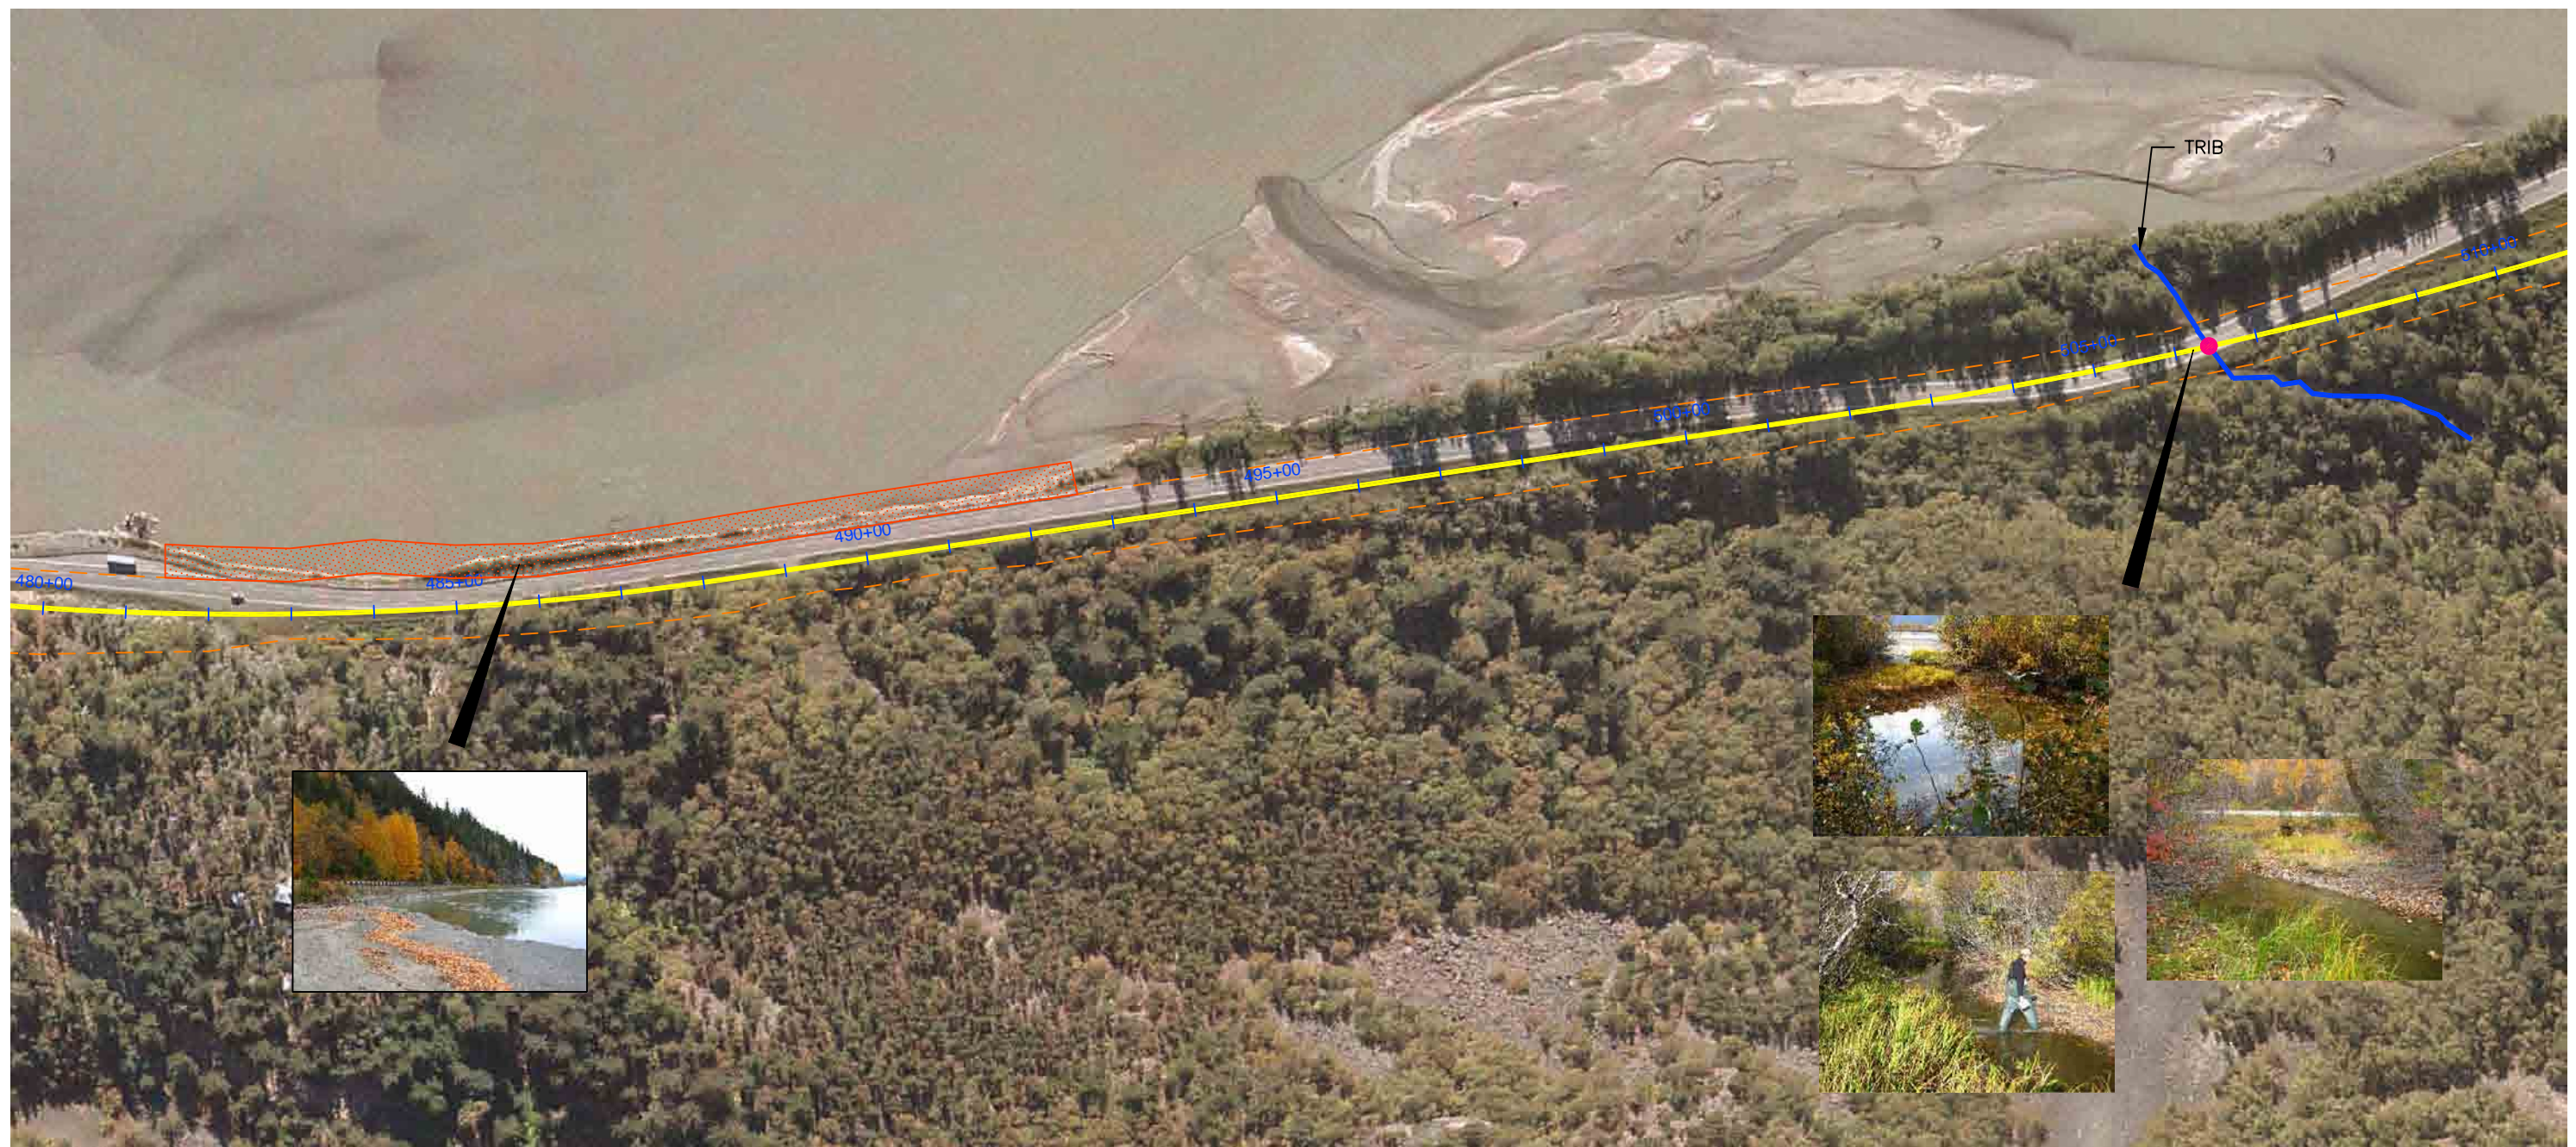
Stream and Habitat Inventory
Plan View: 450+00 to 480+00

BANK STATION 481+50
TO 492+75

TRIB STATION 506+25

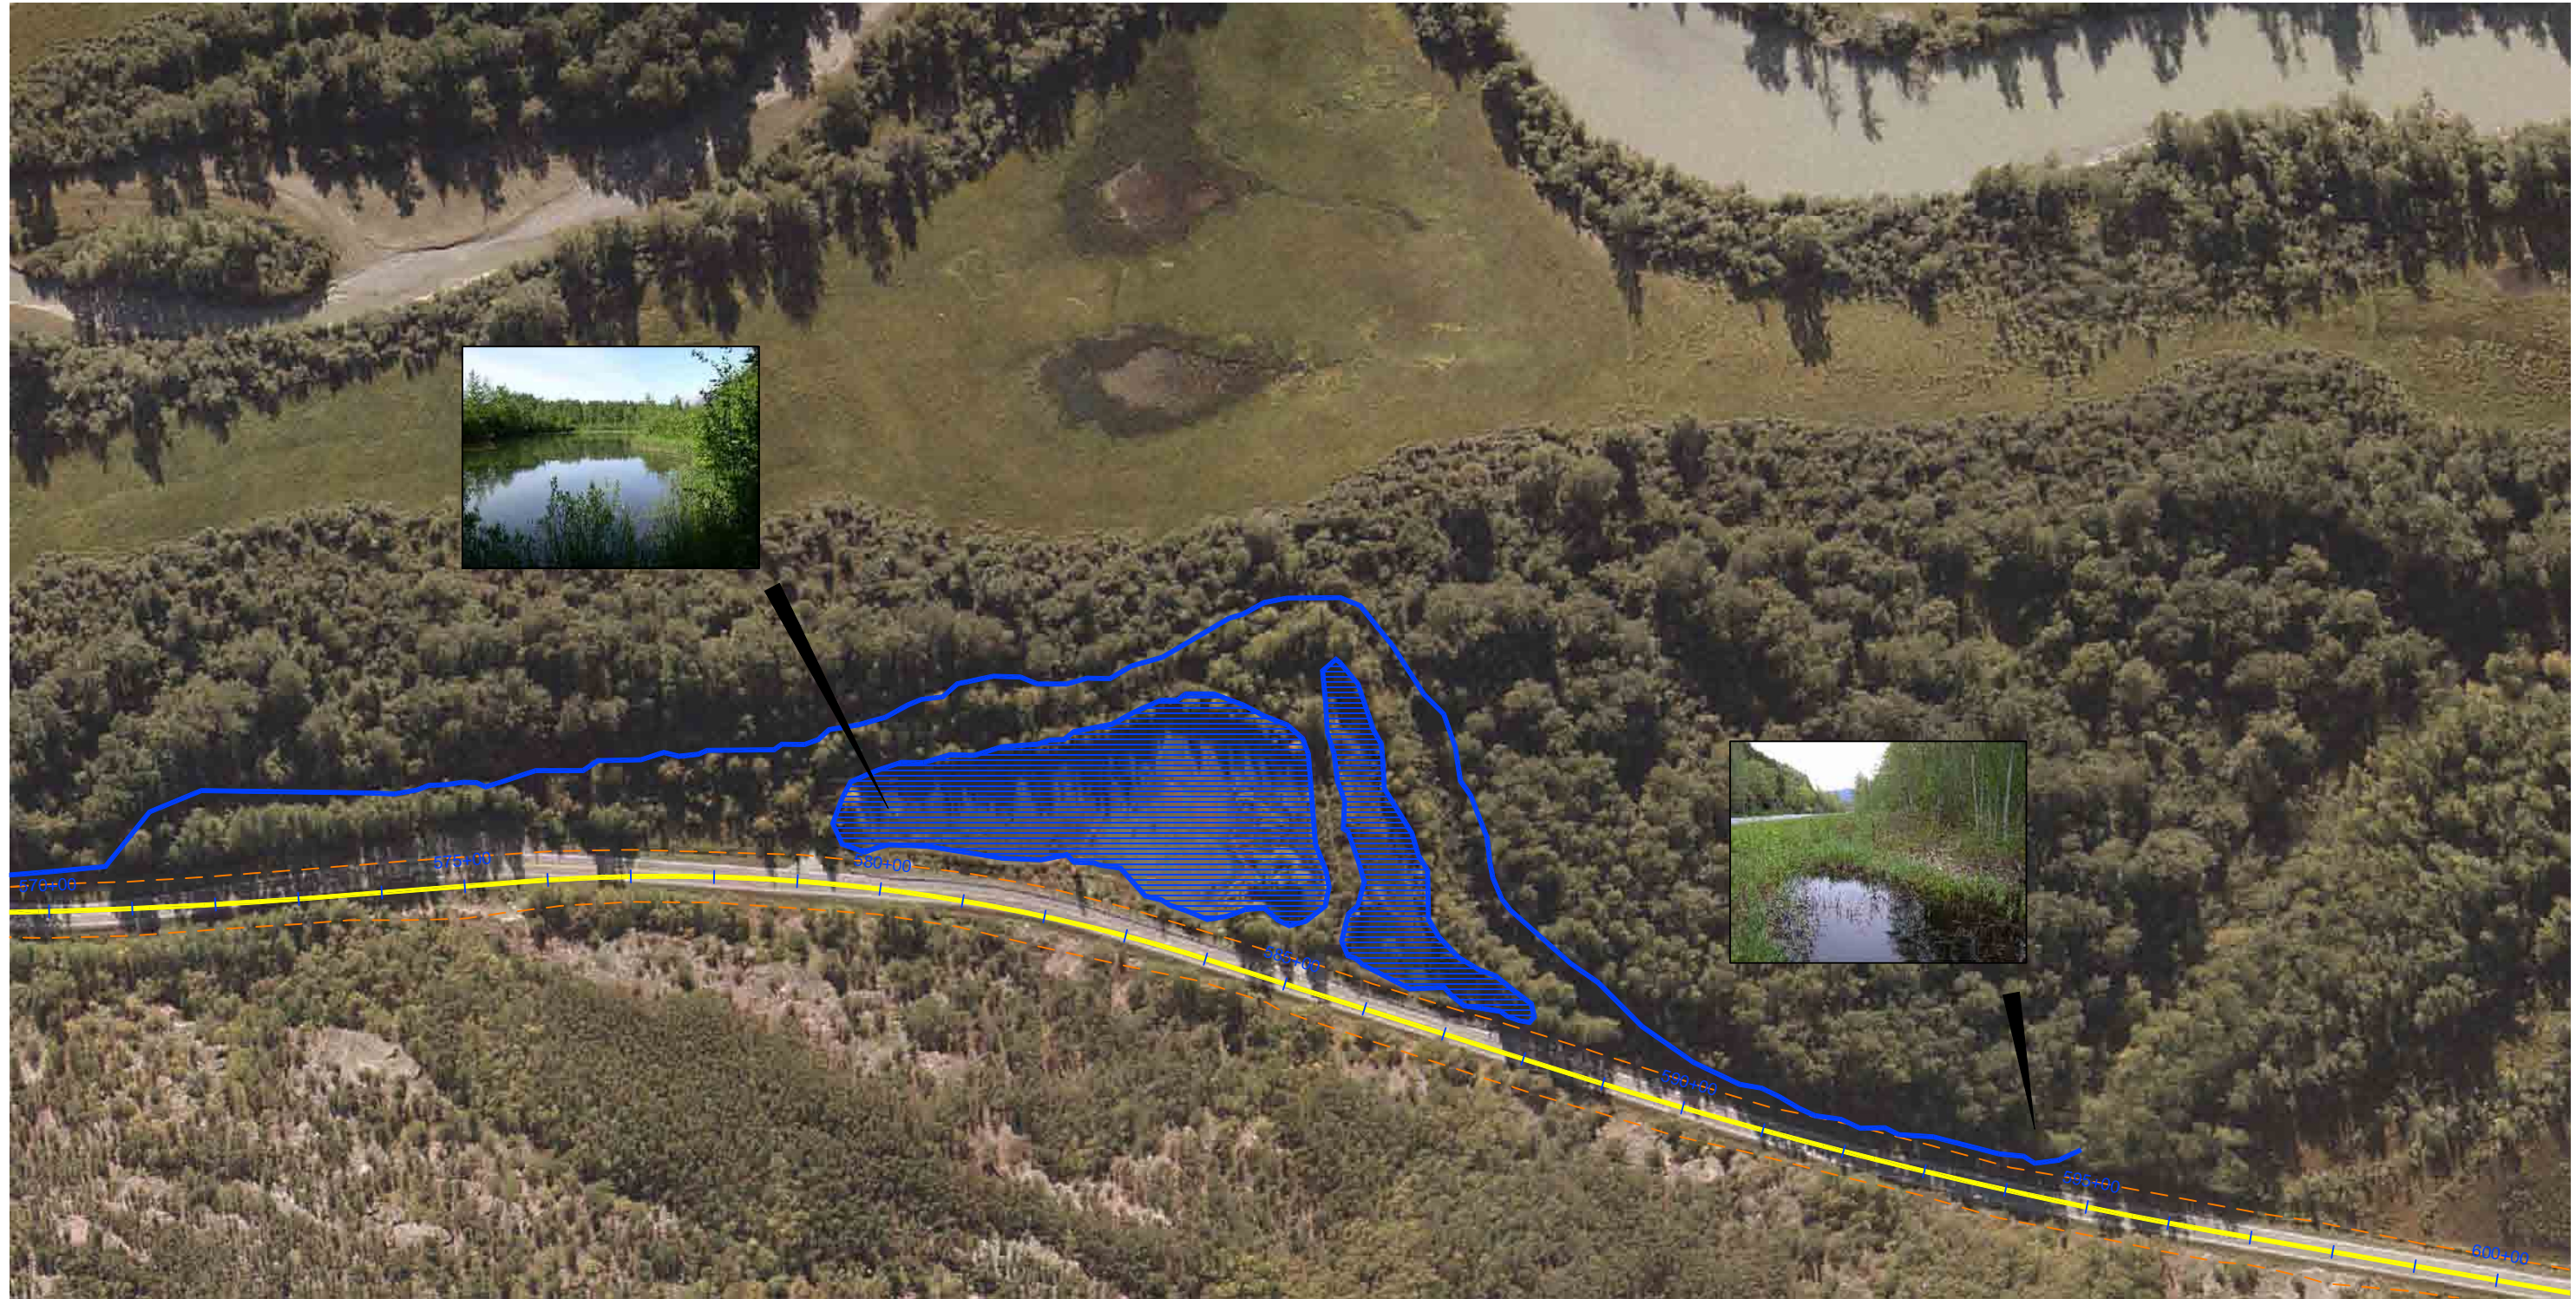
Stream and Habitat Inventory
 Plan View: 540+00 to 570+00
 SHEET
 13 of 36

TRIB STATION 579+50 TO 588+00

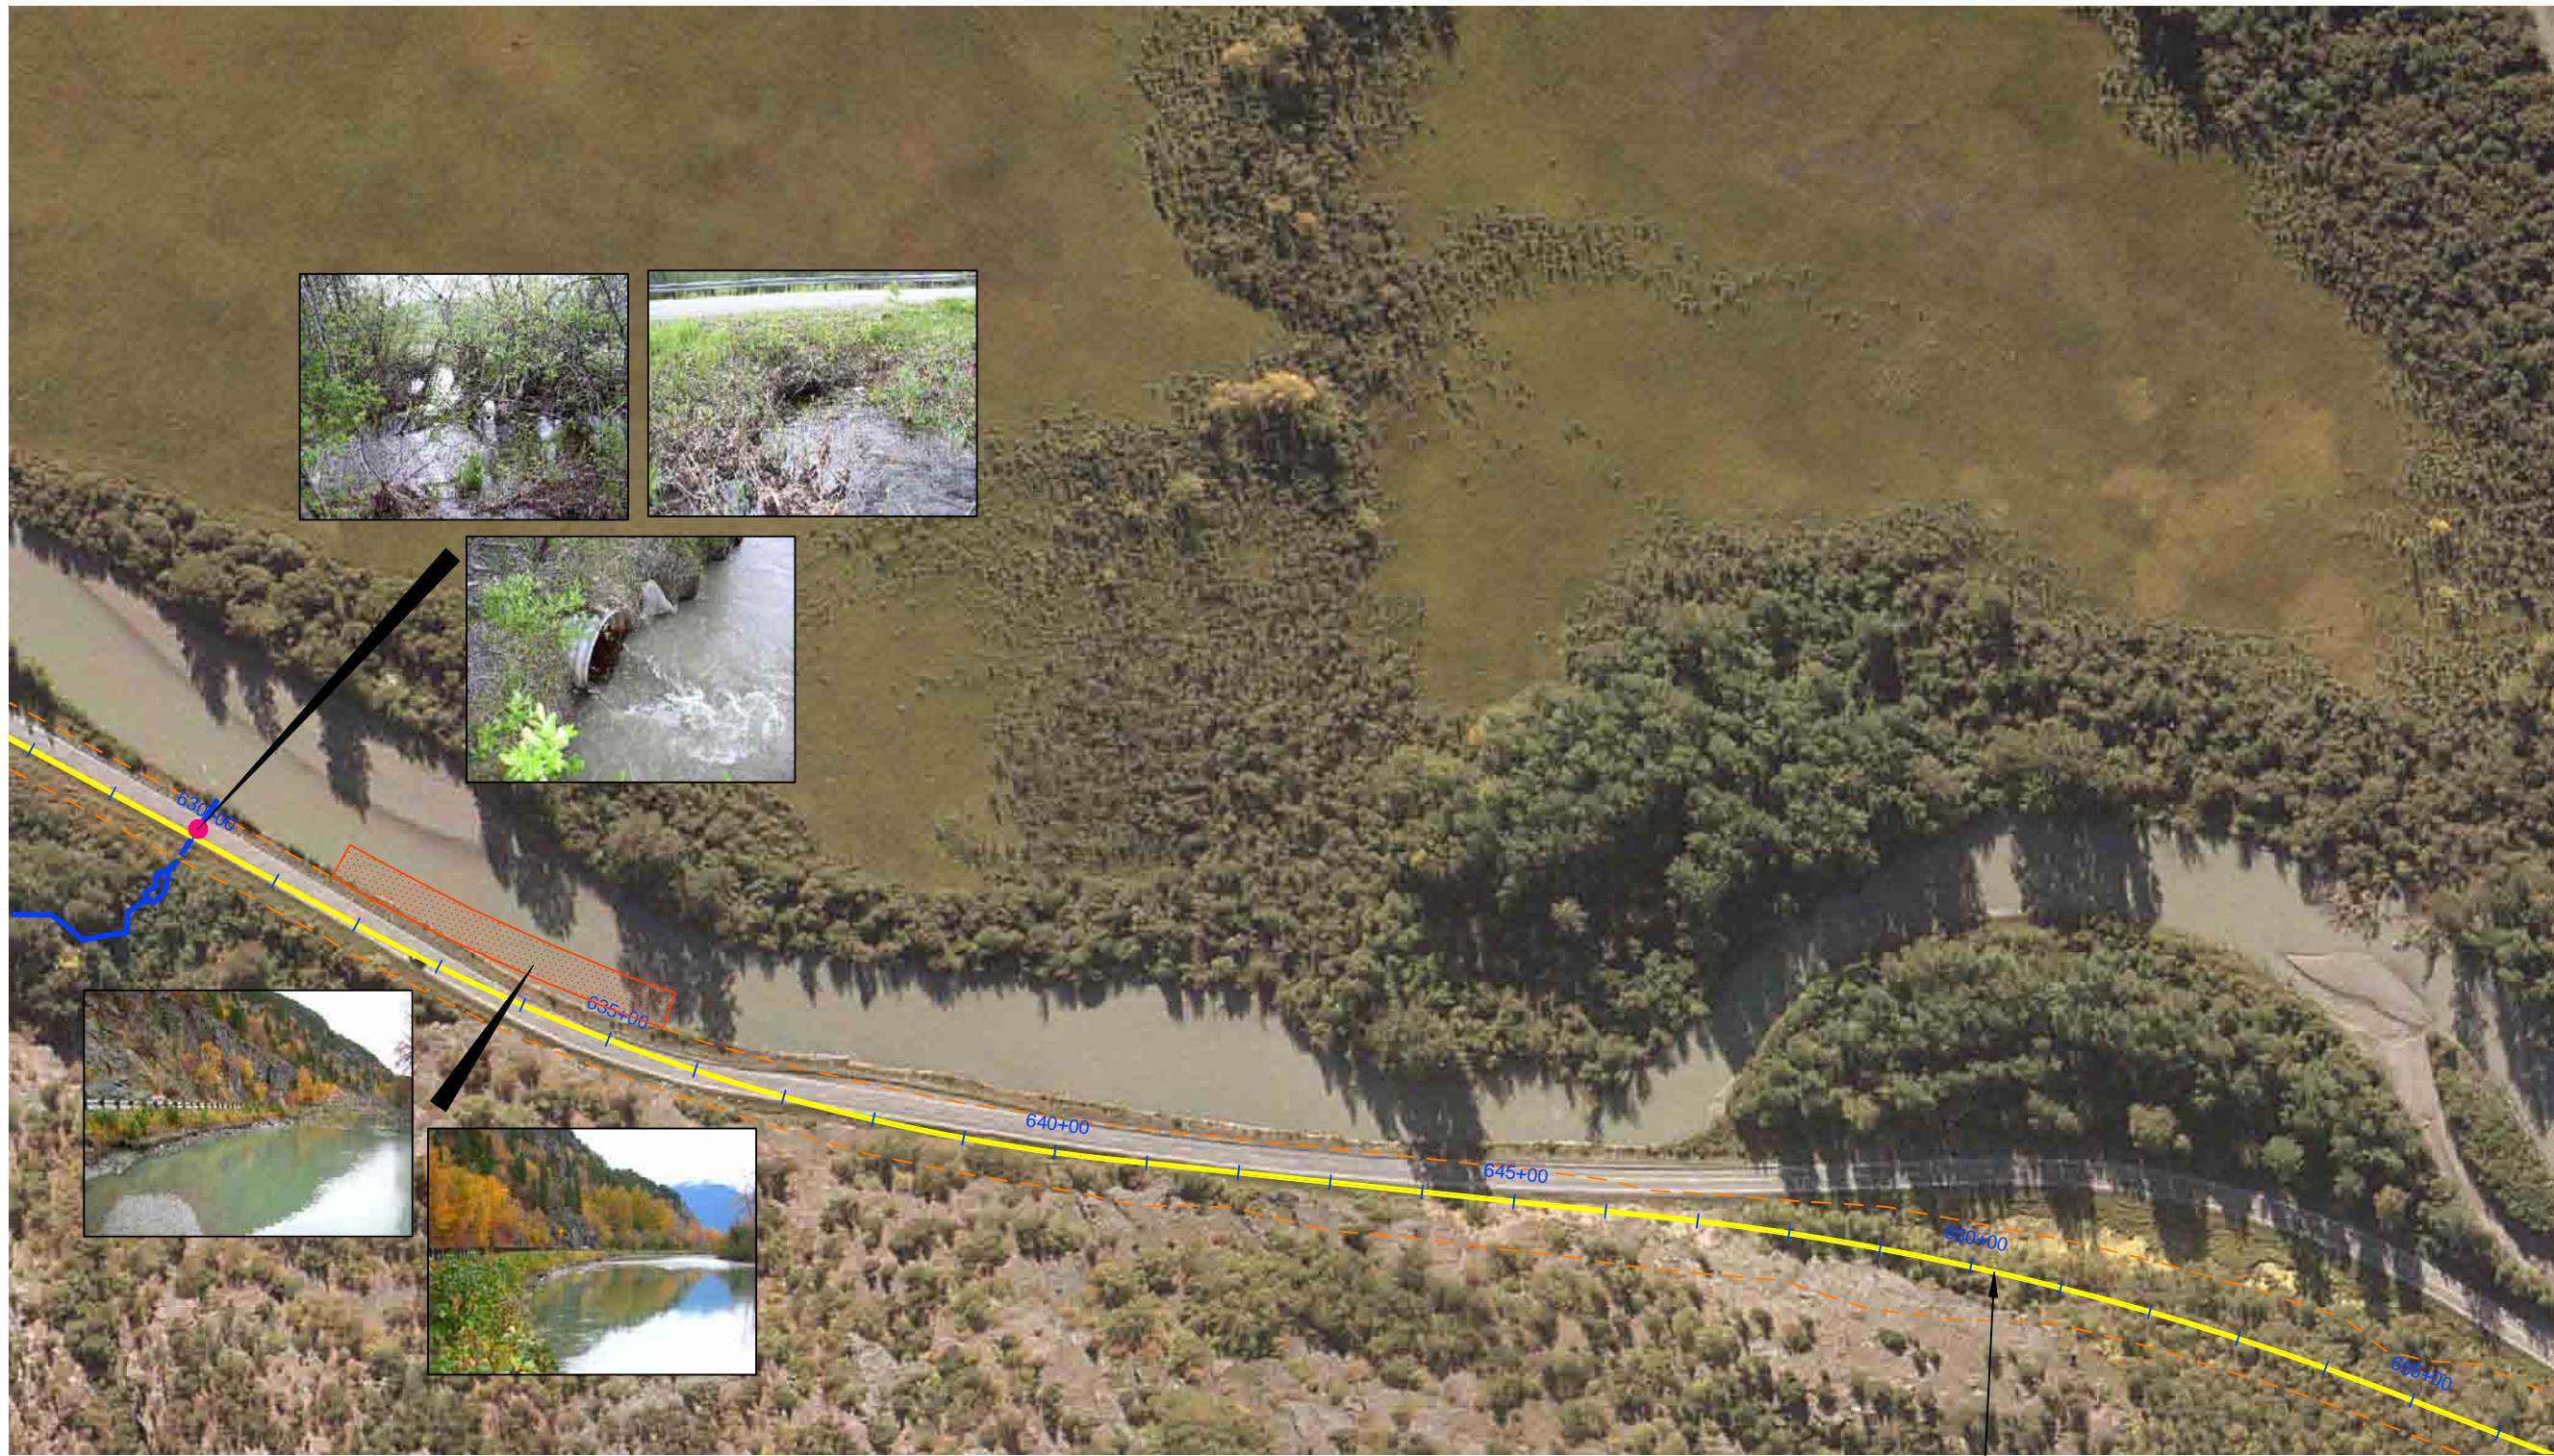
Stream and Habitat Inventory
 Plan View: 600+00 to 628+00

TRIB STATION 630+00

FISH USE: REARING CUTTHROAT AND DOLLY VARDEN
 DESCRIPTION: THE FLOOD OF NOVEMBER 2005 DIRECTED APPROXIMATELY TWO-THIRDS OF THE FLOW FROM THE WATERFALL AT STATION 629+50 TOWARDS THIS CULVERT. THE REST OF THE FLOW EXITS THROUGH THE CULVERT AT 612+40. ABOVE THE CULVERT INLET THE STREAM DIVIDES INTO A 6-8' WIDE, 1-2' DEEP RIFFLE, POOL, GLIDE COMPLEX RUNNING THROUGH AN ESTABLISHED ALDER AND BIRCH FOREST. THE STREAM SUBSTRATE IS SILT AND ORGANICS FOR THE FIRST 100', THEN CHANGES TO RECENTLY DEPOSITED ALLUVIAL MATERIAL. THE CULVERT EMPTIES DIRECTLY INTO THE CHILKAT RIVER AND IS PERCHED AT LOW WATER.

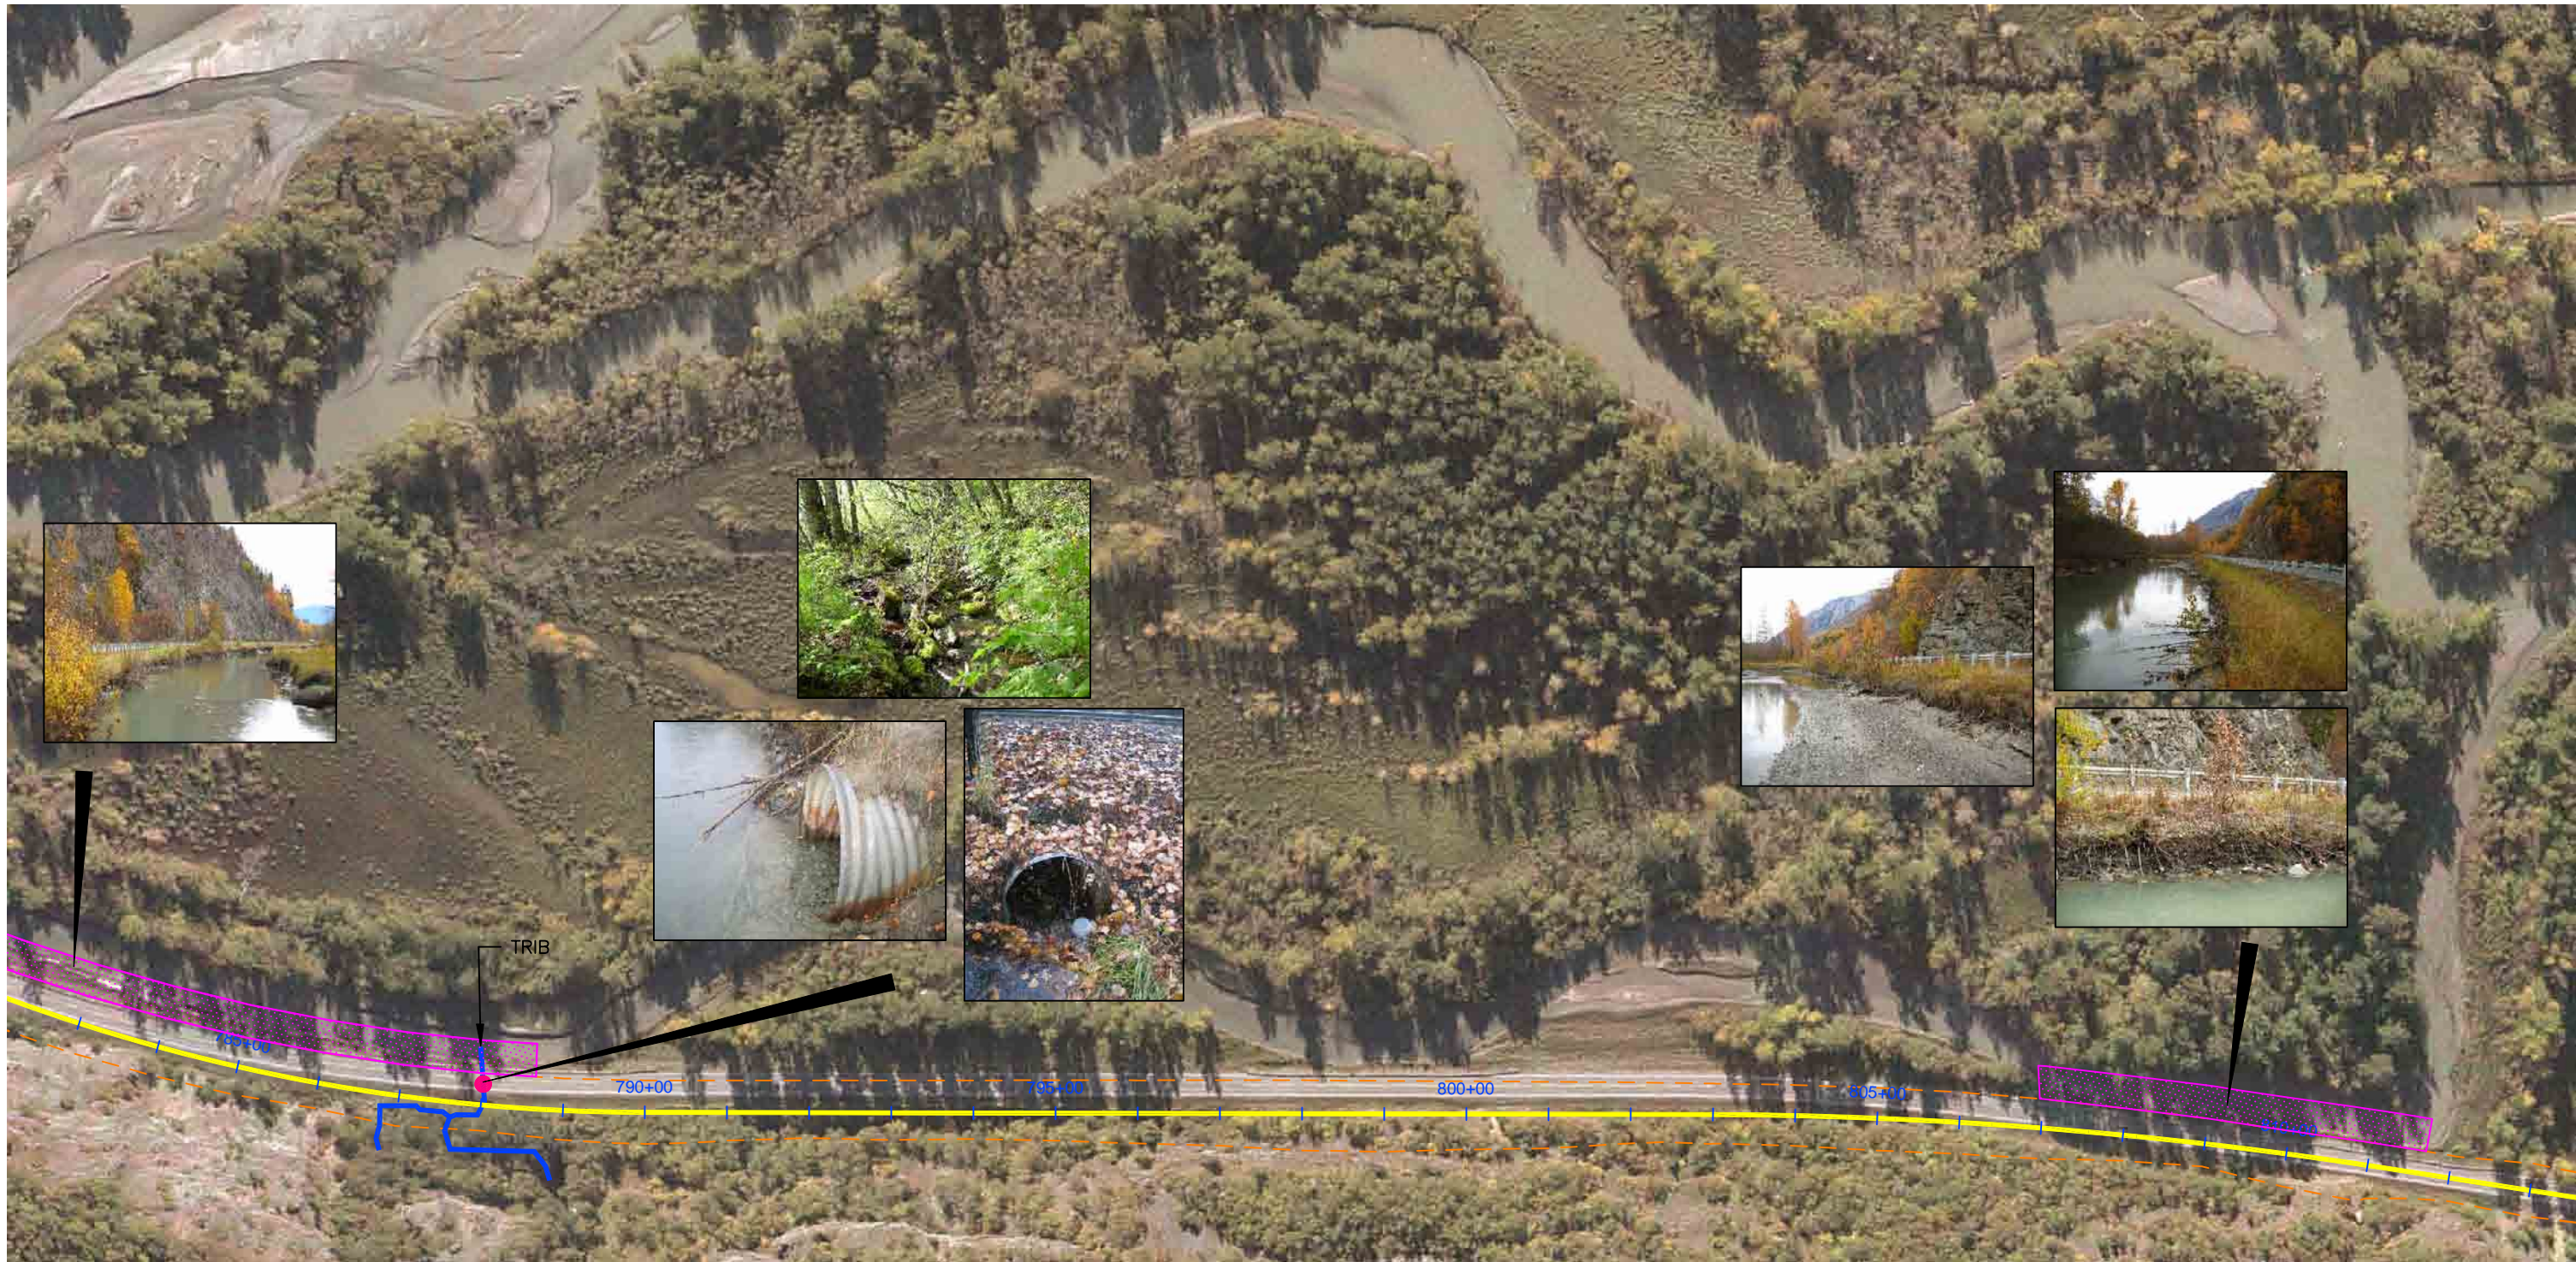
Stream and Habitat Inventory
Plan View: 750+00 to 783+00

BANK STATION 776+00
TO 788+75

FISH USE: REARING COHO, CHINOOK AND DOLLY VARDEN.
POSSIBLE REDD OBSERVED (OCTOBER 2005)
DESCRIPTION: THE CULVERT IS FED BY TWO MOUNTAIN STREAMS THAT JOIN TOGETHER ABOUT 20' UPSTREAM OF THE INLET. ONE OF THE STREAMS RUNS 100' BACK ON LINE IN A SHALLOW, 2-3' WIDE, GRAVEL BOTTOMED ROADSIDE DITCH WHICH ENDS IN A WATERFALL. THE SECOND BRANCH RUNS FOR A DISTANCE OF 120' AWAY FROM THE ROAD AND ALONG THE TOE OF THE MOUNTAIN BEFORE TURNING UPSLOPE AS A WATERFALL. THIS 120' OF STREAM IS COMPOSED OF 2-3' WIDE POOL/RIFFLE HABITAT WITH ROCK AND GRAVEL SUBSTRATE. IT IS WELL VEGETATED. THE CULVERT OUTLET EMPTIES DIRECTLY INTO THE RIVER.

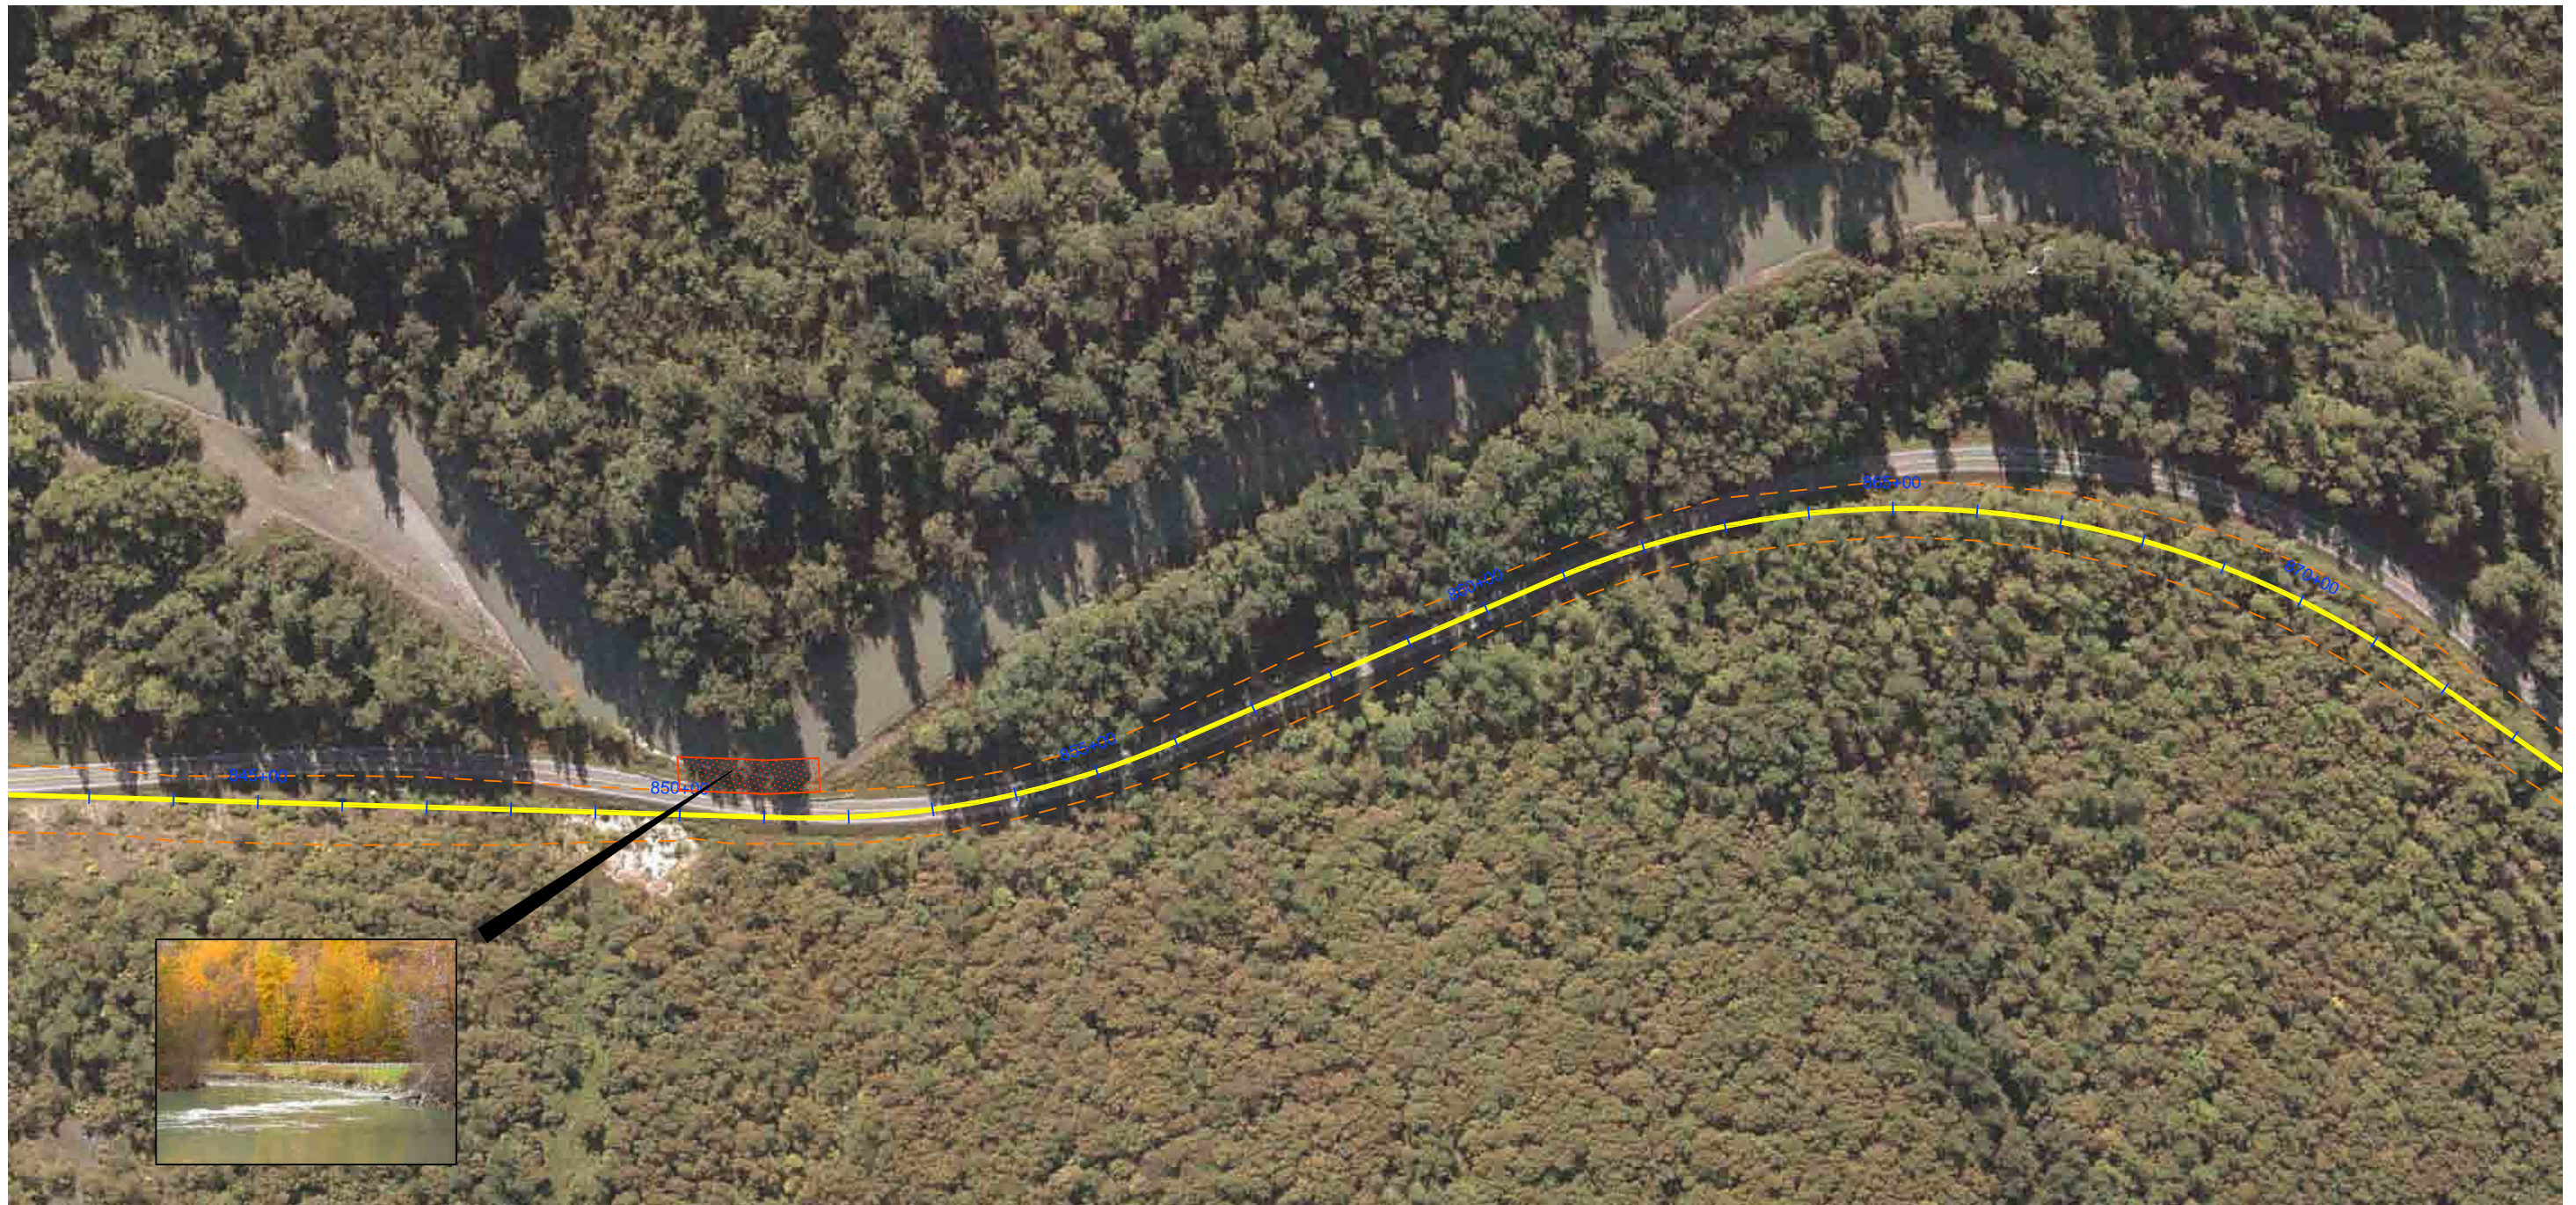
Stream and Habitat Inventory
 Plan View: 813+00 to 843+00

BANK STATION 850+00
TO 851+75:
 SALMON HOLDING

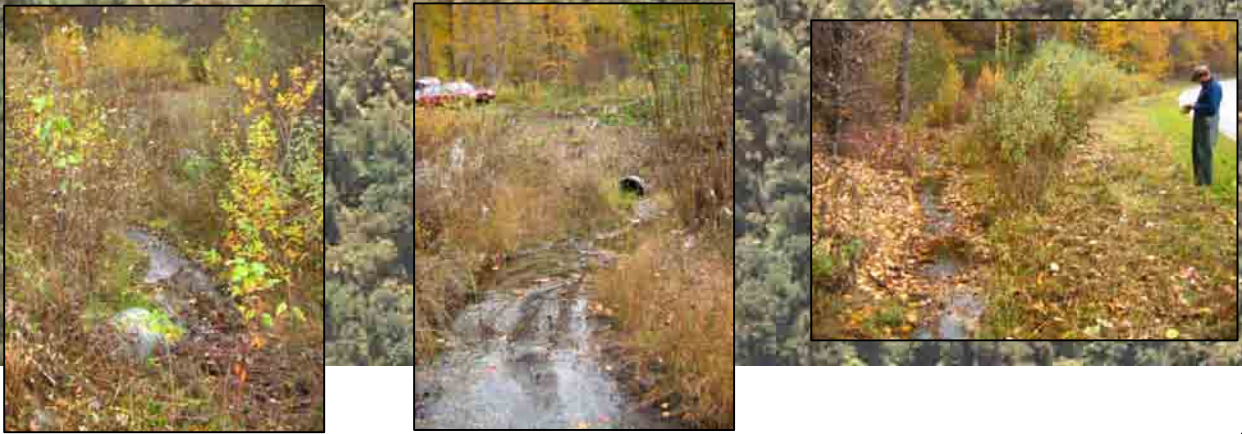
STATION 981+00 TO
1118+00
SALMON SPAWNING
CHUM AND COHO SPAWN IN THIS AREA FROM
SEPTEMBER THROUGH DECEMBER

STATION 1064+00 TO
1125+00
SALMON REARING
COHO AND CHINOOK SALMON REARING

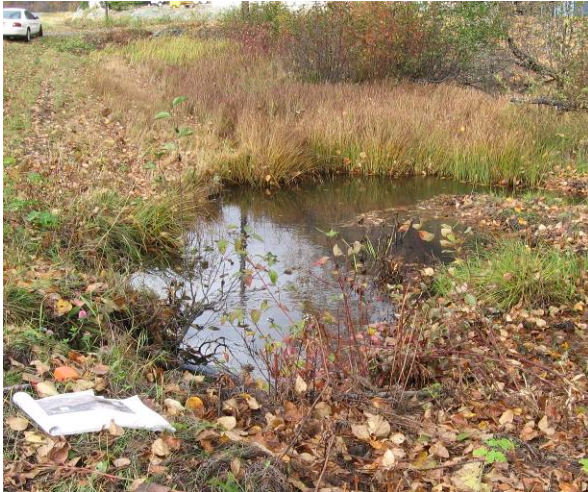
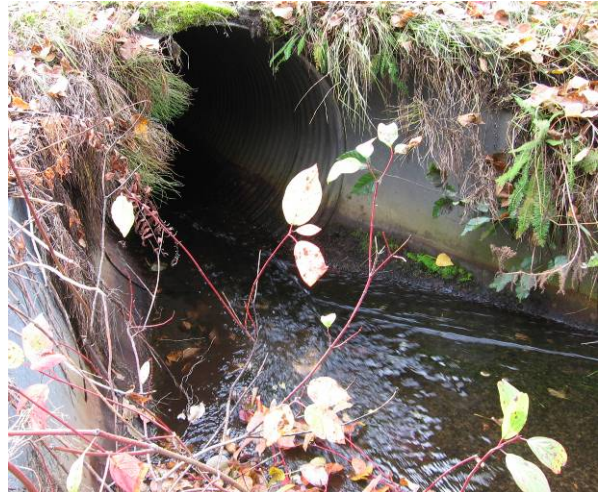
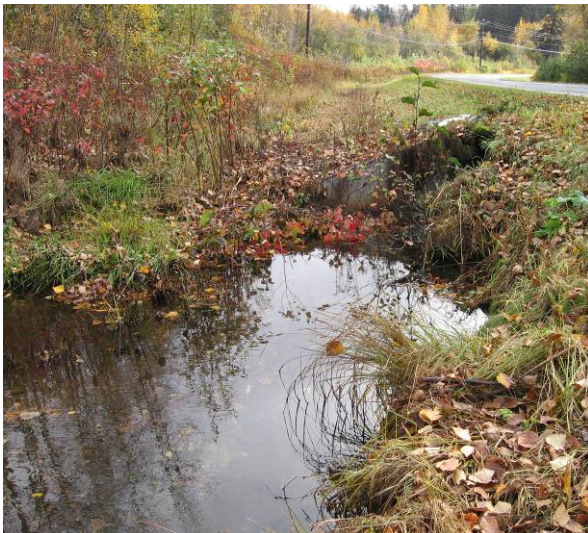
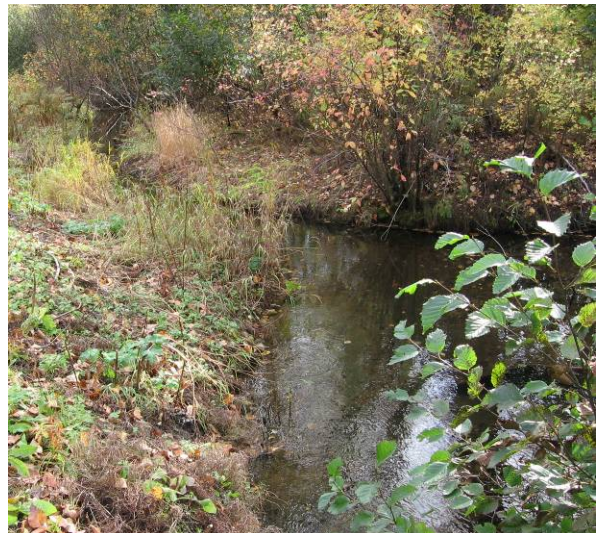
Description: This location was referenced as Station 245+50 in the S&HI. Based on hand measurements, upstream of the culvert the stream is a 3-6' wide, E type channel with a substrate of mixed sand and organics. There is a small pool at the culvert inlet. Downstream of the culvert the stream winds along the toe of the road fill slope back to (S&HI) station 234+50. The upstream half of this reach is also an E type channel 3-6' wide with a sandy/organic substrate. Stream banks are grassy, woody debris is present and alder often overhangs the stream. The lower half of this reach is influenced by the river backwater, wider (6-10'), more open and 6-18" deep. Substrate is silt, sand, fine gravels and organic matter. Aquatic weeds shape the stream meander and banks are grassy or vegetated with alder and willow.

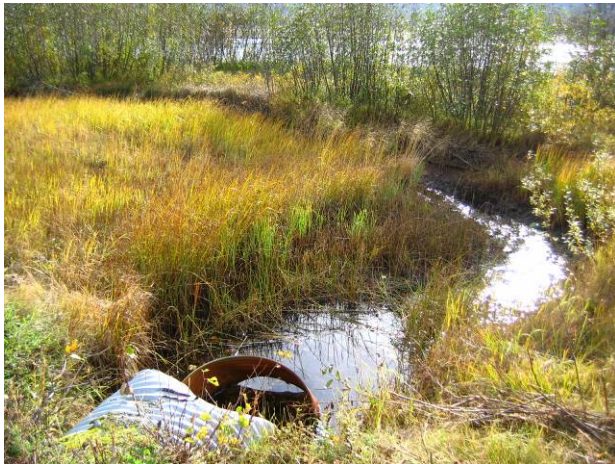
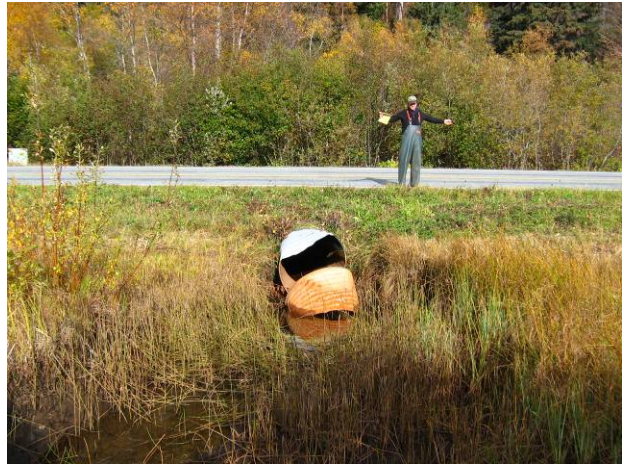
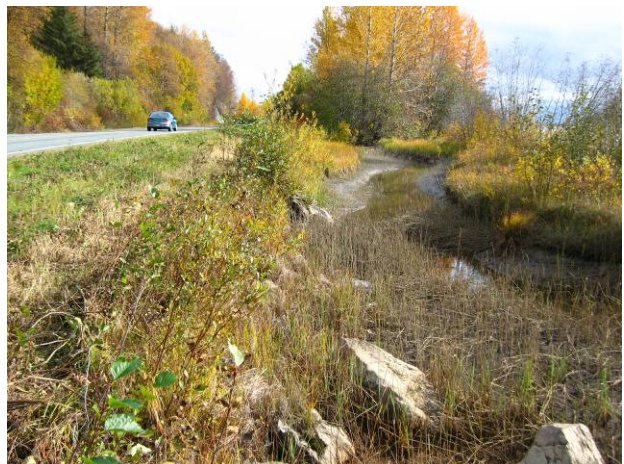
Description: This location was referenced as Station 342+00 in the S&HI. Based on hand measurements, upstream of the culvert the complex channel of the stream meanders among alder roots and downfall. The stream is 1-3' wide with a substrate of gravel and organics. Depth is 6-8" and overhanging cover is dense. The downstream end of the culvert is perched 3-4" and unraveled. The stream meanders along the road back to station 316+50 before entering the Chilkat River. The river backwaters the stream and deposits silt over the gravel bed. The stream is 4-6' wide and 3-4" deep. It lies in an old flood channel of the river. Stream banks are grass covered.
