Essential Fish Habitat Assessment

DRAFT
ESSENTIAL FISH HABITAT ASSESSMENT
HAINES HIGHWAY FROM MP 3.5 TO 25.3
HAINES, ALASKA

DOT&PF Project No. 68606
Federal Project No. SHAK-095-6(28)

DOWL HKM
4041 B Street
Anchorage, Alaska 99503
(907) 562-2000

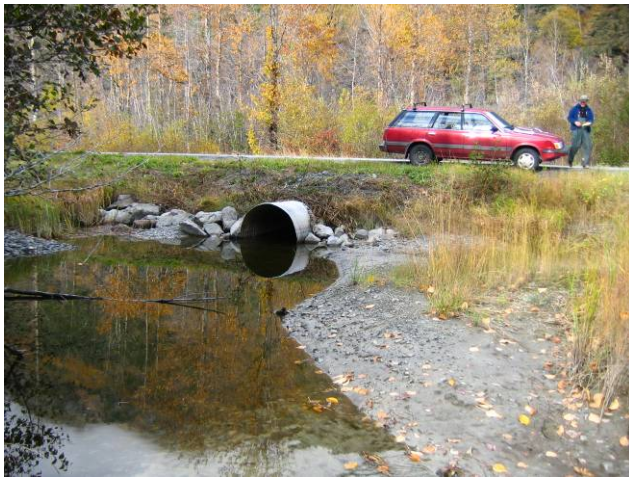
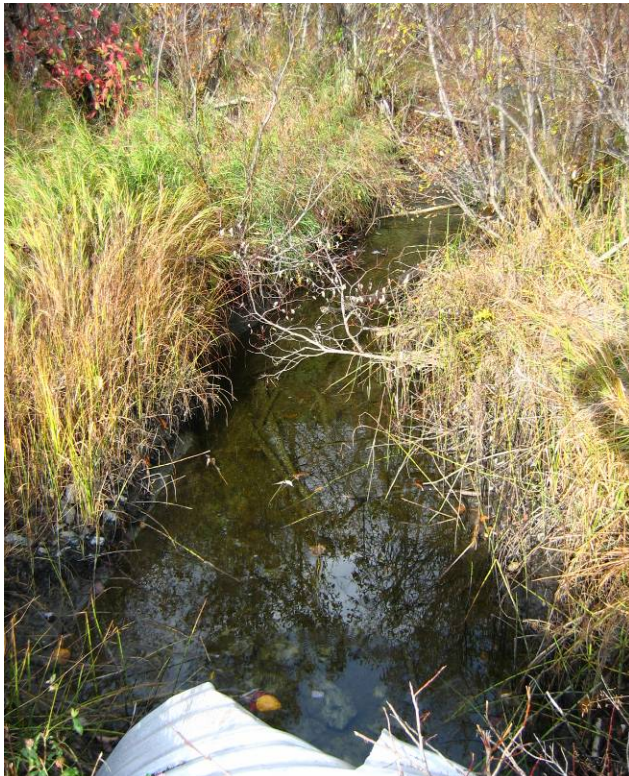
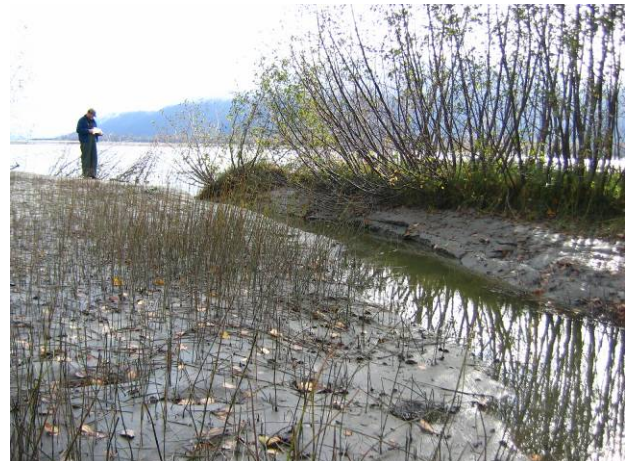
Description: This location was referenced as Station 347+50 in the S&HI. The culvert appears to be fairly recently replaced. Based on hand measurements, upstream of the culvert the stream is a 1-2' wide E type channel with a fine silt and gravel substrate. The stream drains a swamp fed by numerous springs along the toe of the mountain. The culvert outlet empties into a short section of gravel bottomed stream with a width of 2-3' and grassy banks. The stream then turns into a 3-6' wide backwatered slough with a silt substrate. Springs feed this section of the stream.

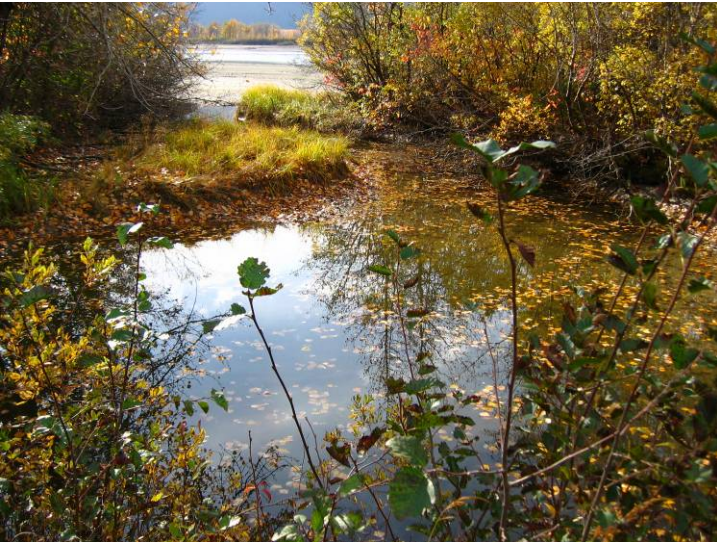
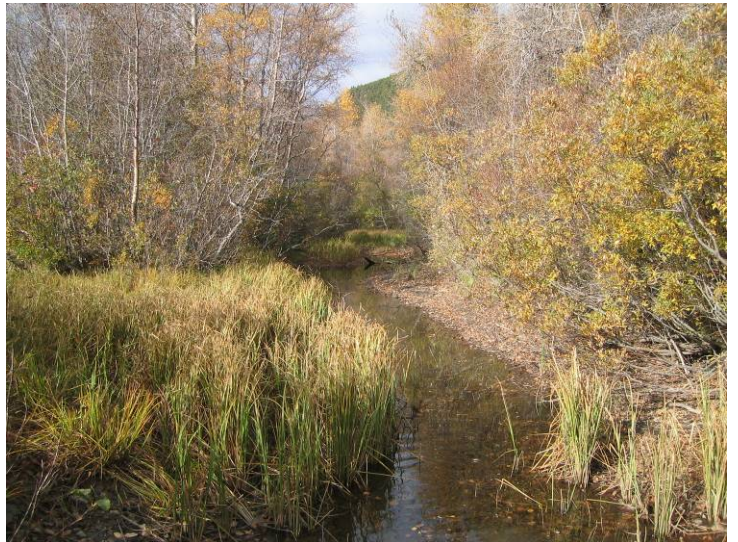
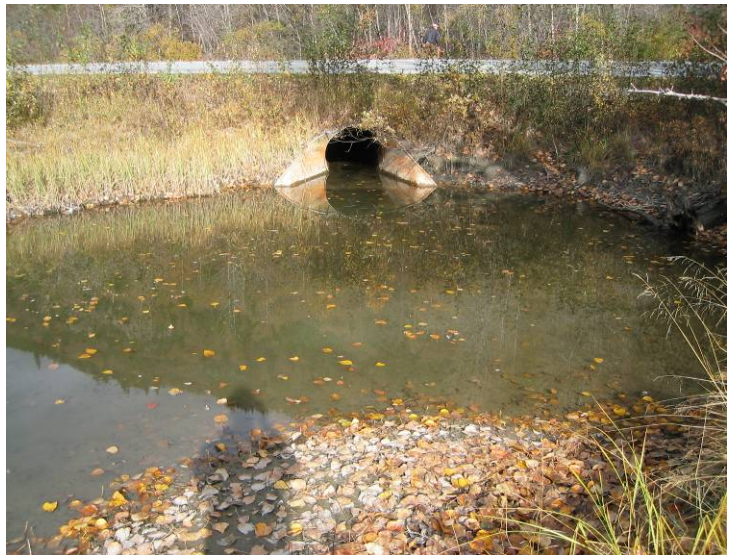
Description: This location was referenced as Station 506+25 in the S&HI. Based on hand measurements, upstream of the culvert the stream is about 8' wide and flows over a silt/organic substrate. The stream is backwatered by the Chilkat River and had a depth of 6-8" at the time of the survey. Banks are muddy and grassy, with willow and alder growing close to the water on one side. The culvert empties into a 30' diameter pool with a depth of 3'. Banks are silty up to the level of frequent river backwater and then formed of grass and young willow/alder. Substrate is silt. Downstream of the pool the channel is 10' wide but terminates abruptly at a sandbar about 125' from the road. A small trickle flows over the sandbar and into an isolated pool. Fish access is dependent on the river water level.

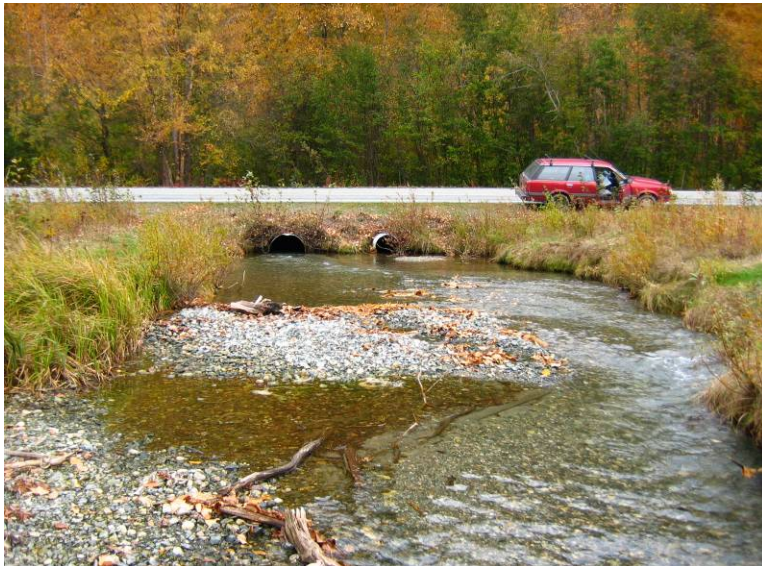
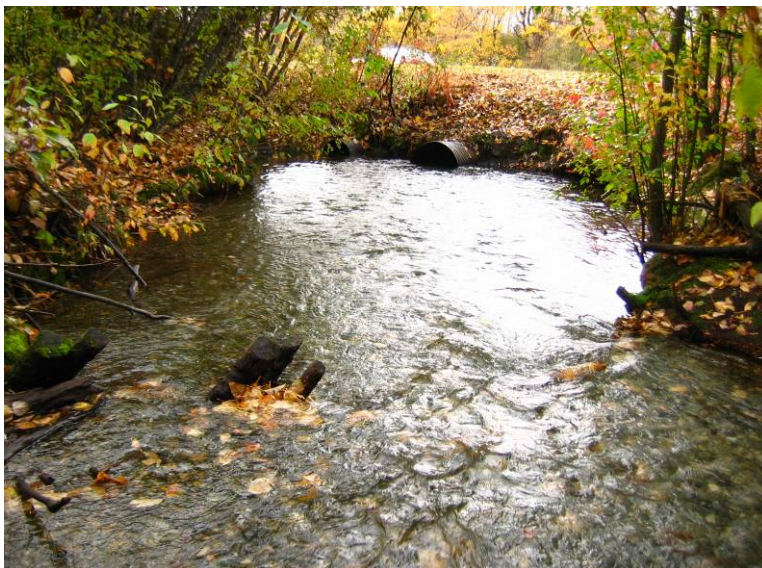
Description: This location was referenced as Station 535+50 in the S&HI. Based on hand measurements, upstream of the culverts the stream is about 15' wide and flows in riffles over ideal spawning gravels. The banks are well vegetated and overhang the stream. A hydroelectric plant is upstream. Downstream of the culverts the stream varies in width from 15-20', the bottom is gravel and the stream is heavily utilized by spawning salmon. Stream banks are fully vegetated with grasses. Further downstream the stream meanders through a wide, old river channel that is frequently backwatered by the river.

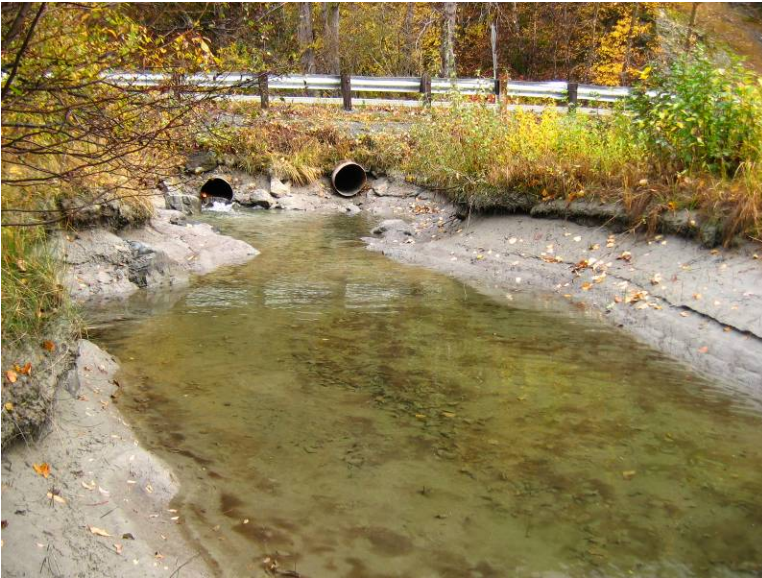
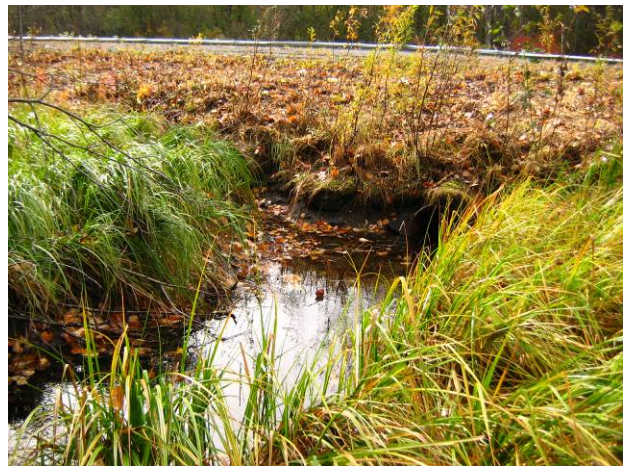
Description: This location was referenced as Station 612+40 in the S&HI. Based on hand measurements, upstream of the culverts the stream is a 2' wide E type channel with a very low gradient. It is infrequently backwatered by the Chilkat River. The banks are thickly vegetated with grasses and the substrate is a blend of organics and silt. The stream leads into a broad swamp. Downstream of the culvert the stream banks are bare sand and the stream is heavily backwatered by the river. The substrate is silt/gravel and there is no cover.

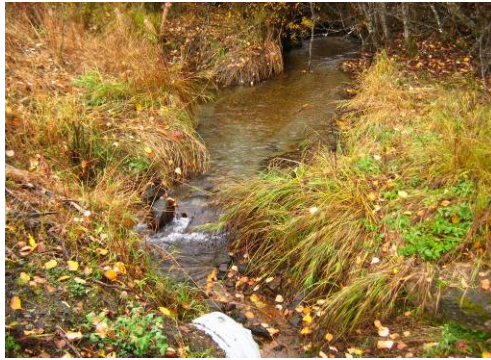
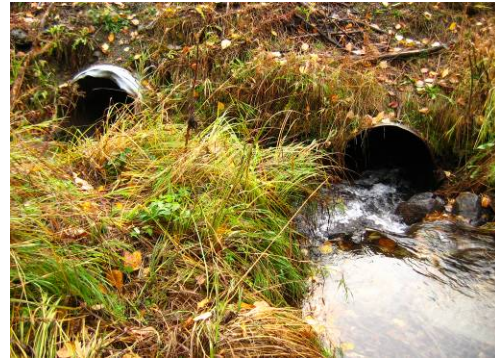
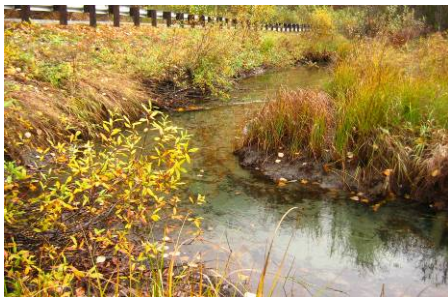
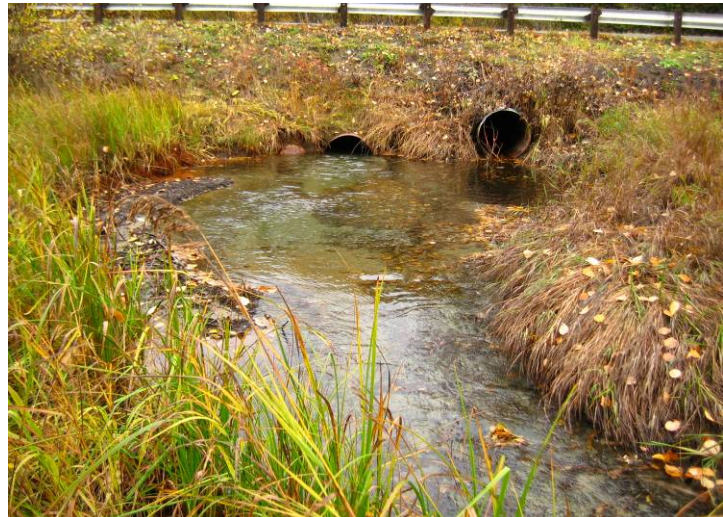
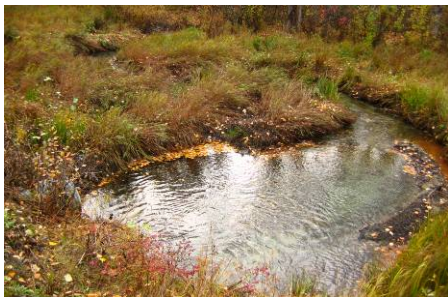
Description: This location was referenced as Station 670+00 in the S&HI. Based on hand measurements, upstream of the culverts the stream splits almost immediately. The minor branch runs in a roadside ditch up to near (S&HI) station 680+30 where it turns away from the road. The section along the road is an E type channel 2' wide and +1' deep. The banks are vegetated with grasses that frequently overhang the full width of the stream. Substrate is gravel. Where it cuts away from the road, this section of the stream broadens and winds through established forest. The major branch of the stream is gravel bottomed and meanders away from the road in a stable bed with well forested banks. Downstream, the culverts empty into a broad 15' by 20' pool that leads into a 4-8' wide E-channel backwatered at times by a beaver dam and the influence of a side channel of the river. The stream joins the river near (S&HI) station 668+40. The stream banks are predominantly grass, with some willow. At times, the stream flows directly along the toe of the road fill. The lower section of the stream is much less well vegetated than the upper portion.

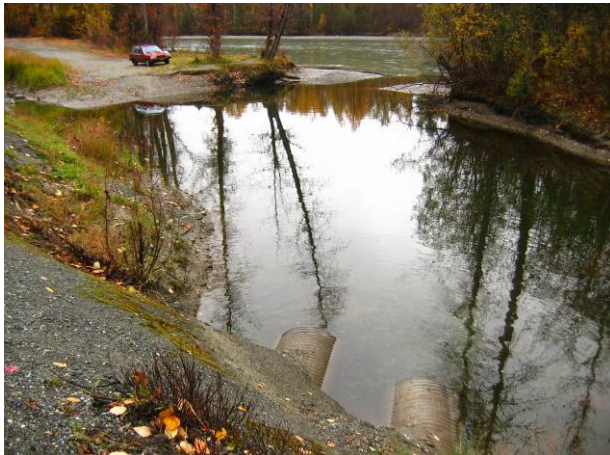
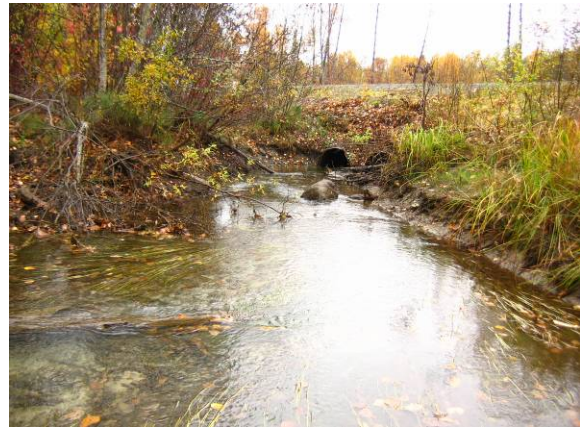
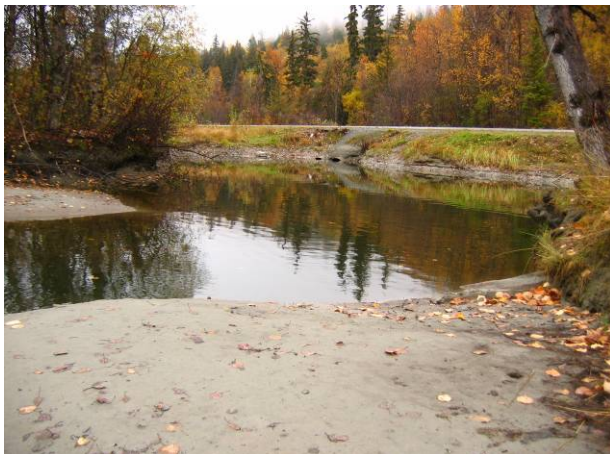
Description: This location was referenced as Station 731+00 in the S&HI. Based on hand measurements, upstream of the culverts the stream is 8-10' wide and leads into a vegetated meadow. Stream banks are stable and vegetated with grasses and willow. The substrate is loose silt and organic matter. There is some backwatering by the river. The outlets of the culverts are nearly submerged even at low river levels and empty into a large, deep pool that acts as both a rearing area for fish and a boat launch site. The pool empties into the river via a short channel. There is some overhanging vegetation on one side of the pool. Substrate is sand and silt.

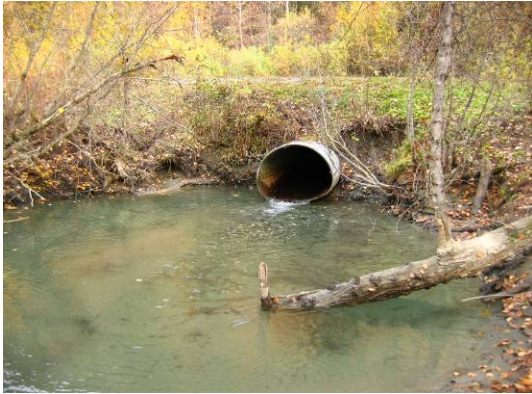
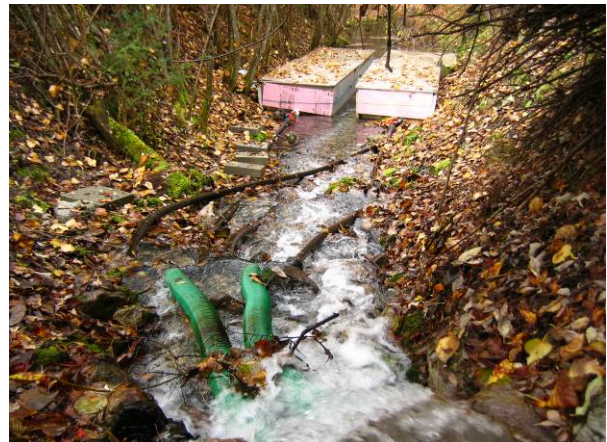
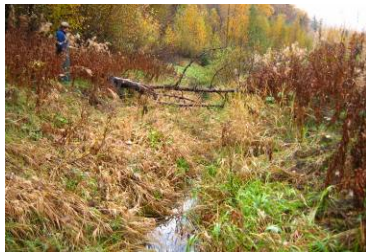
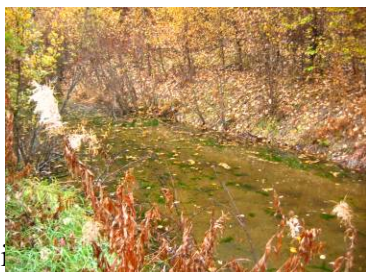
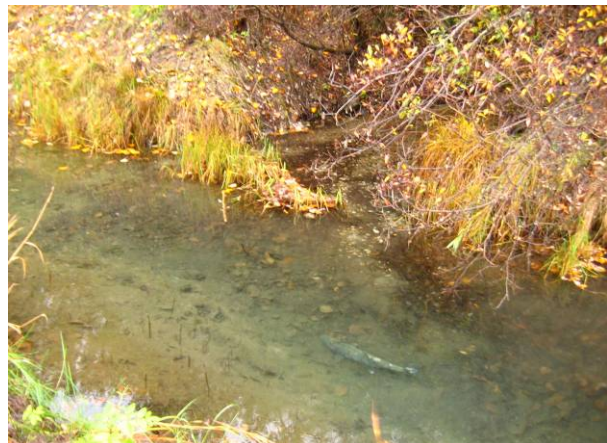
Description: This location was referenced as Station 886+00 in the S&HI. The stream upstream of the culvert is a man-made complex consisting of two distinct branches. The main branch is a spring fed channel that runs up to 2009 station 871+75 where it ends in a beaver dam or man-made berm. Based on hand measurements, the lower half of this channel is excavated with a consistent 8-10' width and forms a slow moving pool 1-2' deep. The steep banks are vegetated with overhanging grasses. Several springs feed into the channel from under the bank on the mountain side. The upper half of the channel is a 2-3' wide riffle winding through boulders and thickly vegetated with grasses. The second branch of the complex feeds into the main branch about 100' upstream of the culvert inlet. This branch is fed by a series of springs, as well as a mountain stream, and rises in a series of pools and riffles up to a chum salmon incubation box facility operated by the Northern Southeast Regional Aquaculture Association. The stream substrate is gravel/cobble and the banks are well vegetated. Downstream, the culvert outlet empties into a large pool used as a holding area for adult chum salmon. The pipe is perched 4". Pool substrate is silt covered gravel. A short channel connects the pool to a side channel of the Chilkat River.

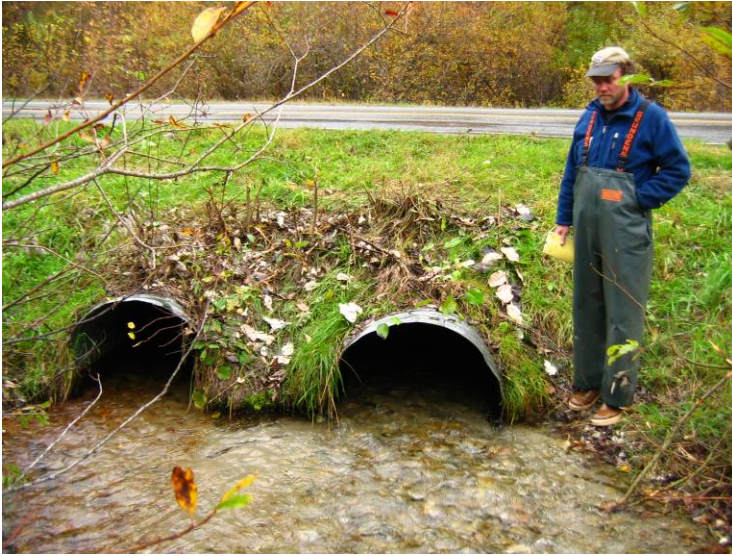
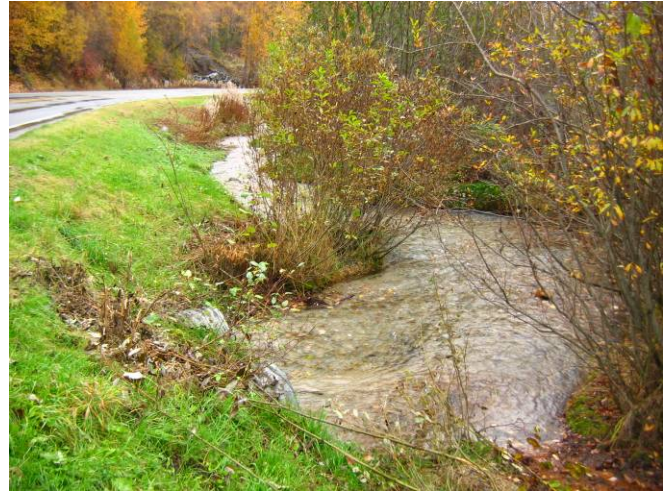
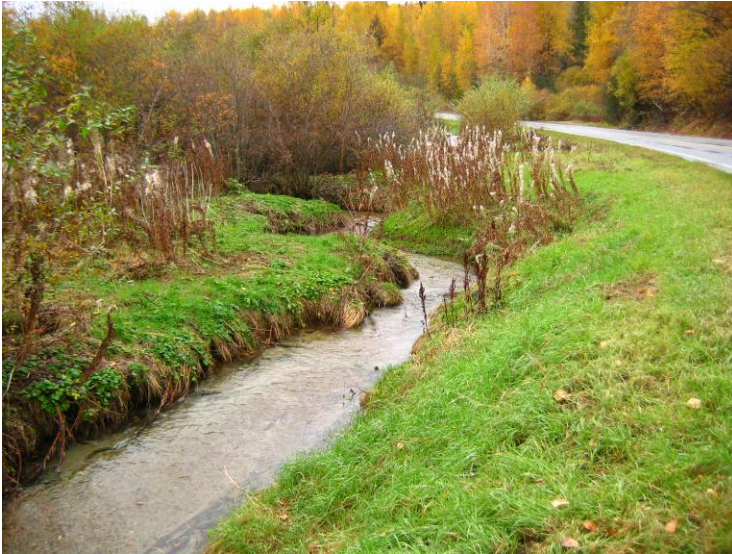
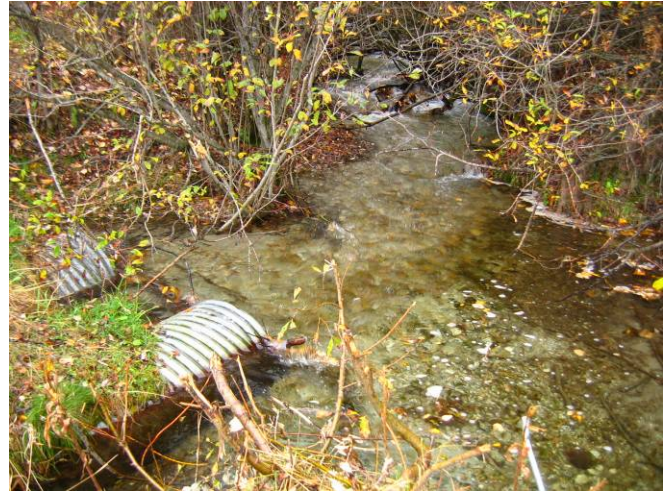
Station 917+00 – Existing conditions photos (cont'd)

Description: The existing location of stream crossing of the highway was referenced as Station 917+00 in the S&HI. Upstream of the culverts the stream is a fast 4-6% continuous riffle with a rocky substrate. The stream is 4-6' wide and meanders through a young forest. Downstream of the culverts the stream meanders along the existing road, intersecting the new alignment centerline at (2009) station 887+60. The roughly 1200' of stream between the culvert outlet and the confluence with Eighteen Mile Slough can be approximately divided by habitat type into three reaches. The first 400' section, measured from the culvert outlet downstream, is a 4-6' wide E-channel composed primarily of riffles, with a substrate of gravel. Although it is of similar width, the second 400' section is flatter in gradient and more complex, composed of riffles combined with numerous deep pools associated with the root structures of well established vegetation. The substrate of this reach is more silt/organic, although the November 2005 flood did deposit a good deal of gravel. The downstream reach connecting to the slough widens to a maximum width of 15' and is subject to backwatering when the Chilkat River is high. The stream substrate is silt, and the banks are steep and well vegetated. Two small streams draining adjacent wetlands enter Horse Farm Creek from the west.

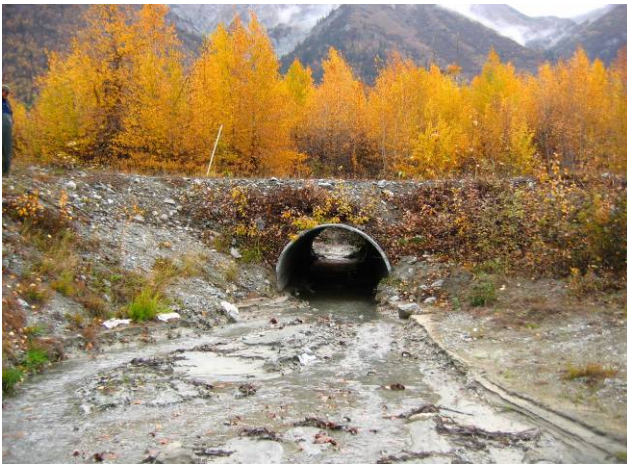
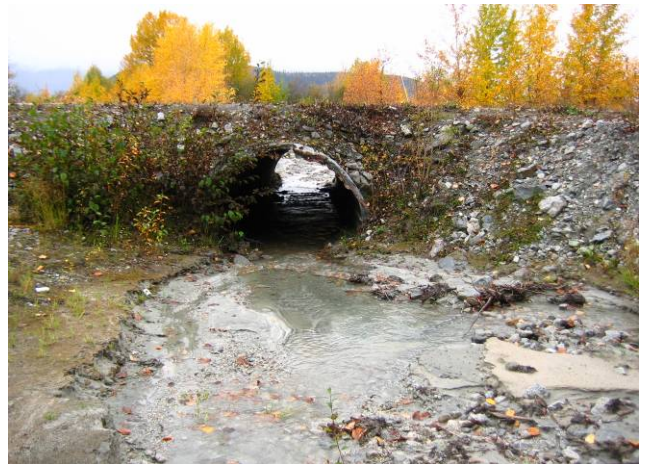
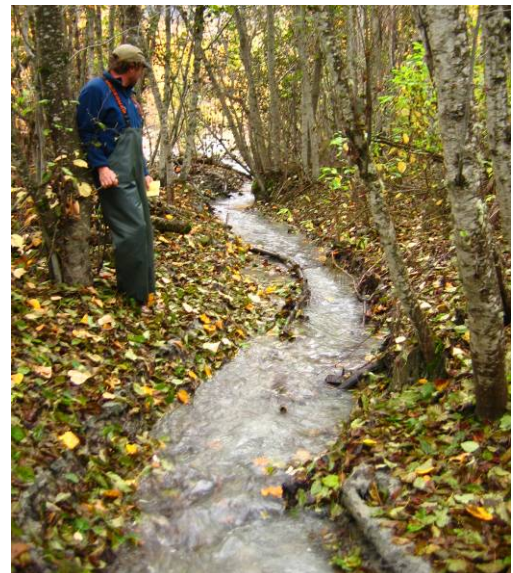
Description: This location was referenced as Station 983+25 in the S&HI. This stream is part of the 19 mile slide area and is subject to alteration by the periodic influx and mechanical removal of large quantities of slide material. This material consists of fine decomposed rock and gravels mixed with cobbles. The stream above the culvert runs in an open ditch along the road back to (2009) station 958+00. No vegetation is present yet numerous juvenile fish were seen in the stream. The stream turns away from the road and runs toward the mountain for about 75’ before any upstream movement of fish is prevented by a barrier falls. Downstream of the culvert the stream is braided and open until it intersects the woods several hundred feet below the pipe. The substrate is slide material and initially there is little vegetation. Once the stream enters the woods it is a 2-3’ wide fast riffle until it empties into a series of riverside pools fed by upwelling water.

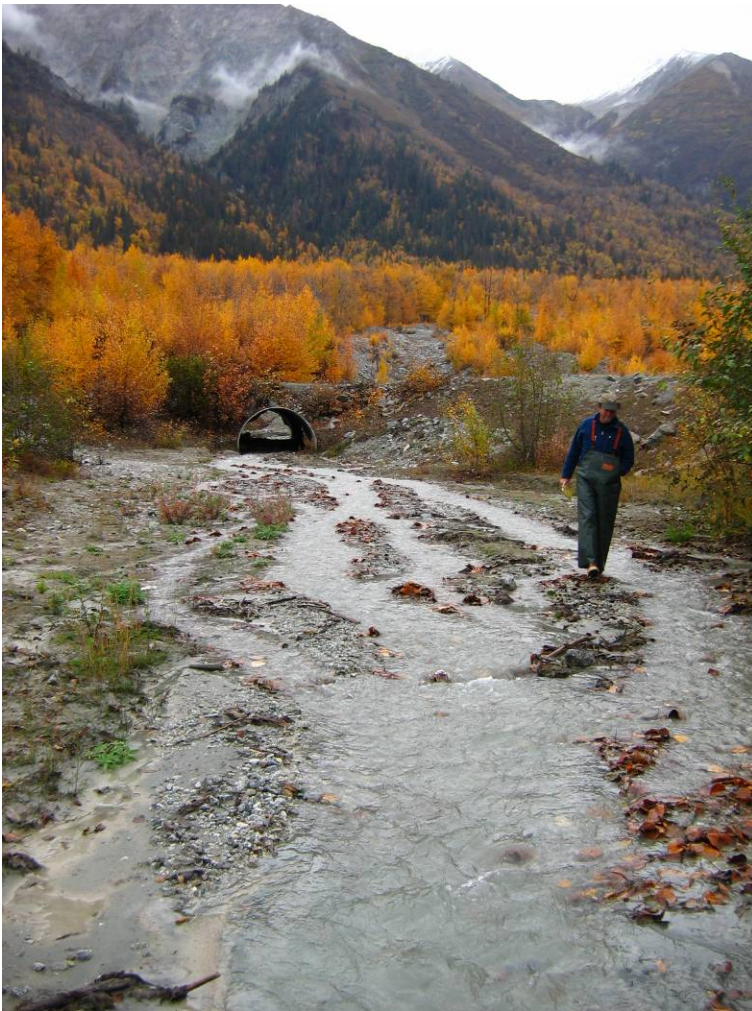
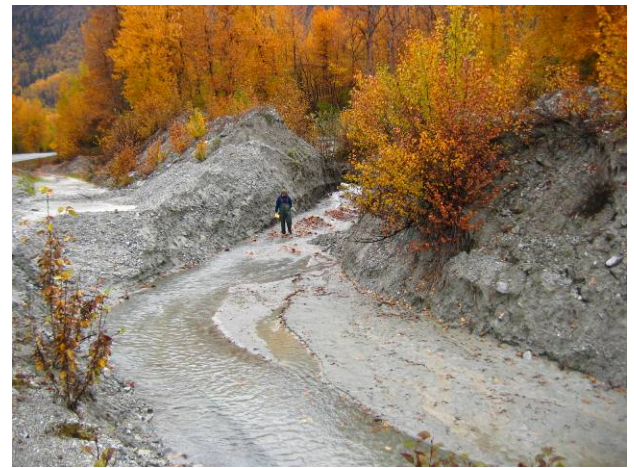
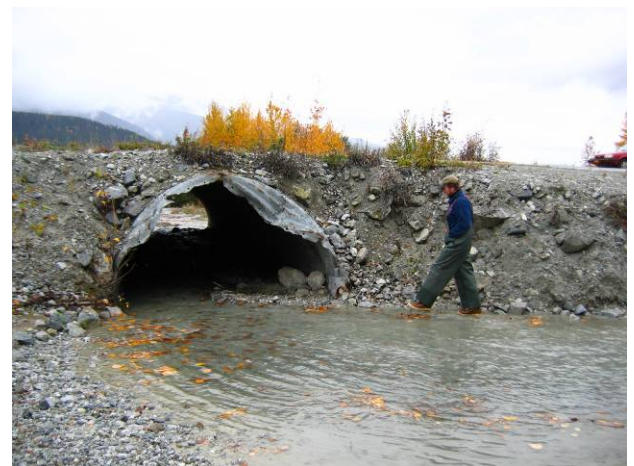
Description: This location was referenced as Station 994+50 in the S&HI. The stream above the culvert of this 19 mile slide stream is very unstable and often excavated by heavy equipment. Substrate is mobile slide material. Some vegetation is beginning to be established on the banks. Fish passage above the culvert is blocked by a headcut upstream 200'. Downstream of the culvert the stream is initially a braided riffle with little sign of viable fish habitat. Two hundred feet downstream of the culvert outlet the stream becomes a steep cascade through boulders until it enters the river.

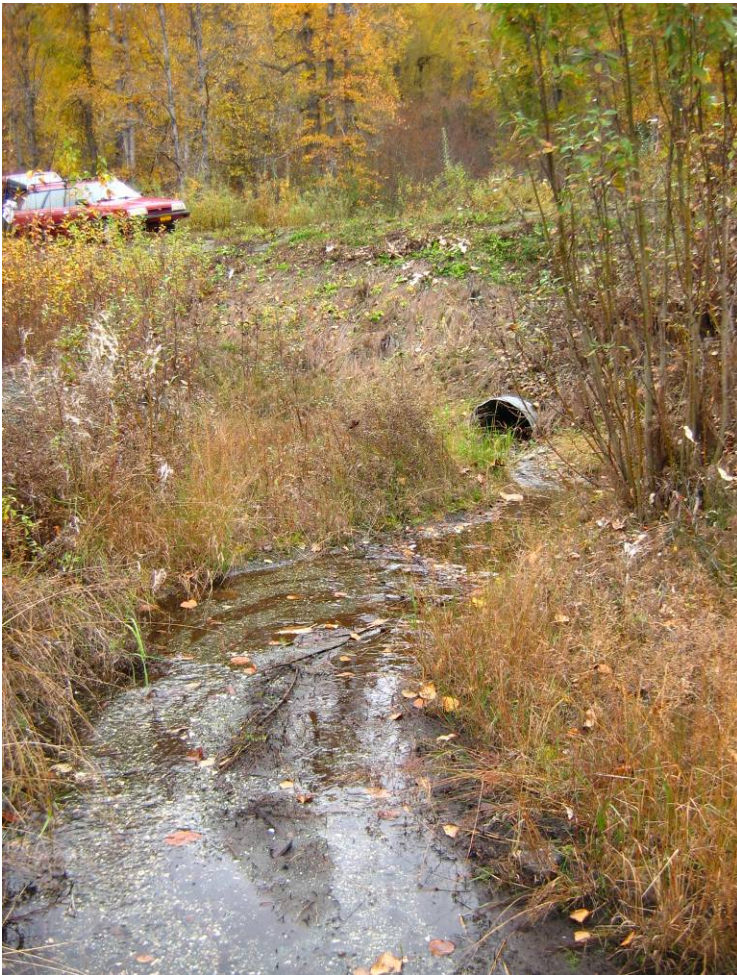
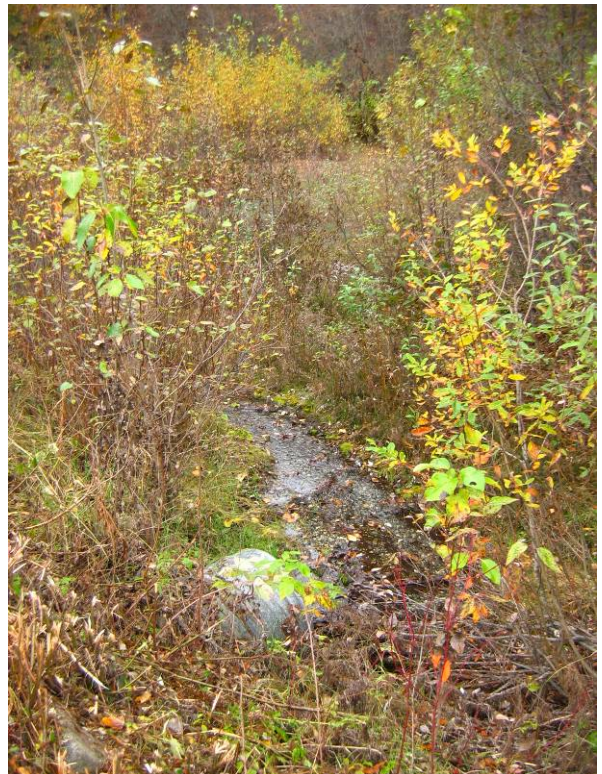
Description: This location was referenced as Station 1123+25 in the S&HI. Based on hand measurements, upstream of the culverts the stream is 1-2' wide and composed of riffle habitat. The stream runs alongside the road up to (2009) station 1107+00 before the channel turns away from the road. For the first 150' above the culvert the stream lies away from the toe of the road fill slope and cover is provided by adjacent willow and alder. The stream then runs tight along the toe and the banks are vegetated with grasses. Downstream of the culvert the stream flows through a manipulated habitat with patches of willow and grasses beginning to be established. For both portions of the stream the substrate is small gravel.

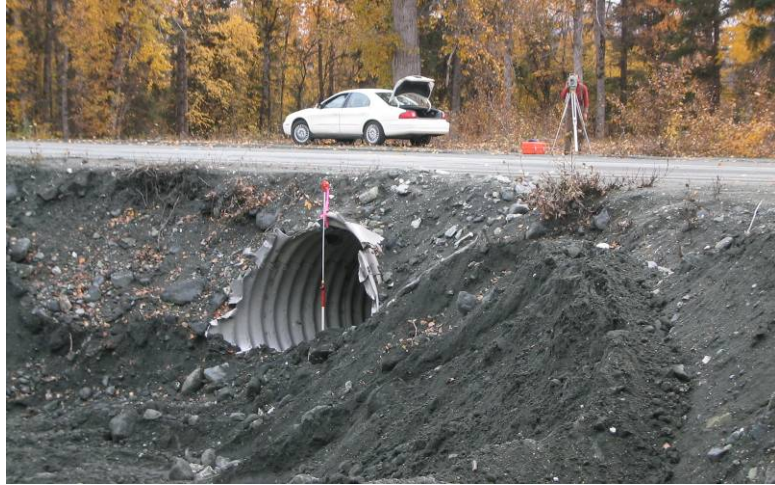
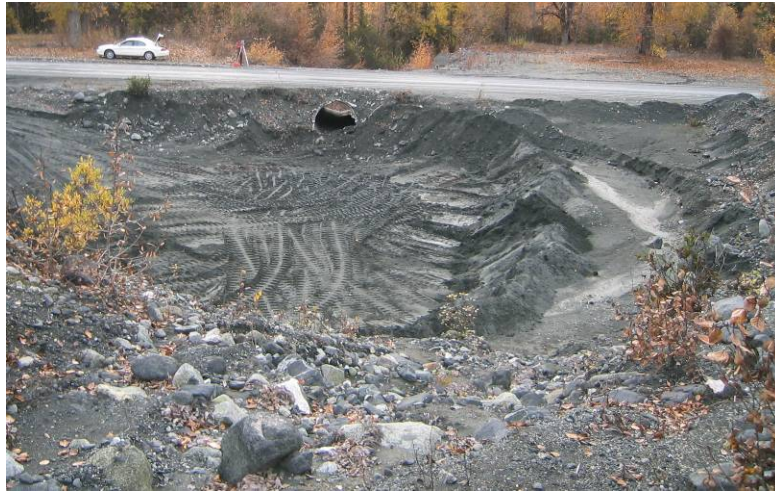
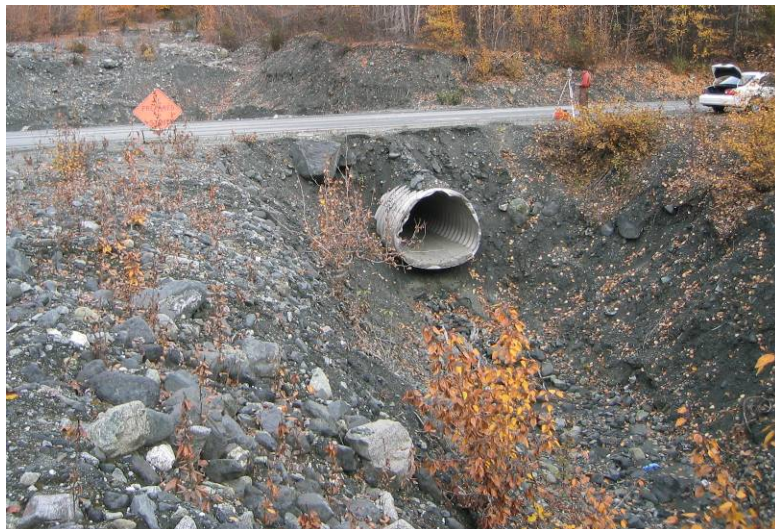
20.3 Station 1187+25 – Existing conditions photos

Existing Culvert: 8'-2" x 5'-9" pipe arch

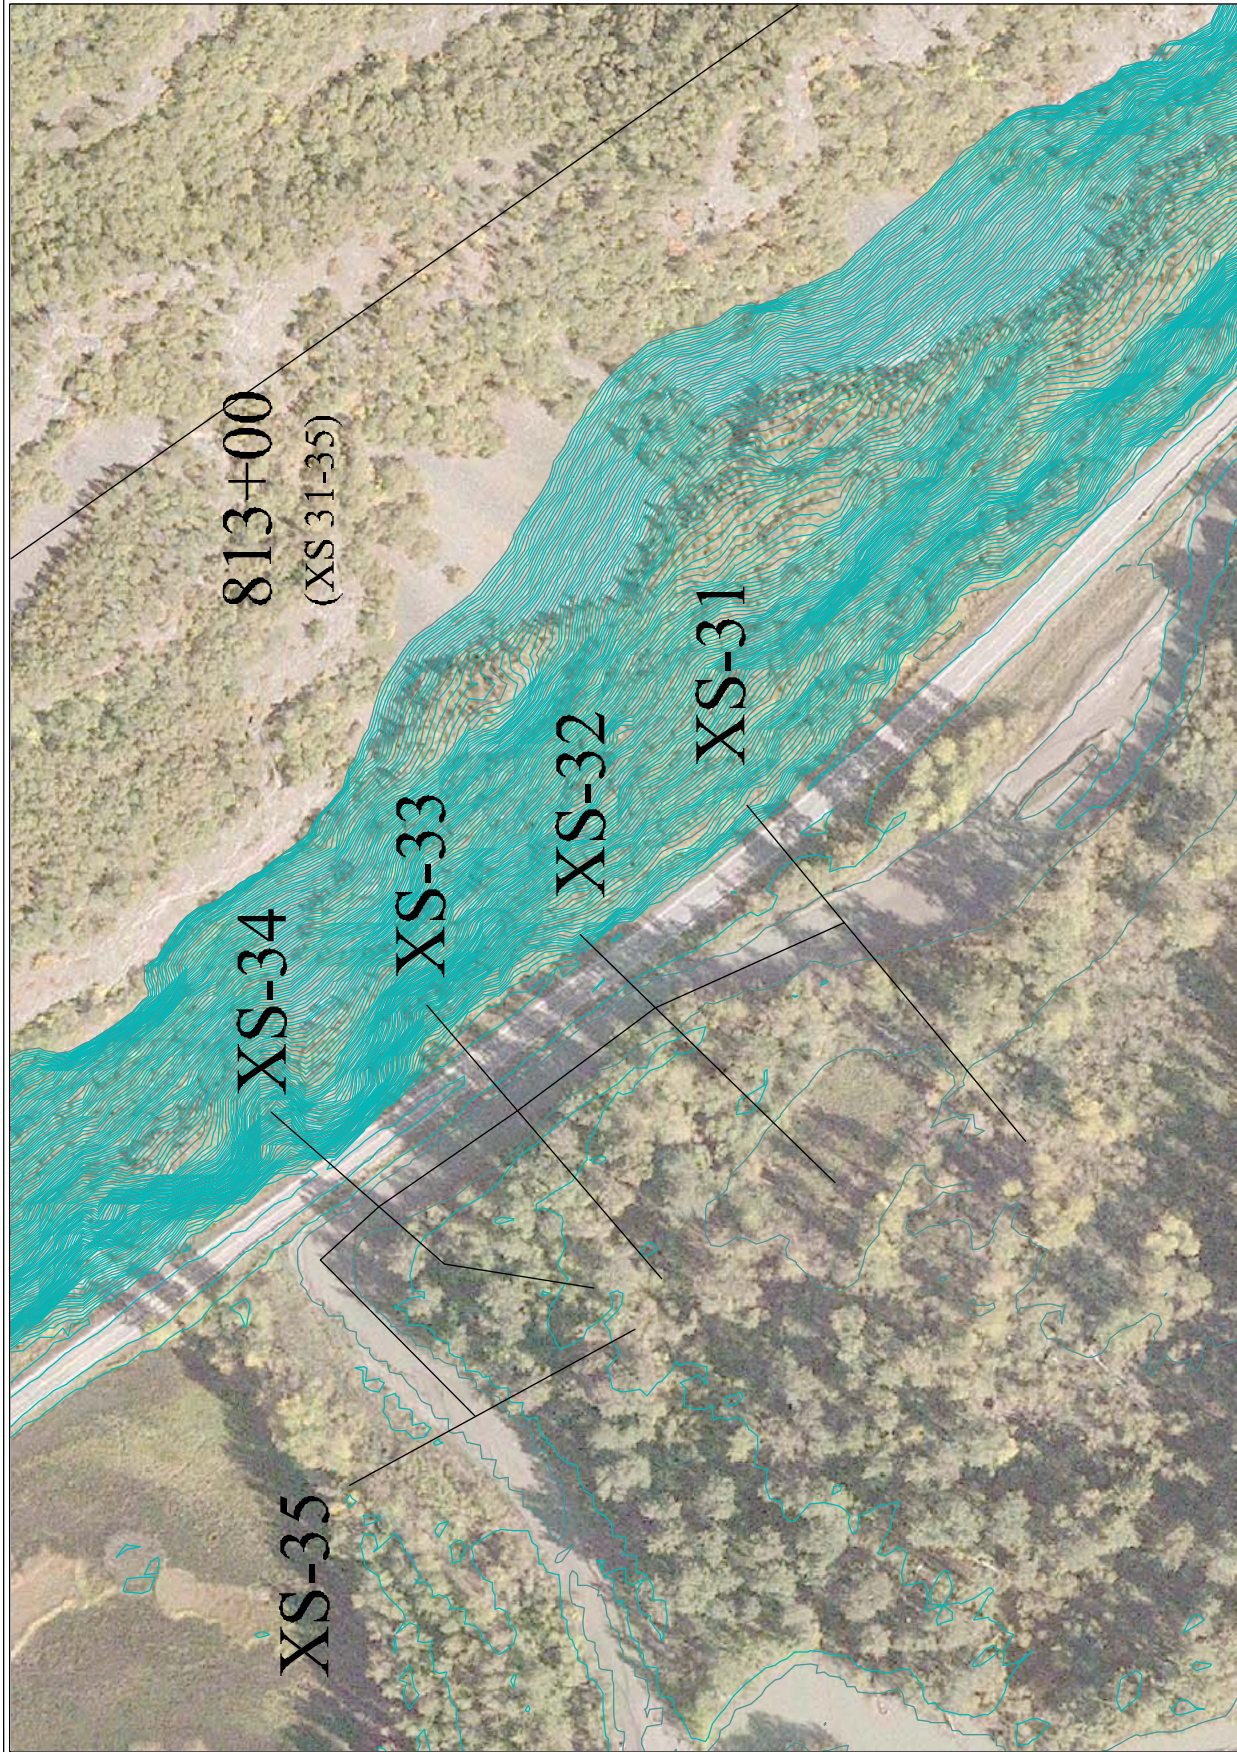
Haines Highway – HEC-RAS Schematic

S&HI Station 813+00

Conversion from relative datum: As described in Section 3.2 cursory survey was collected as part of Inter-Fluve’s October 2005 field investigations. These survey data were used for the preliminary HEC-RAS hydraulic modeling shown in this appendix. Approximate conversions to ADOT&PF datum was obtained by comparing elevations of features at each site surveyed by Inter-Fluve and ADOT&PF or Toner-Nordling. The approximate datum conversion is noted below. Subtract the elevation difference noted in the table from the Inter-Fluve survey and models for stations noted in the table to obtain approximate ADOT&PF elevations. Elevations for culverts not noted in the table are based on ADOT&PF datum. Design level survey of stream cross sections, topography, bathymetry and profiles – based on ADOT&PF project datum - will be required at all culverts to finalize designs for submittal at Plans-in-Hand.

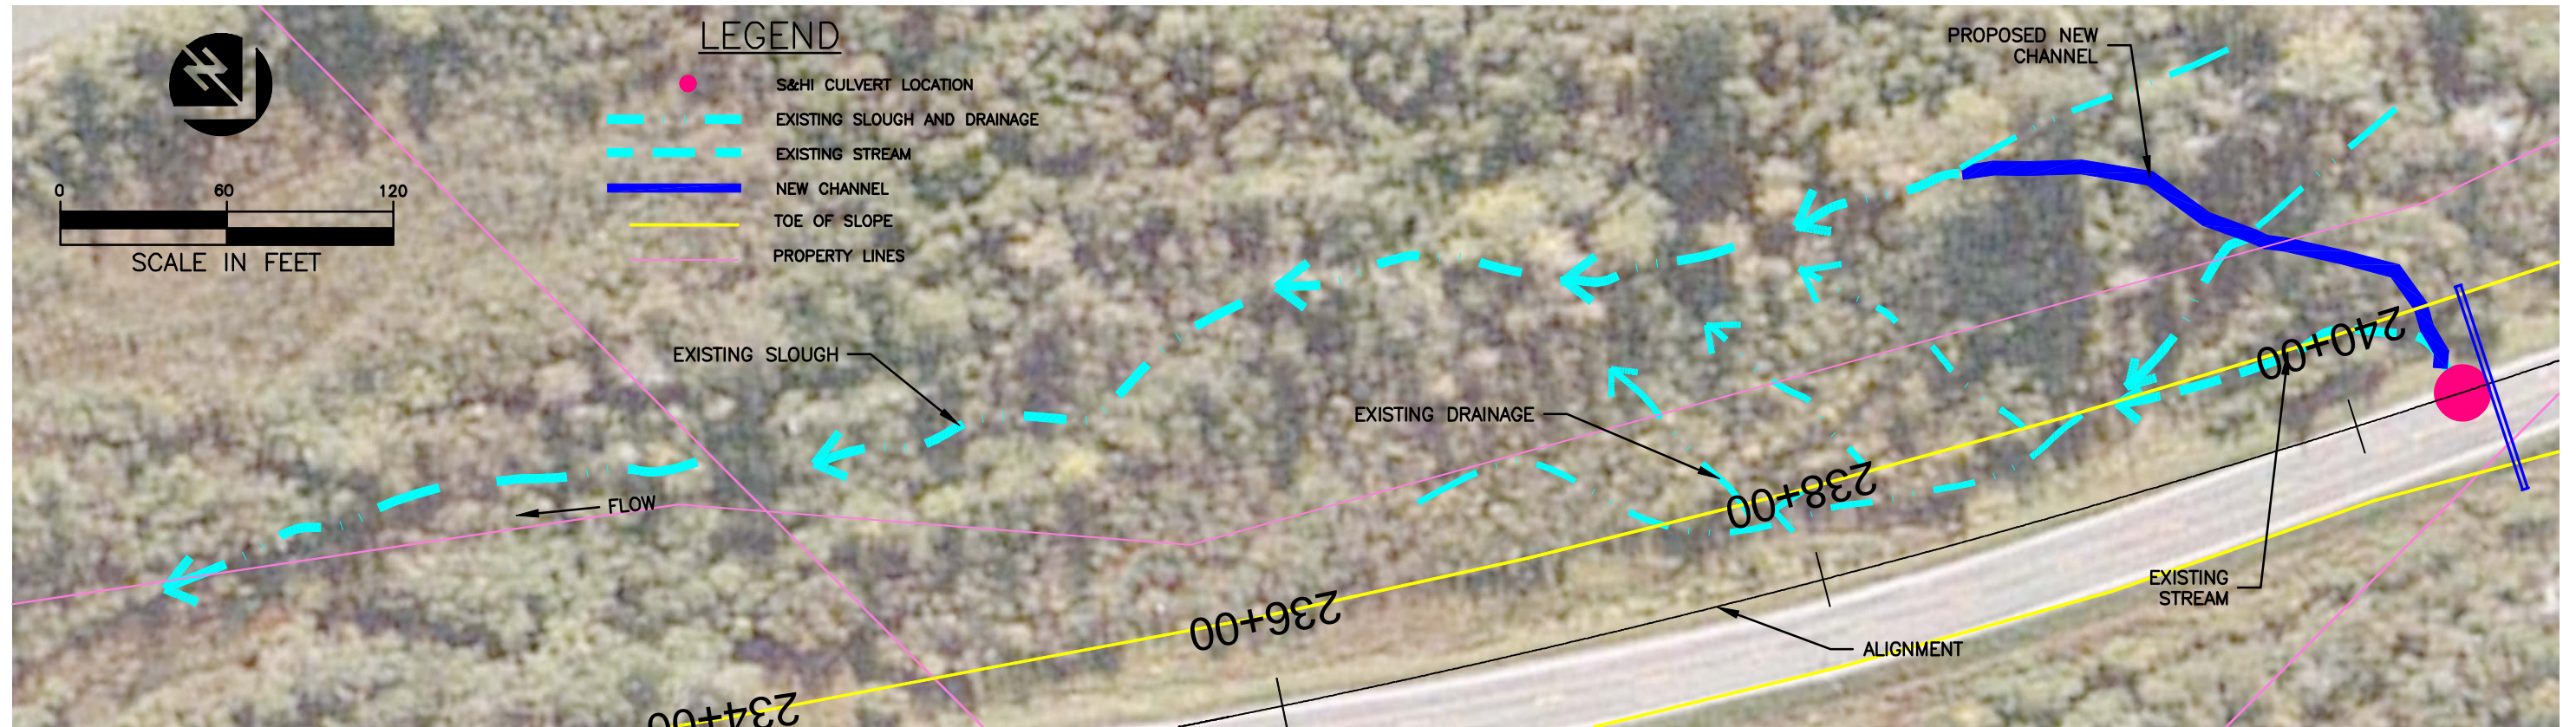
PLAN VIEW: PROPOSED CONDITIONS 240+38

Existing Stream Conditions (length)	Proposed Stream Enhancements (length)
24" culvert; channel 150-250' length along highway toe of slope; left bank has limited riparian vegetation.	Create 200' of new channel away from highway toe of slope; woody debris added, riparian vegetation encouraged on both banks, rearing habitat. New Tier 2 fish passage culvert.

Station Number	Appendix E		Existing Stream Conditions (length)	Proposed Stream Enhancements (length)
	Page	Sheet		
240+38	5	3-4	24" culvert; channel 150-250' length along highway toe of slope; left bank has limited riparian vegetation.	Create 200' of new channel away from highway toe of slope; woody debris would be added, riparian vegetation encouraged on both banks would provide rearing habitat. New Tier 2 fish passage culvert.
319+13	9	5	36" culvert; channel is 225' along highway toe of slope (100' directly impacted by new alignment); left bank with limited riparian vegetation.	Create 100' of new channel away from highway toe of slope; willow plantings along channel and river to encourage riparian habitat growth and provide additional riverbank stability. New Tier 1 fish passage culvert.
512+24	13-14	6-7	1,000' of stream follows relic side channel of river along toe of existing road embankment; at high water, slow flows through thick aquatic vegetation (swamp horsetail and sedges), slough-like; limited riparian vegetation on left bank.	Create 1,000' of new stream channel away from highway toe of slope; located on relic gravel bar for substrate, placement of woody debris, low gradient deep water channel would provide rearing habitat. New Tier 1 fish passage culvert would be installed.
